**STREAM PASSAGE IMPEDIMENTS
AND AQUATIC HABITAT
FRAGMENTATION INVENTORY**

**MILWAUKEE RIVER AND LAKE
MICHIGAN TRIBUTARY STREAMS
OZAUKEE COUNTY, WISCONSIN**

November 16, 2006

Project Number: OZC 01-5400-3000

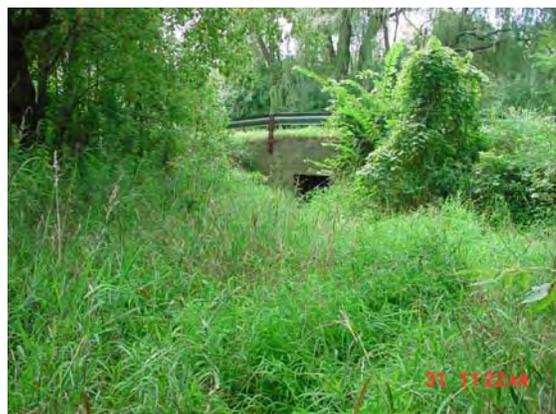
Photograph 2 – River Road Bridge
Lac du Cours Outlet Creek

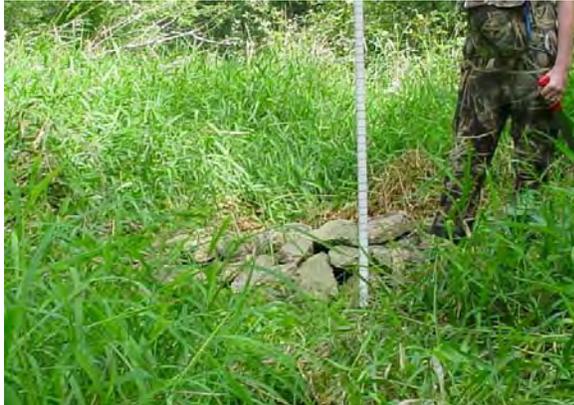
Photograph 3 – Lac du Cours Outlet Creek
Concrete riprap deposit

Between these abutments, the bankfull cross-sectional area of the channel is roughly one-tenth of that found in the stable reach upstream. The constriction likely results in swift flow velocities that are too fast for adult northern pike to traverse during spring-melt (the season when creeks are often swollen and northern pike migrate to spawn). If by chance adult northern pike did make it upstream to the small unnamed lake, another barrier could prevent their offspring from returning to the Milwaukee River. This barrier is a small deposit of concrete riprap that was placed across the channel, likely as a foot crossing (Photograph 3). During flooded conditions it is most likely irrelevant to stream and habitat connectivity. At less than bankfull flows, however, the pervious fill is likely a barrier to larval northern pike passage.

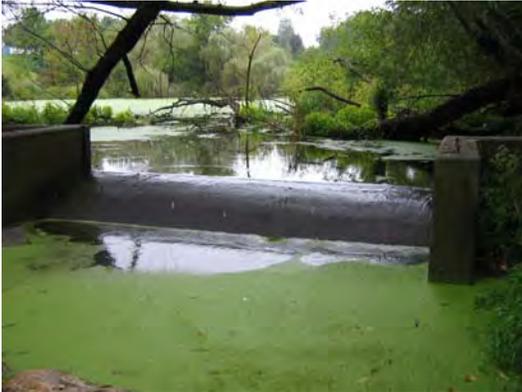
Photograph 1 – Low-head concrete dam (FC PB8)

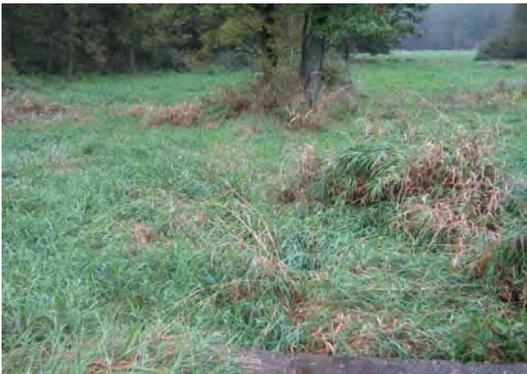
Photograph 5 – Channel lost to wetland infiltration (FC PB15)

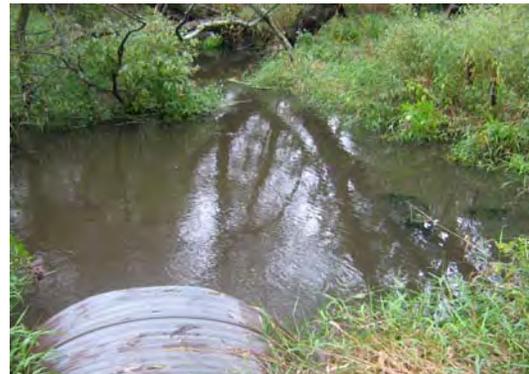
Photograph 6 – Culverts under Waubedonia Park snowmobile trail with downstream scour pool (FC PB15)

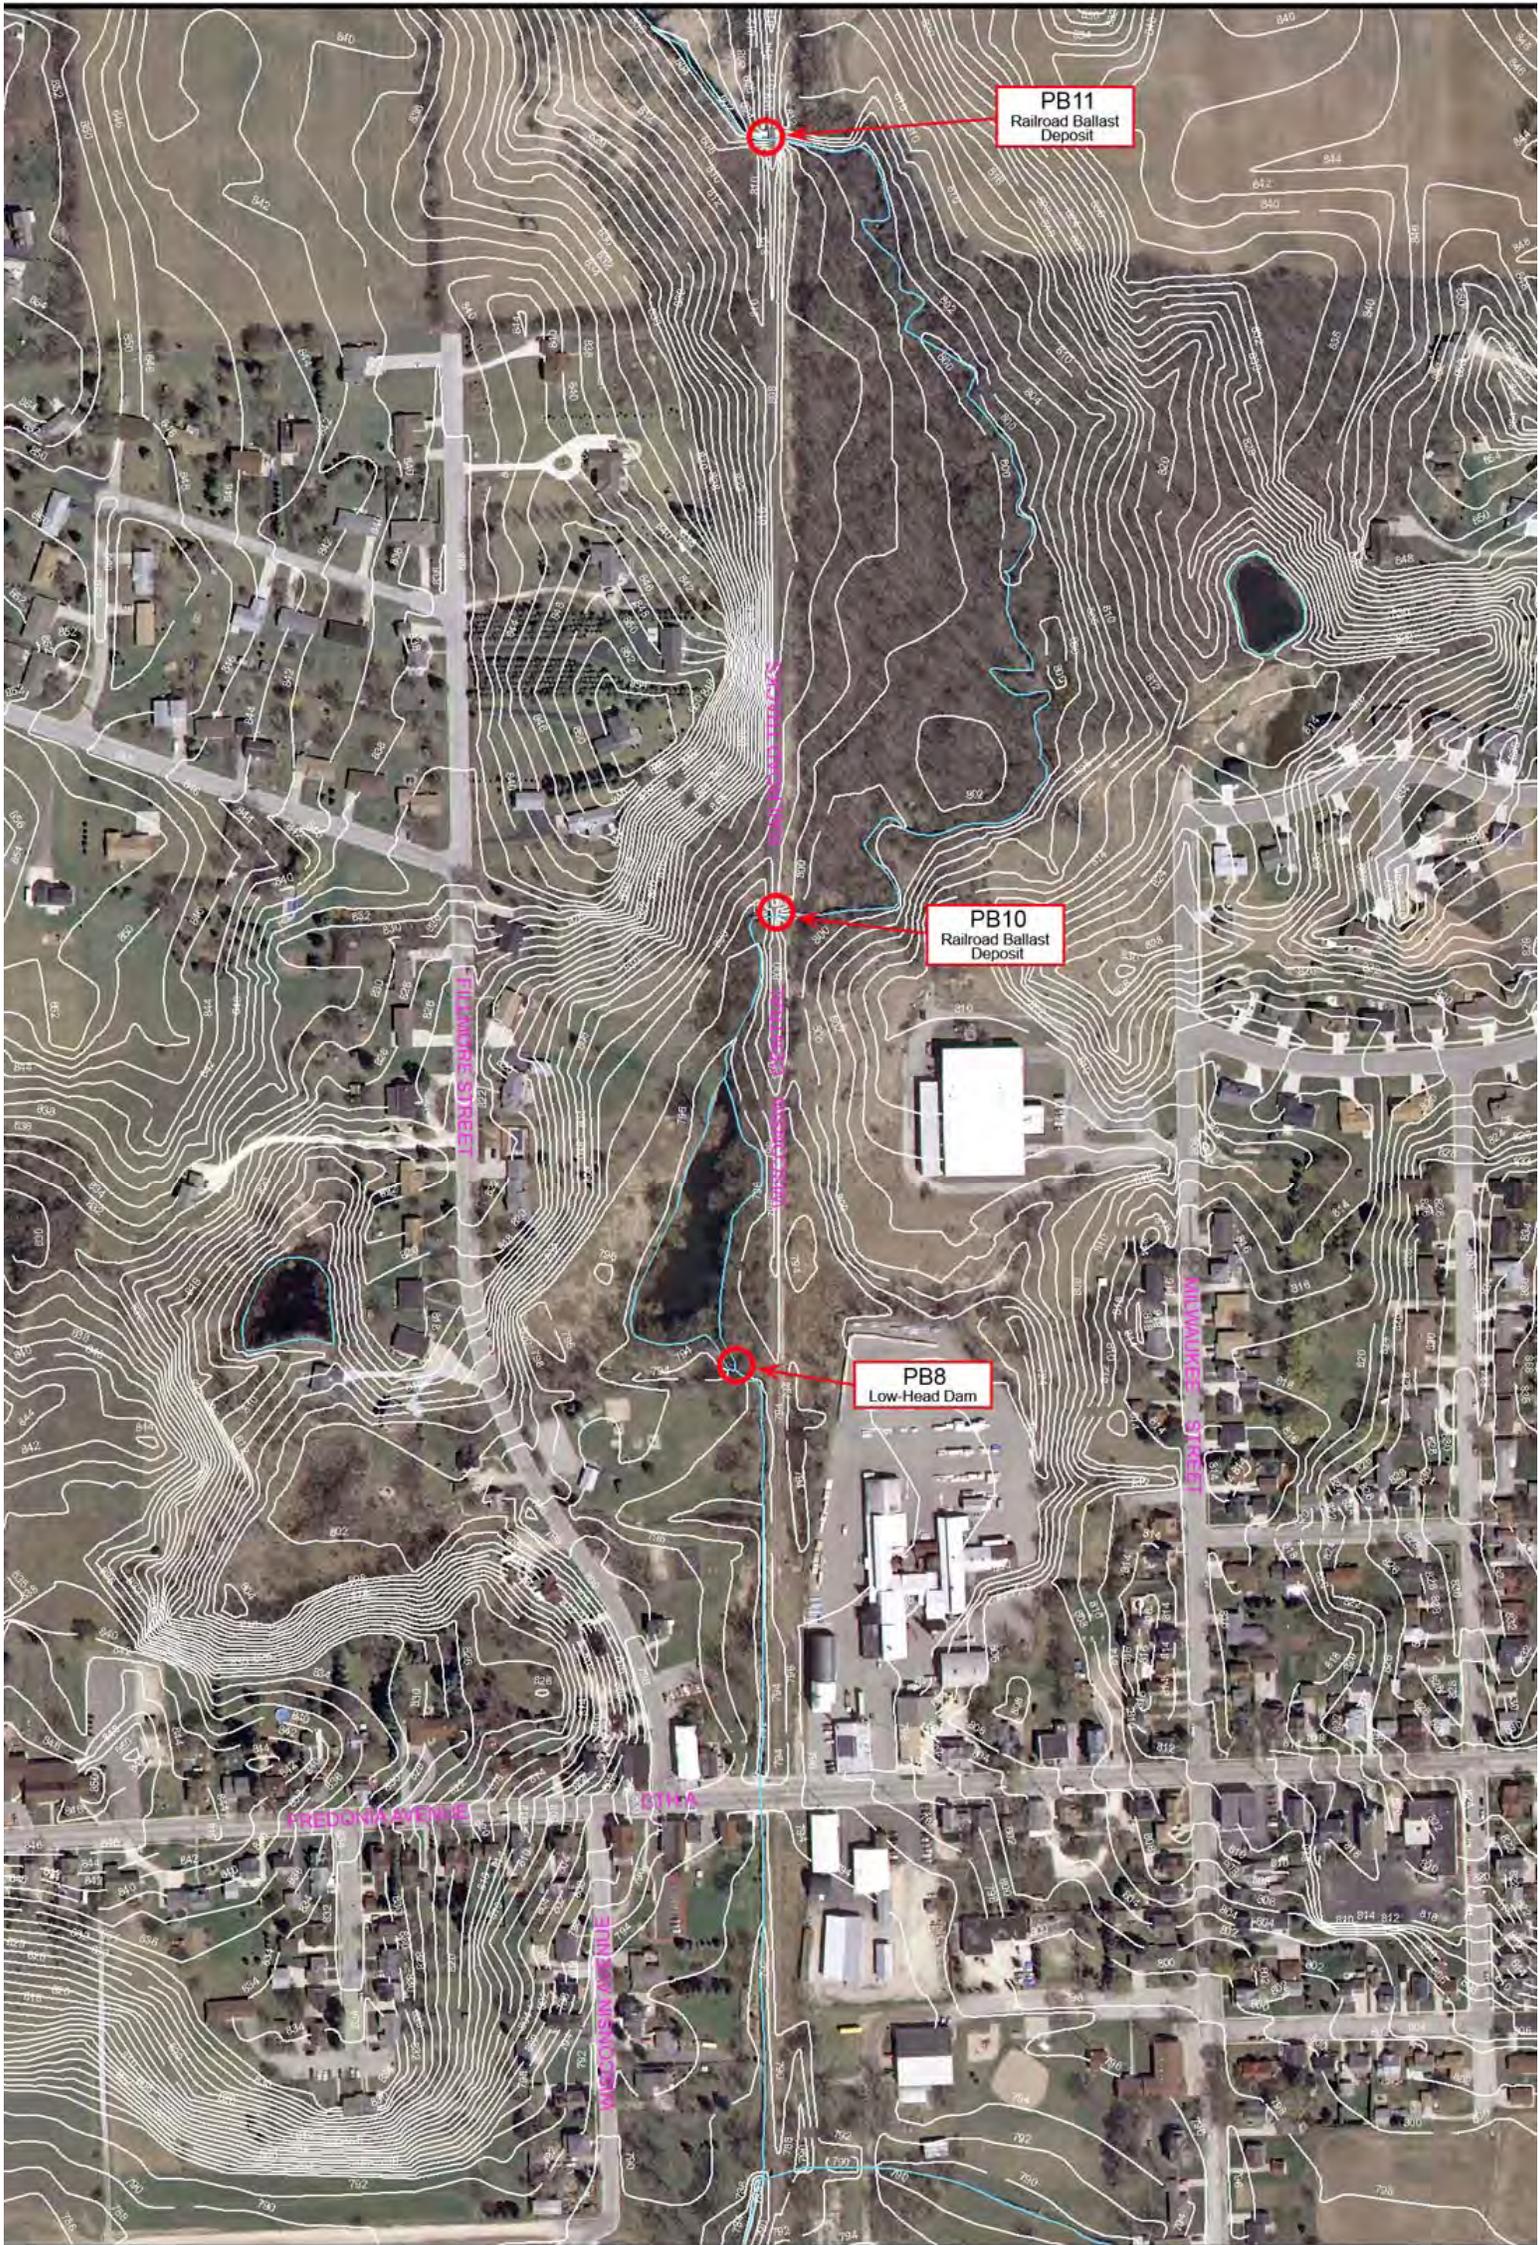
PB11
Railroad Ballast
Deposit

PB10
Railroad Ballast
Deposit

PB8
Low-Head Dam

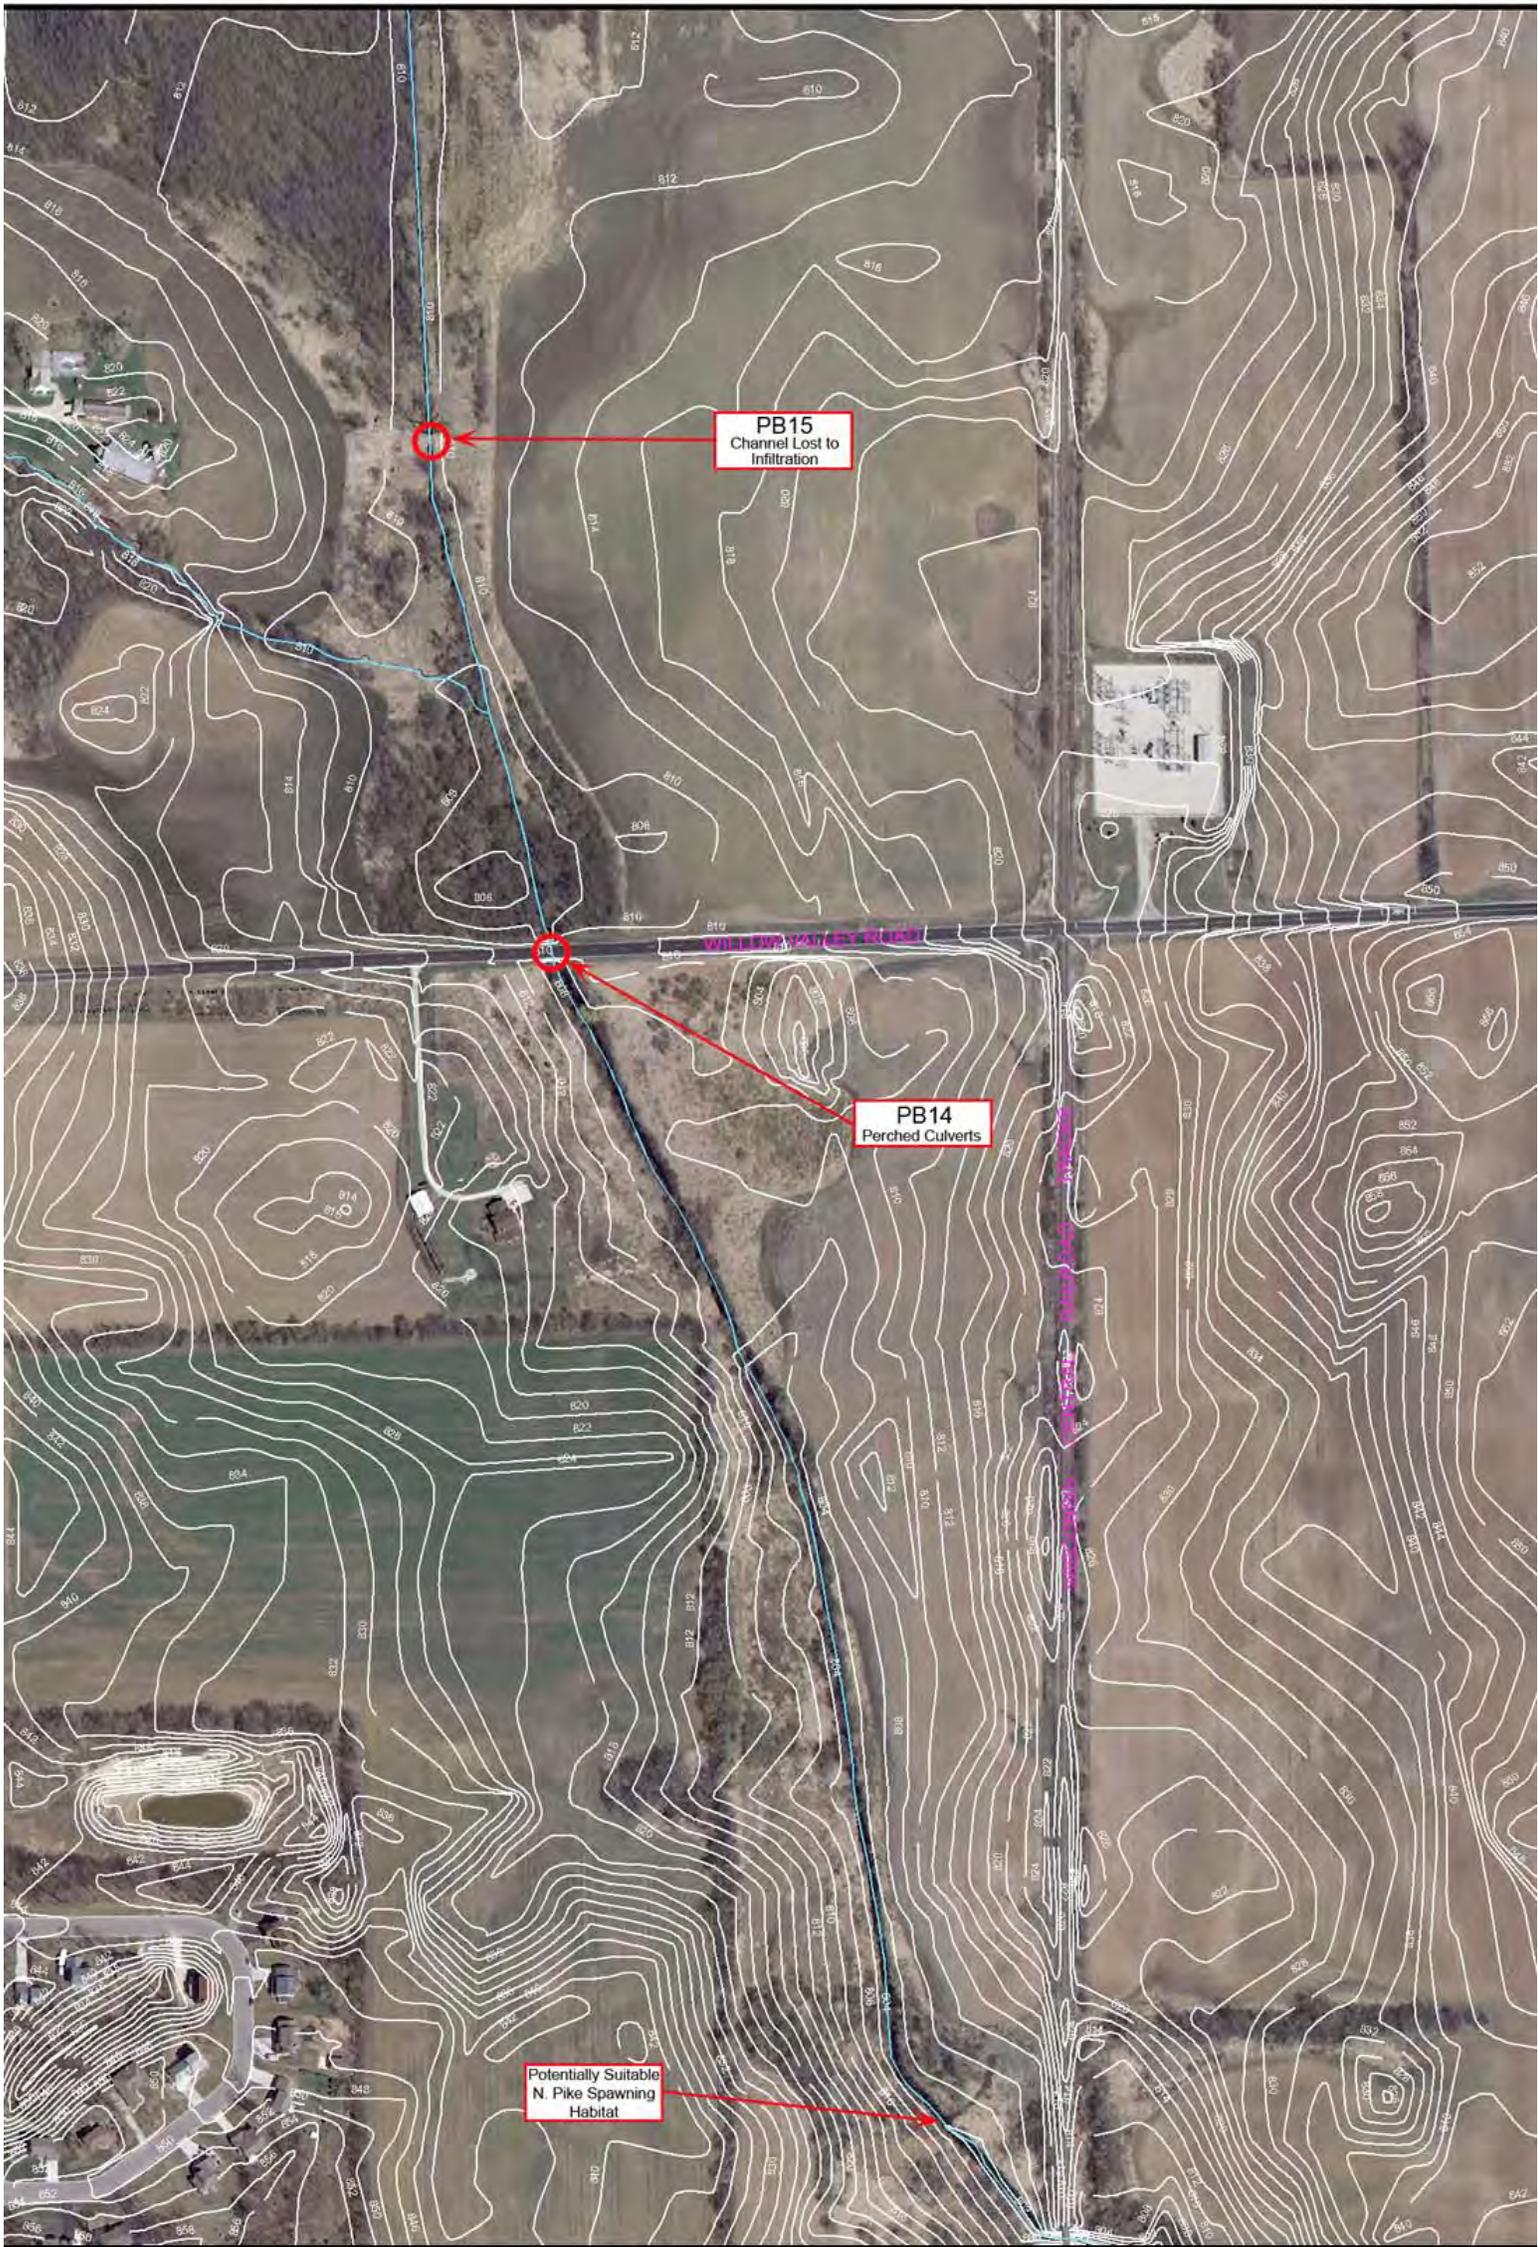
PB15
Channel Lost to
Infiltration

PB14
Perched Culverts

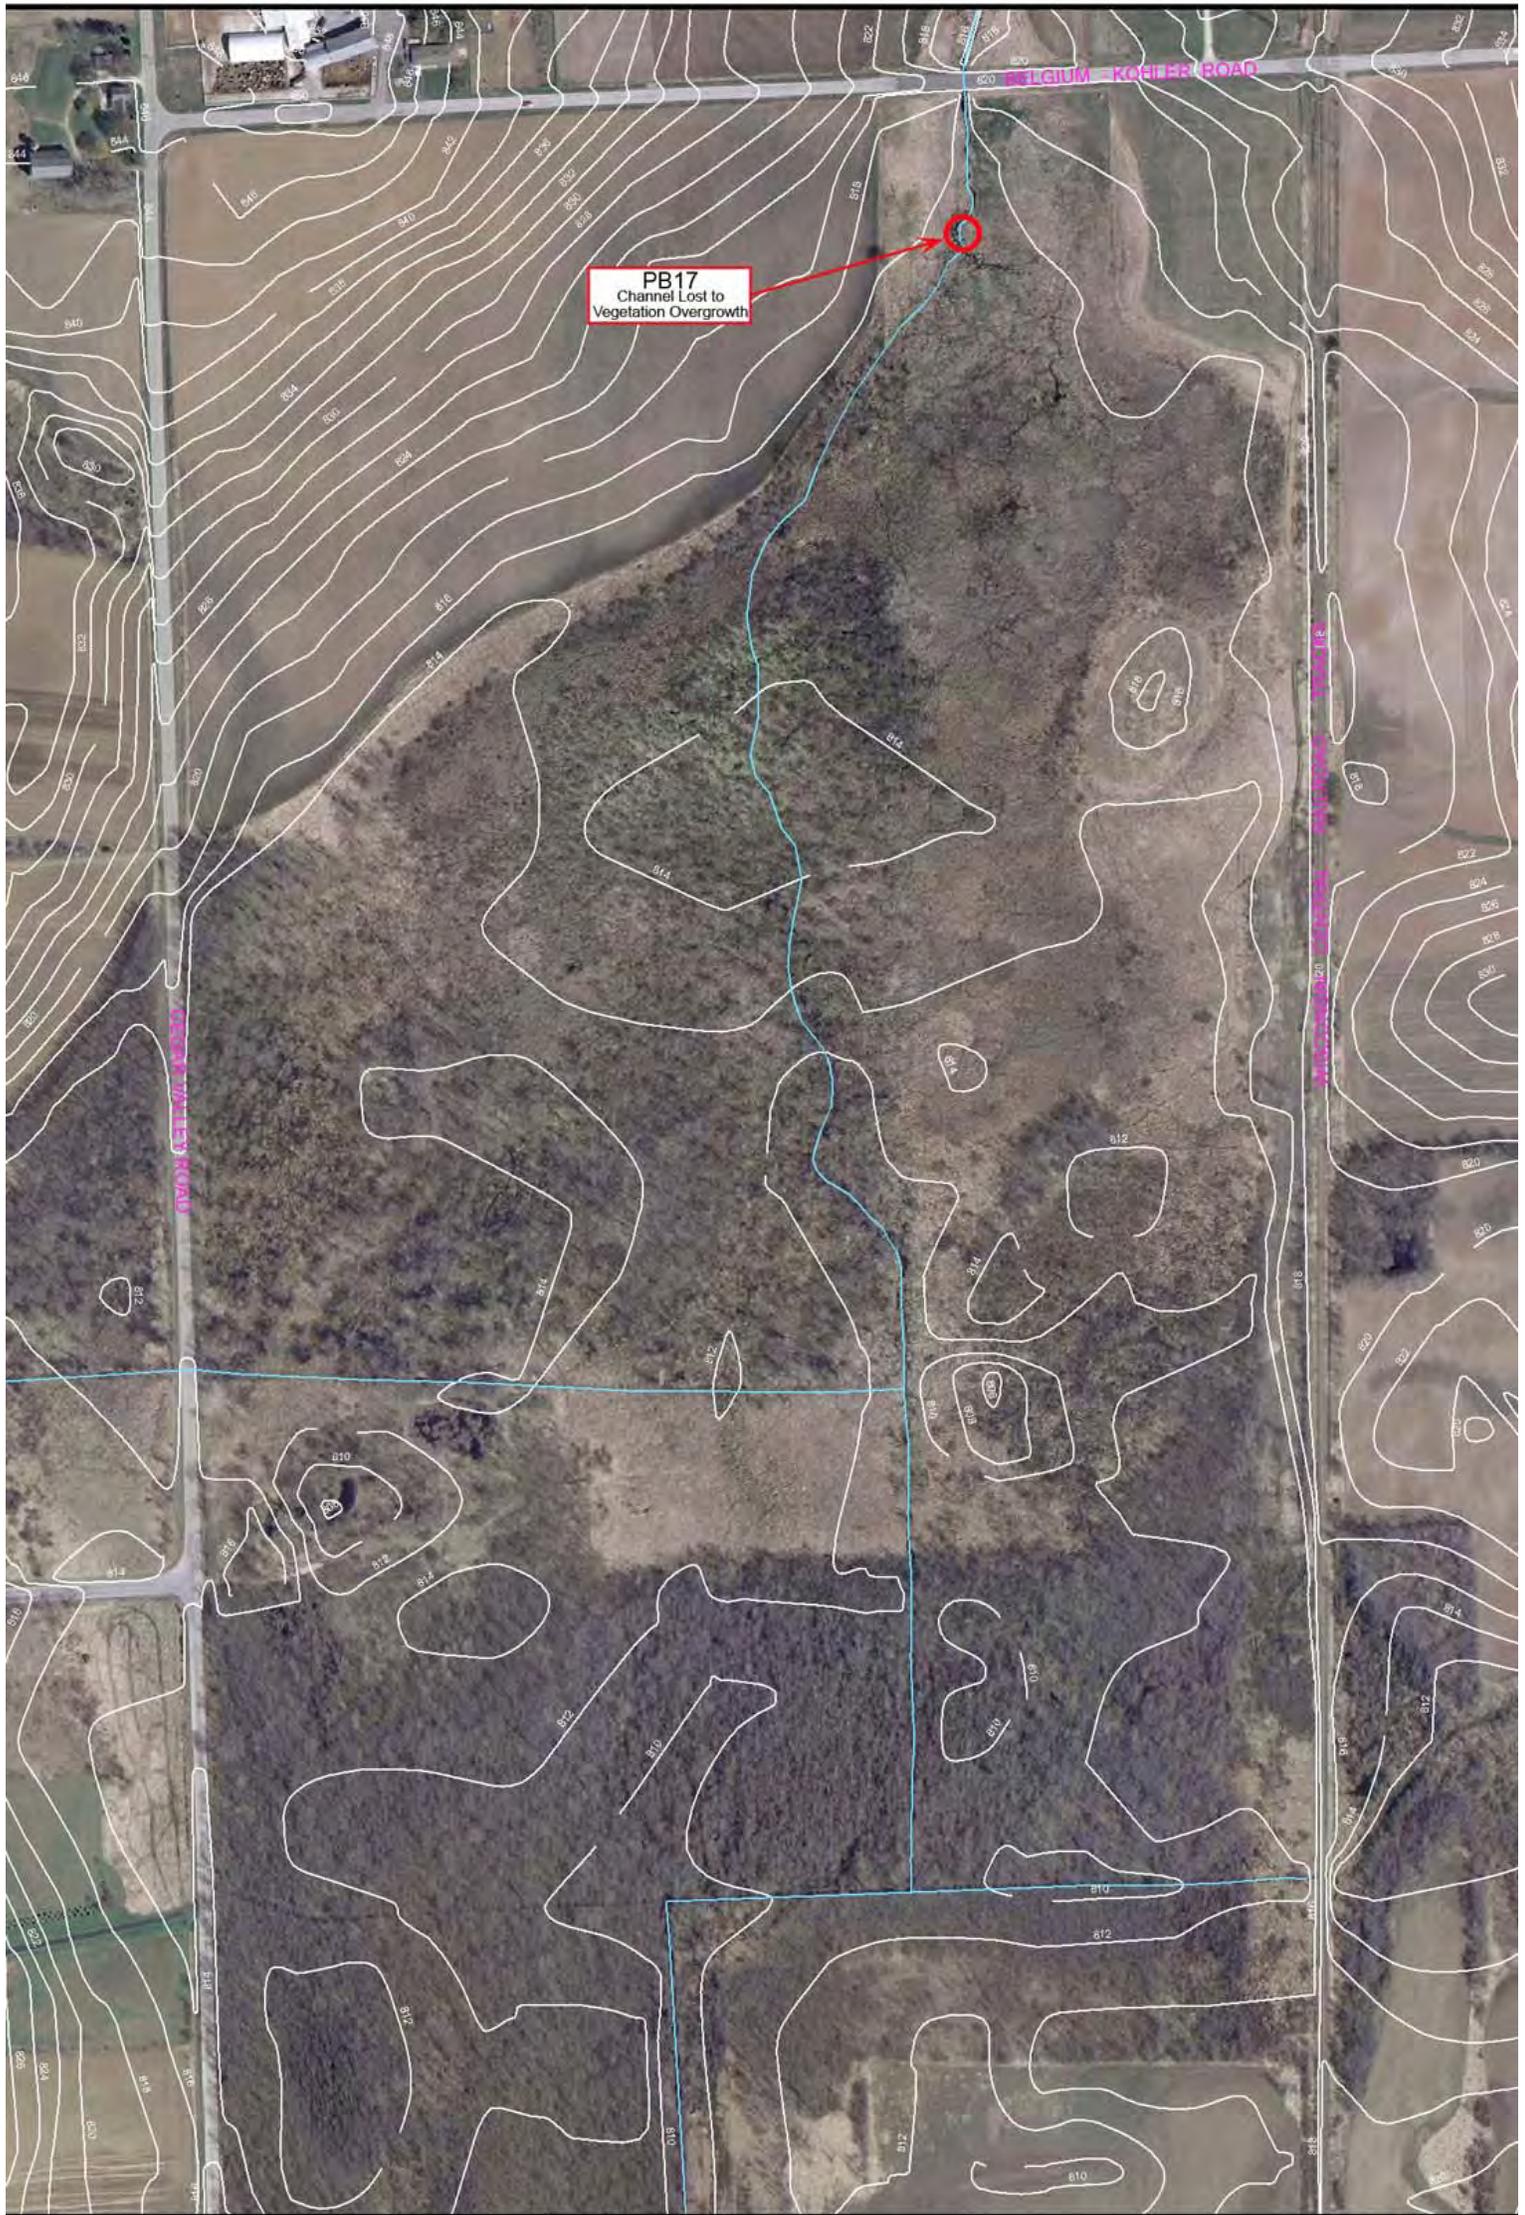
PB17
Channel Lost to
Vegetation Overgrowth

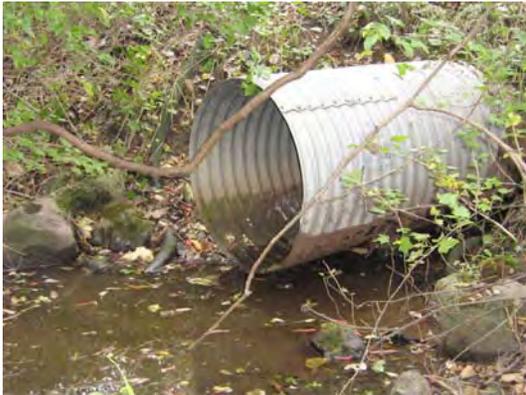
Photograph 1 – Constricting culverts
(GSC PB2)

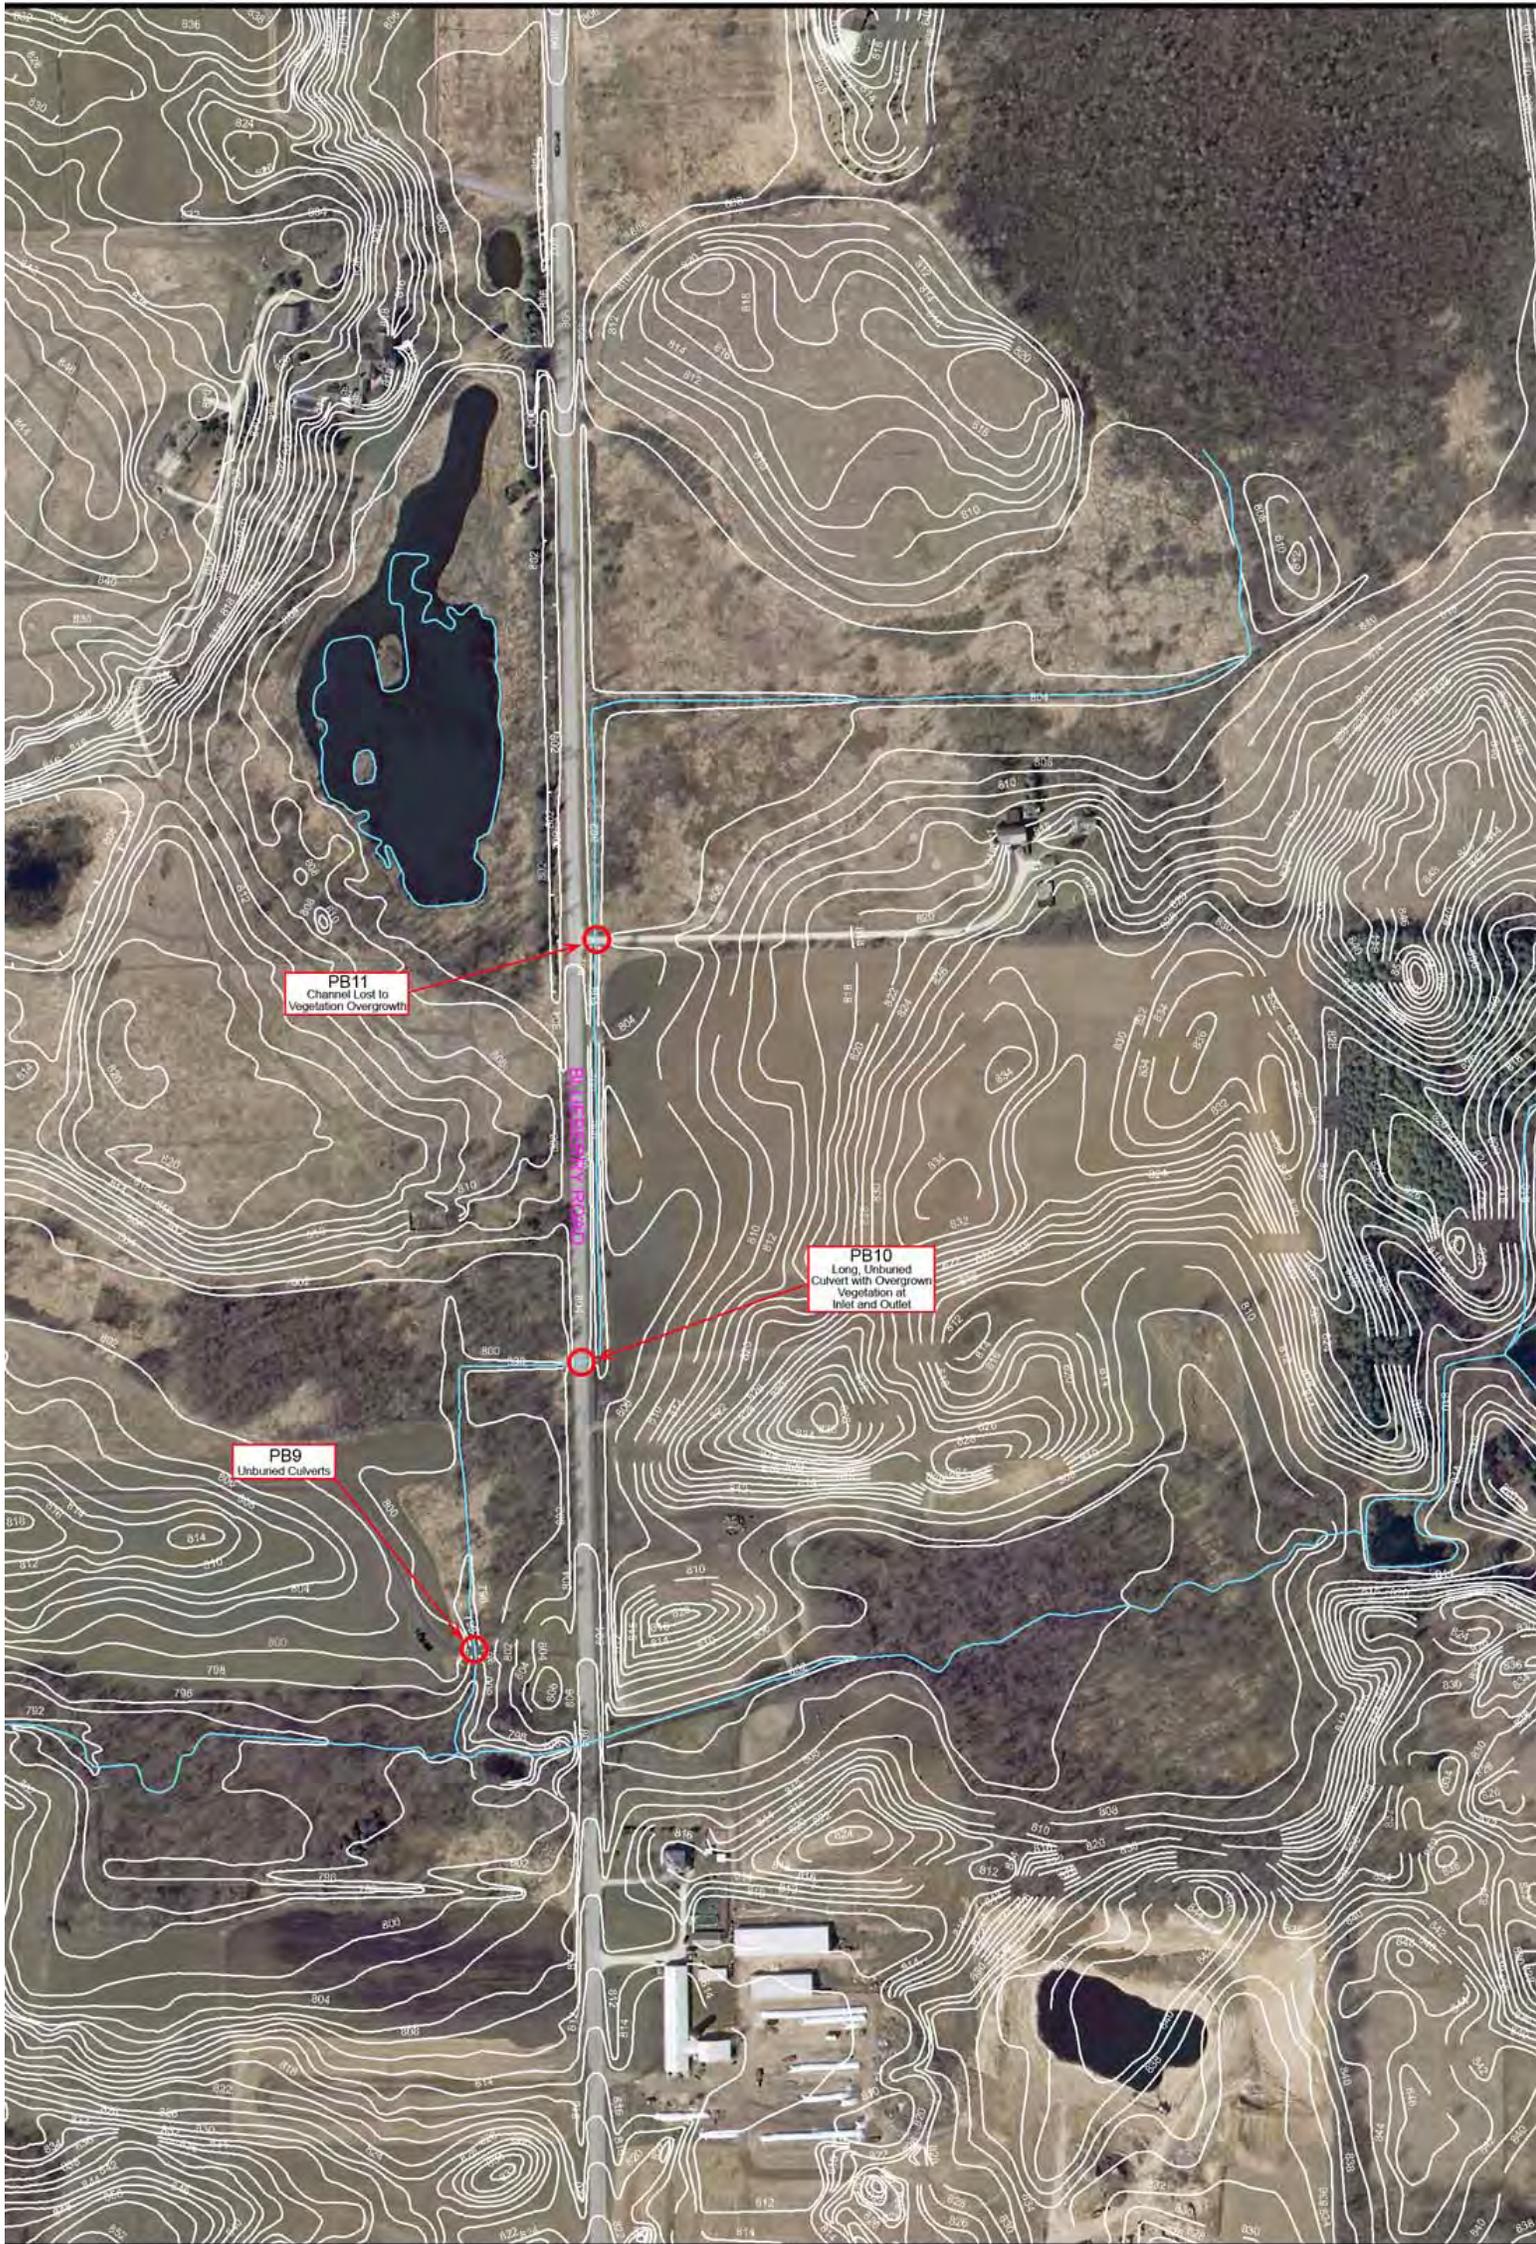
PB11
Channel Lost to
Vegetation Overgrowth

PB10
Long Untuned
Culvert with Overgrown
Vegetation at
Inlet and Outlet

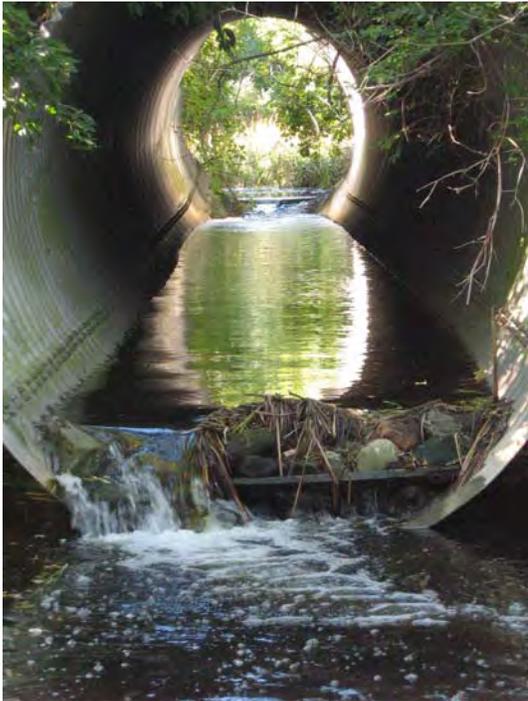
Photograph 1 – Improperly elevated corrugated metal culvert with cascading inlet, perched outlet, and stone/wood debris Jam (MC PB2)

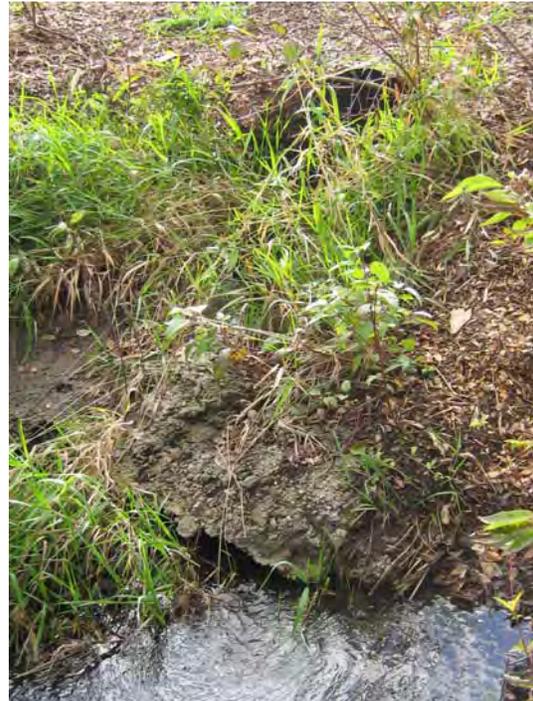
Photograph 2 – Perched culvert with concrete riprap cascade outlet (MC PB29)

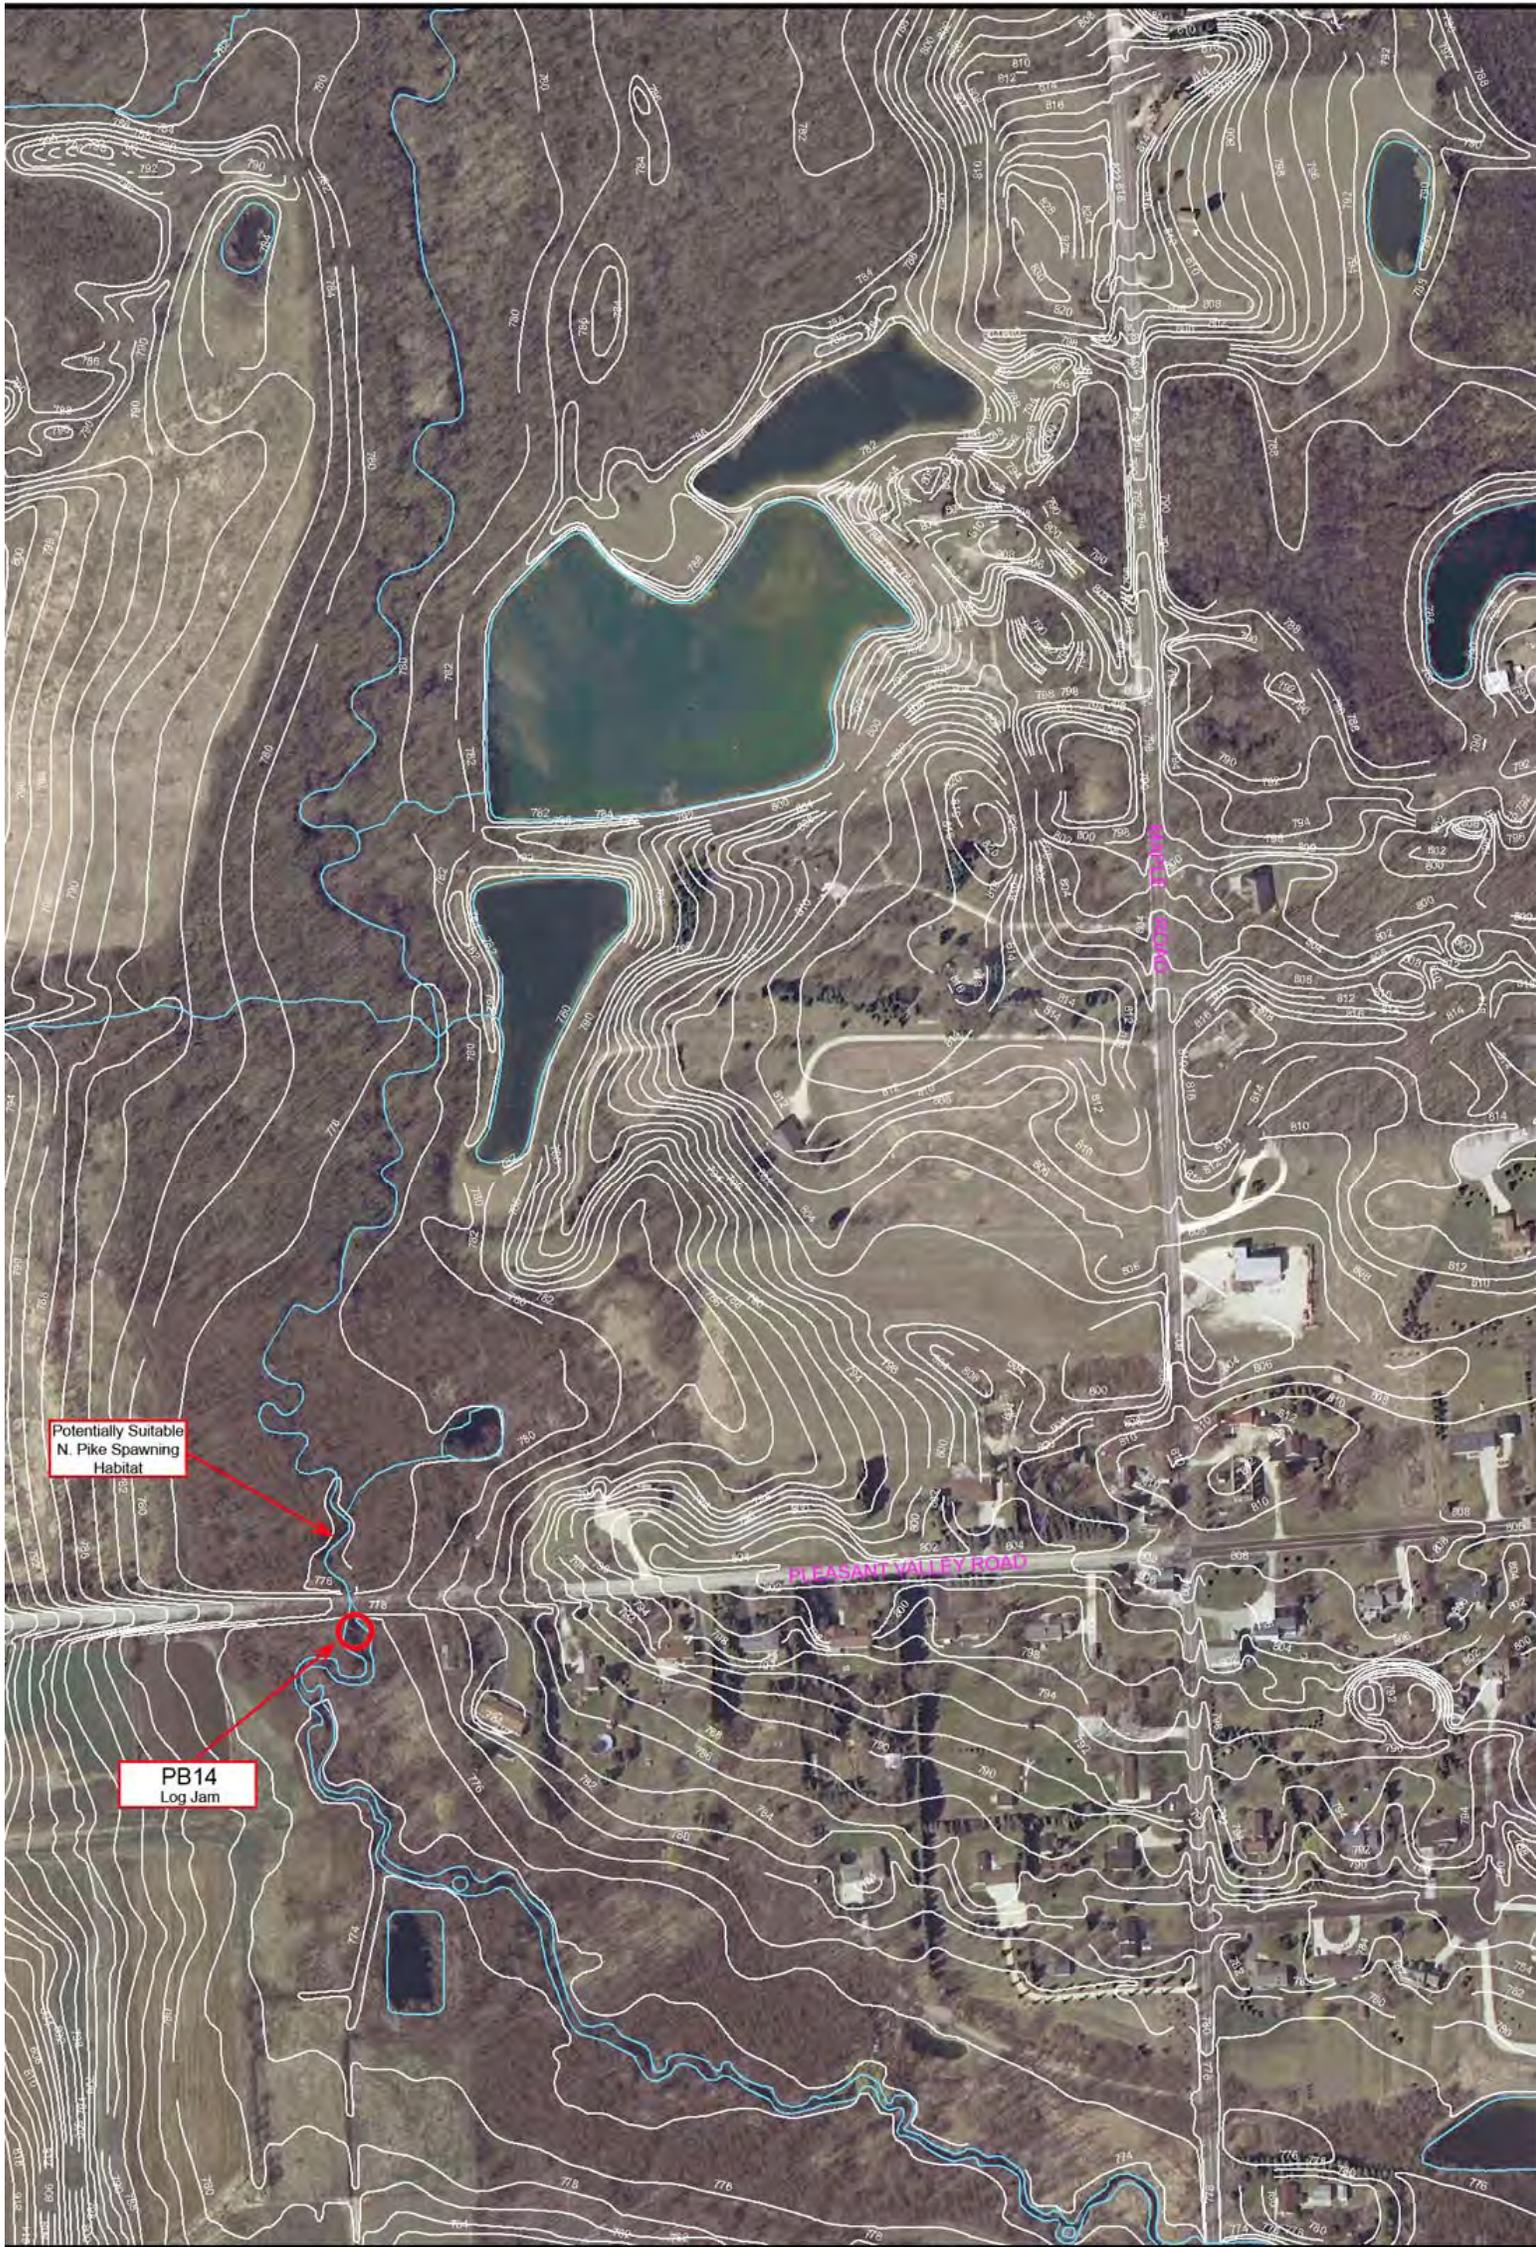
PB14
Log Jam

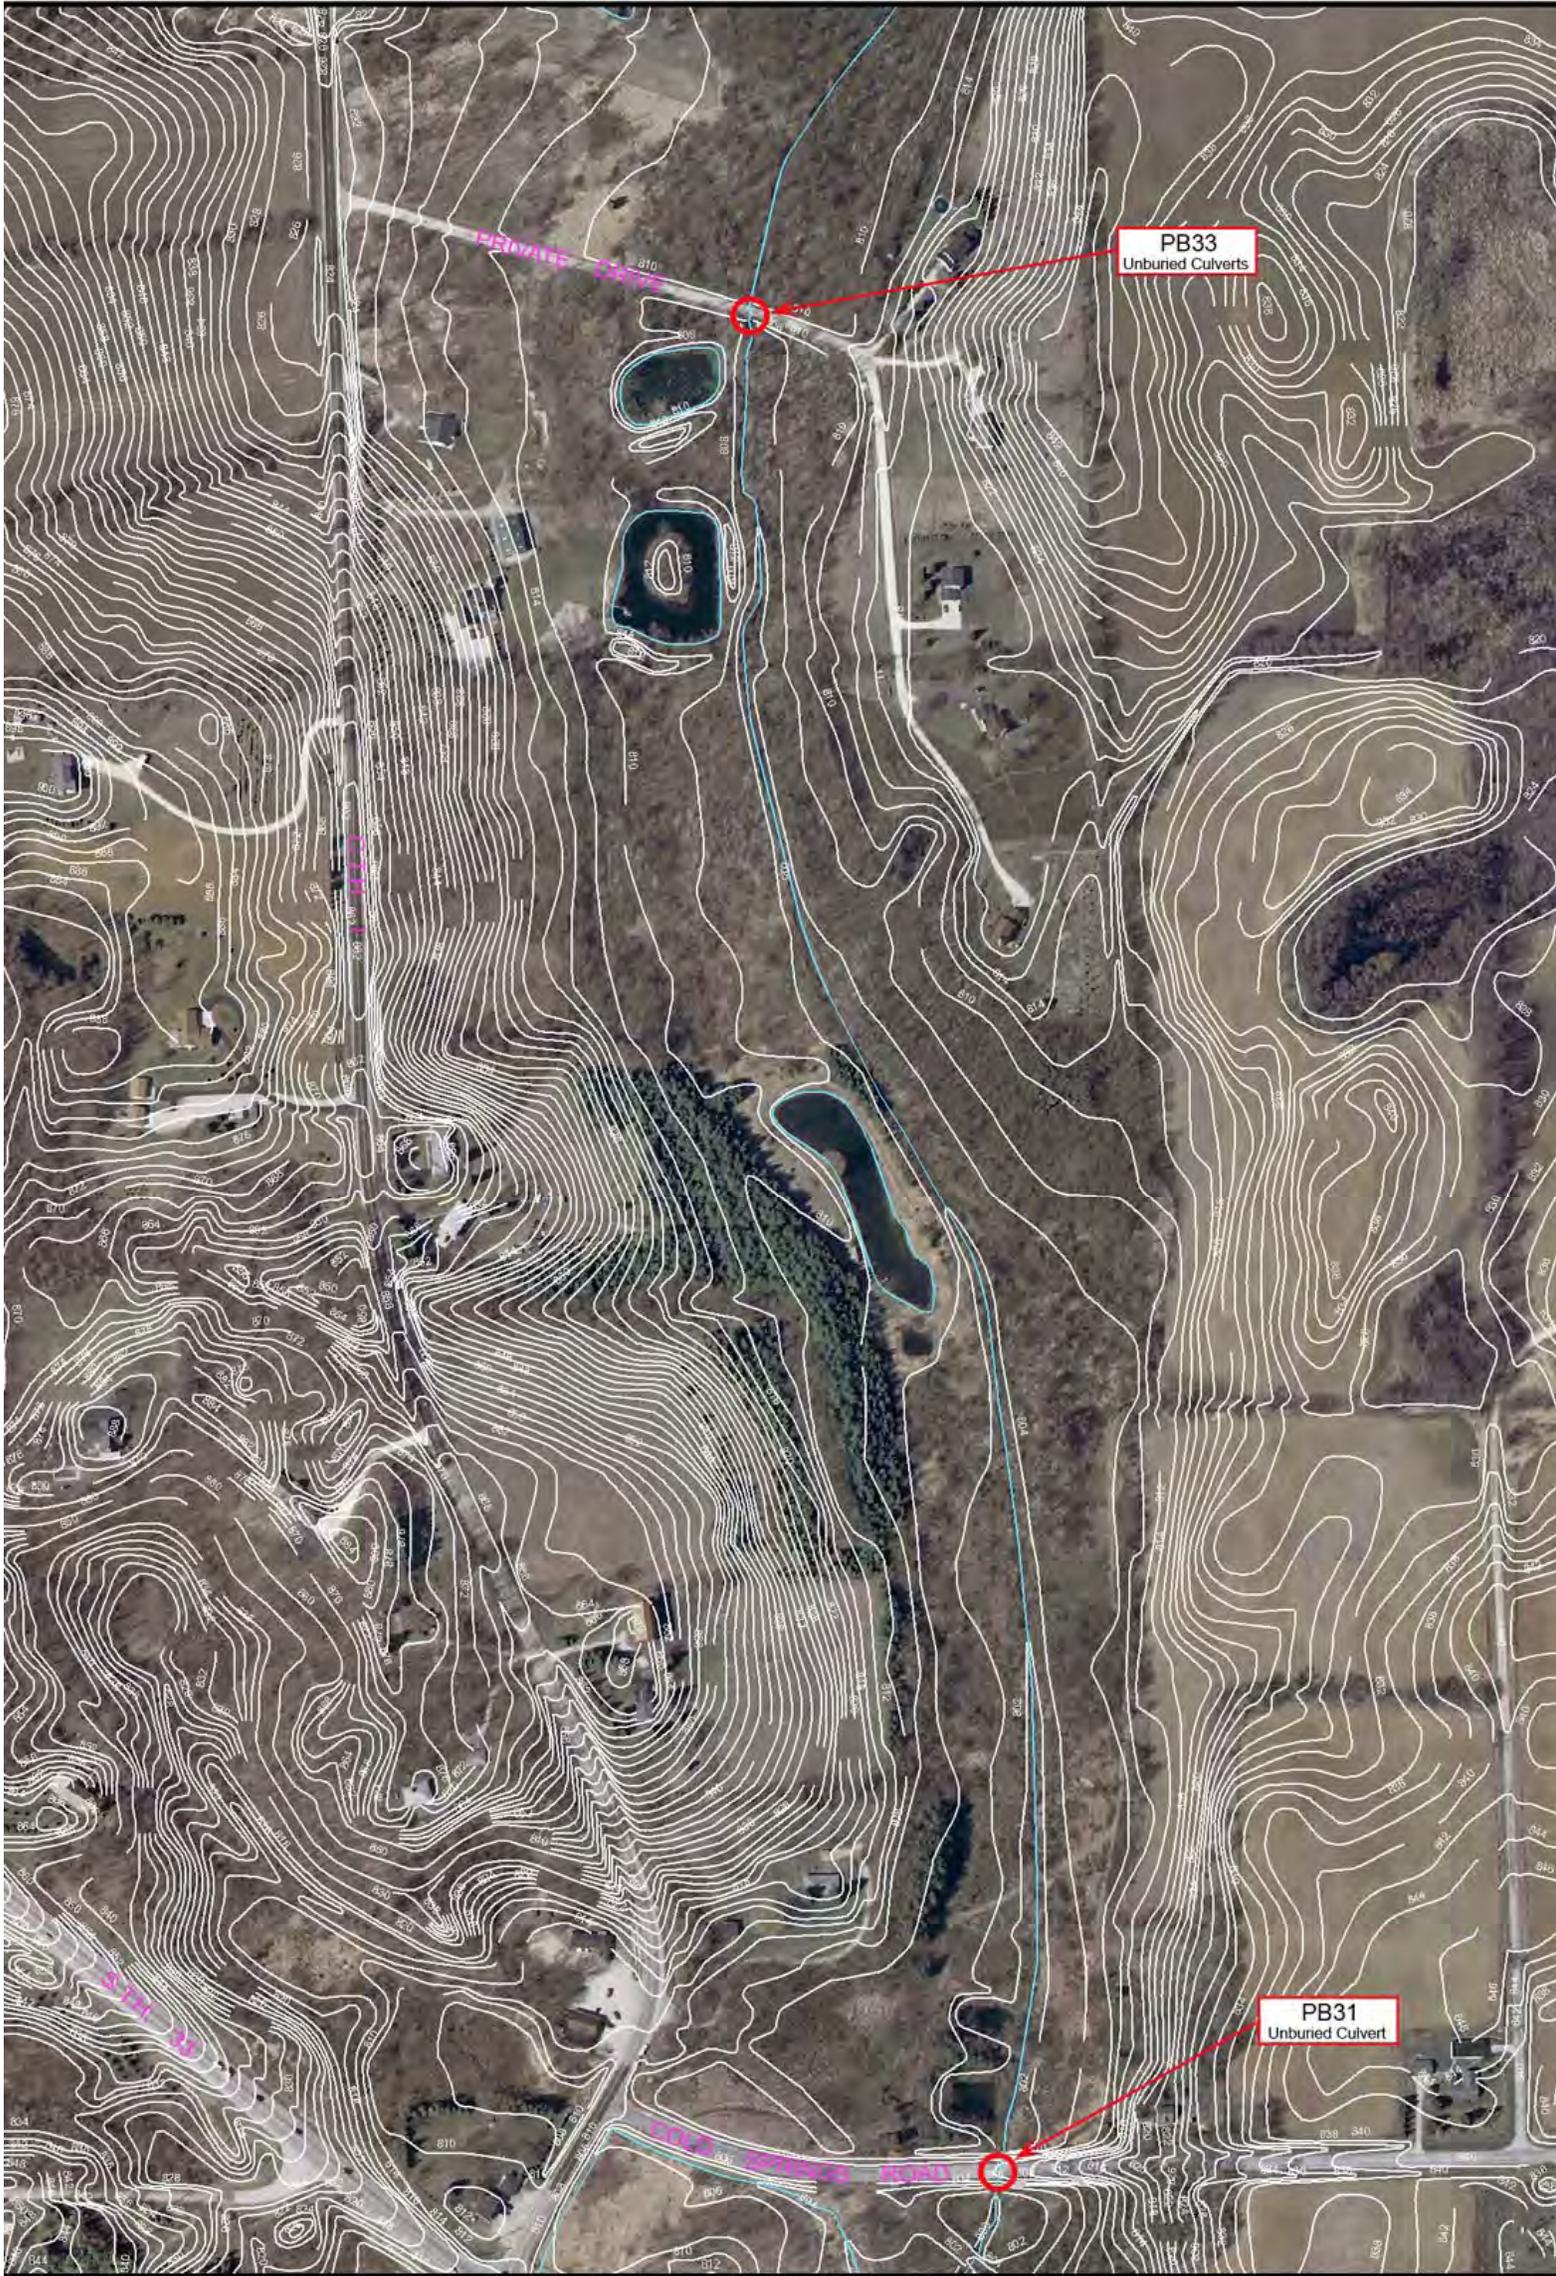
PB33
Unburied Culverts

PB31
Unburied Culvert
