**STREAM PASSAGE IMPEDIMENTS
AND AQUATIC HABITAT
FRAGMENTATION INVENTORY**

**MILWAUKEE RIVER AND LAKE
MICHIGAN TRIBUTARY STREAMS
OZAUKEE COUNTY, WISCONSIN**

November 16, 2006

Project Number: OZC 01-5400-3000

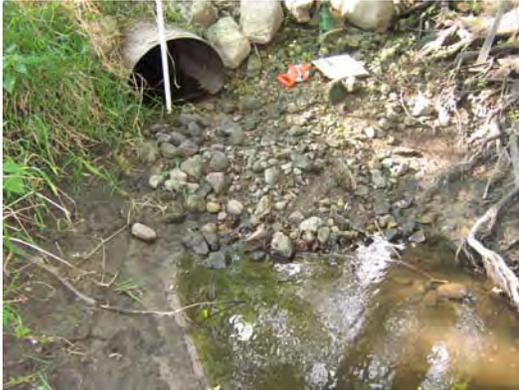
Photograph 1 – Constricting culvert at old farm crossing (ML PB1)

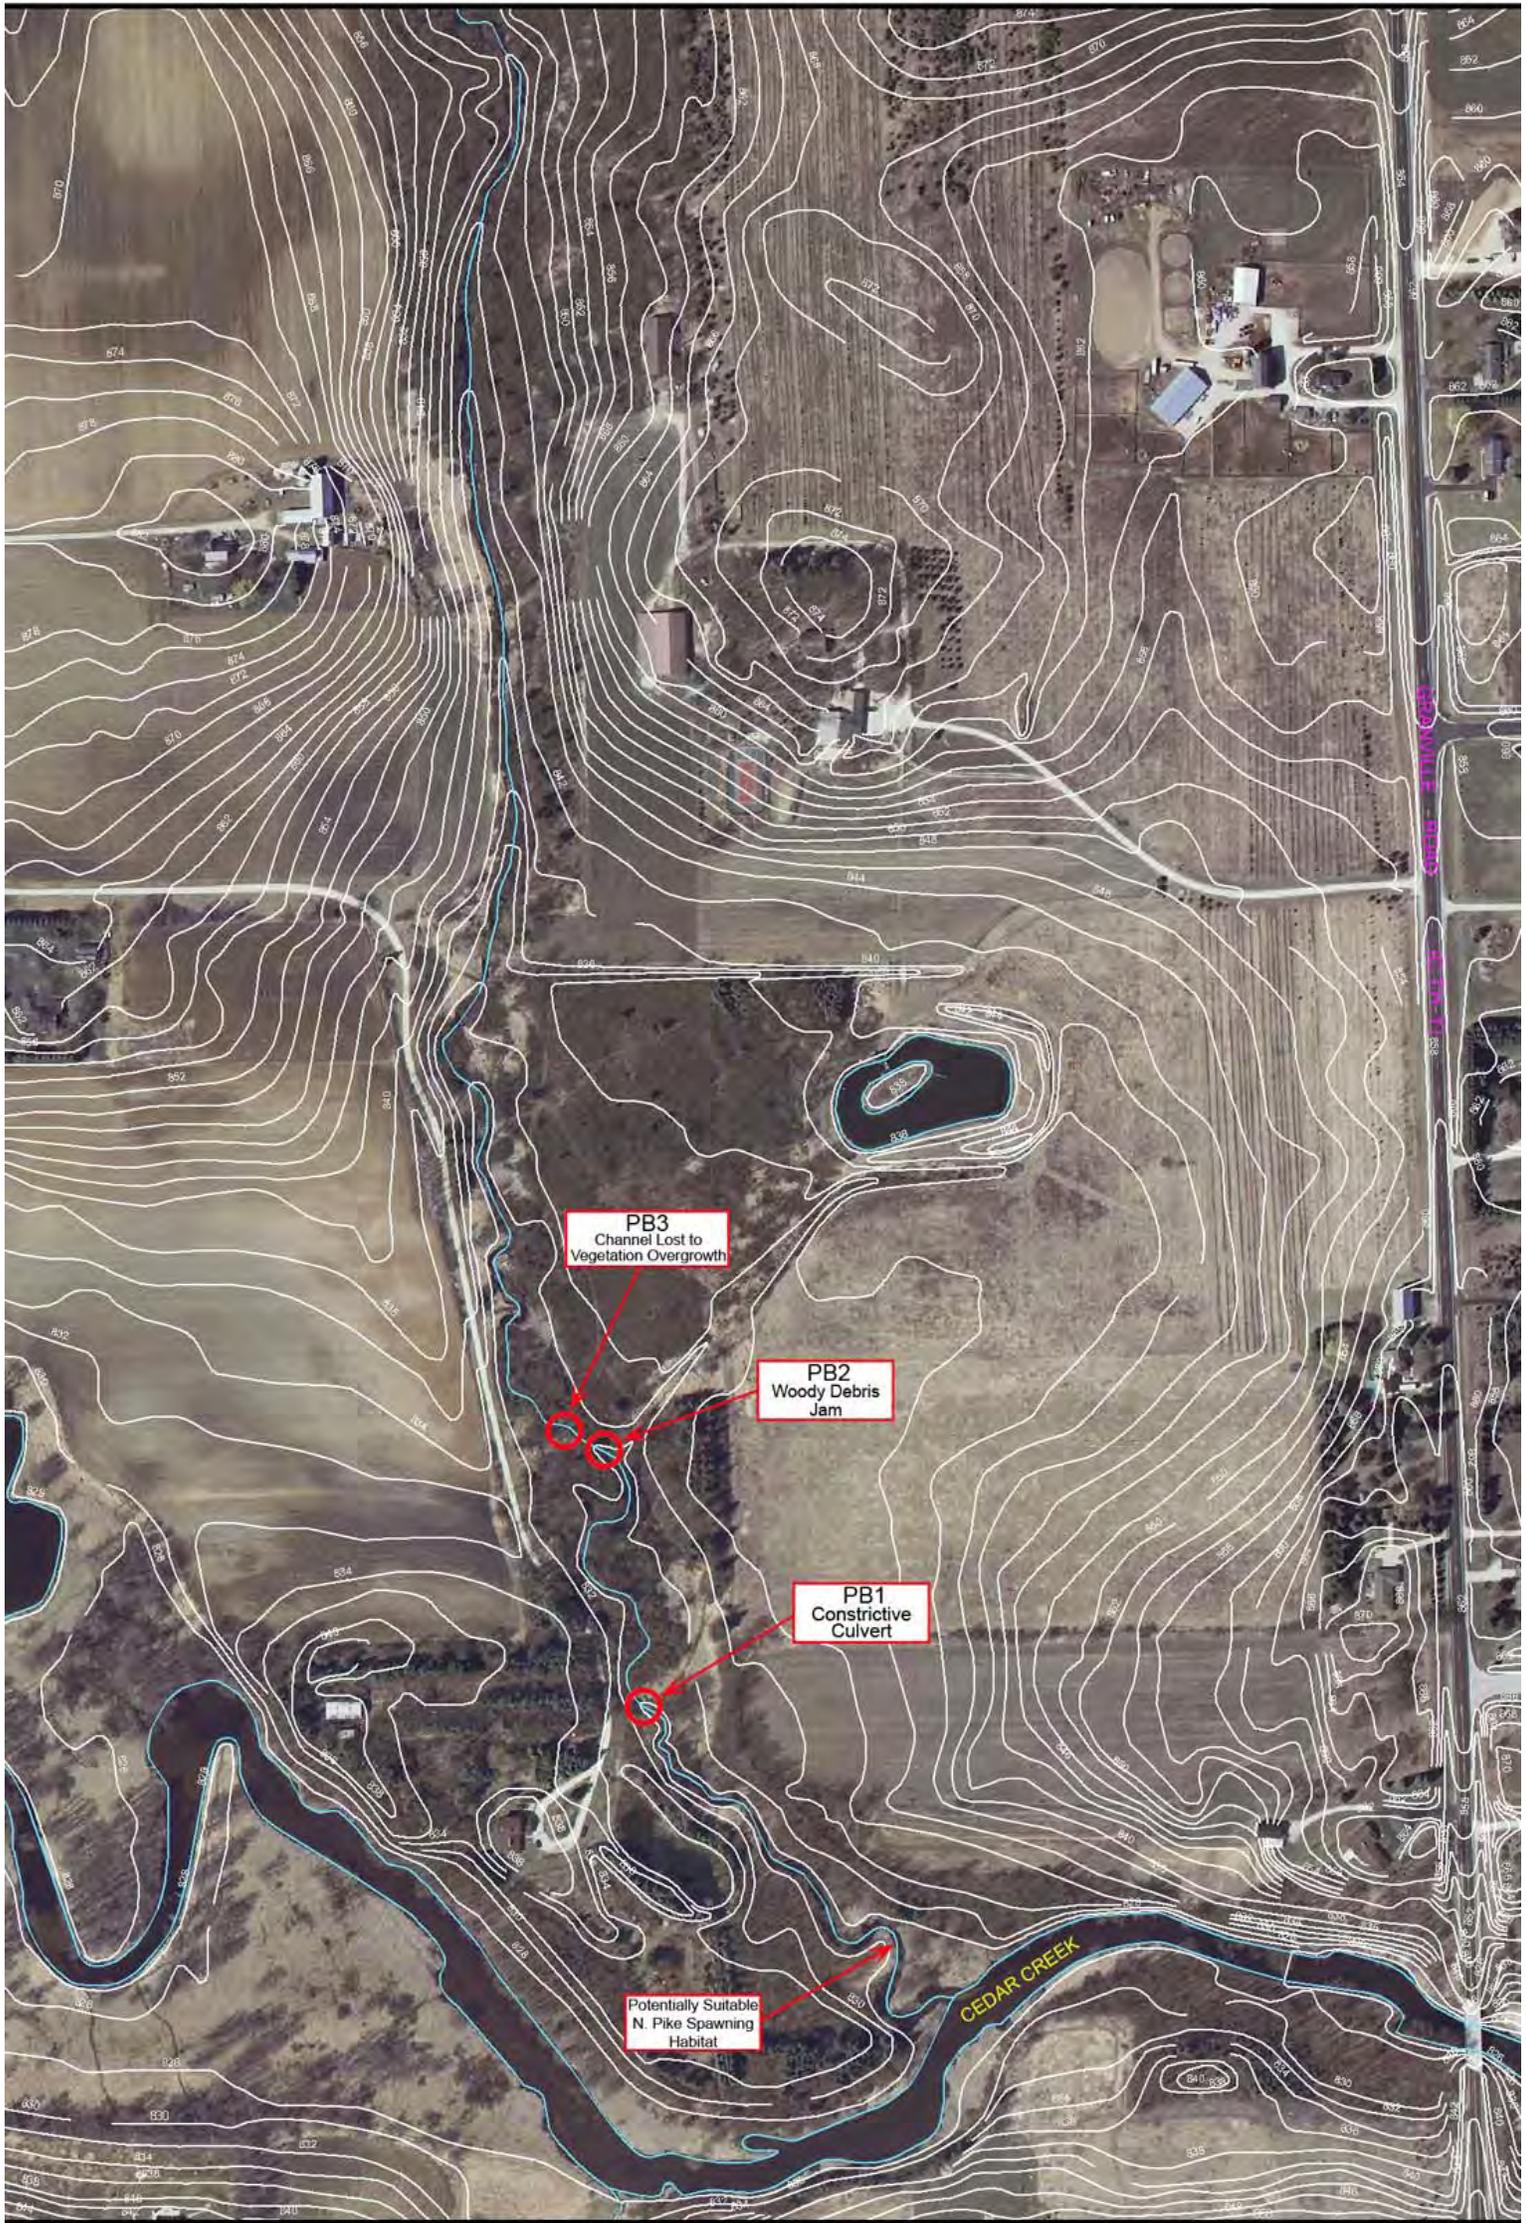
PB3
Channel Lost to
Vegetation Overgrowth

PB2
Woody Debris
Jam

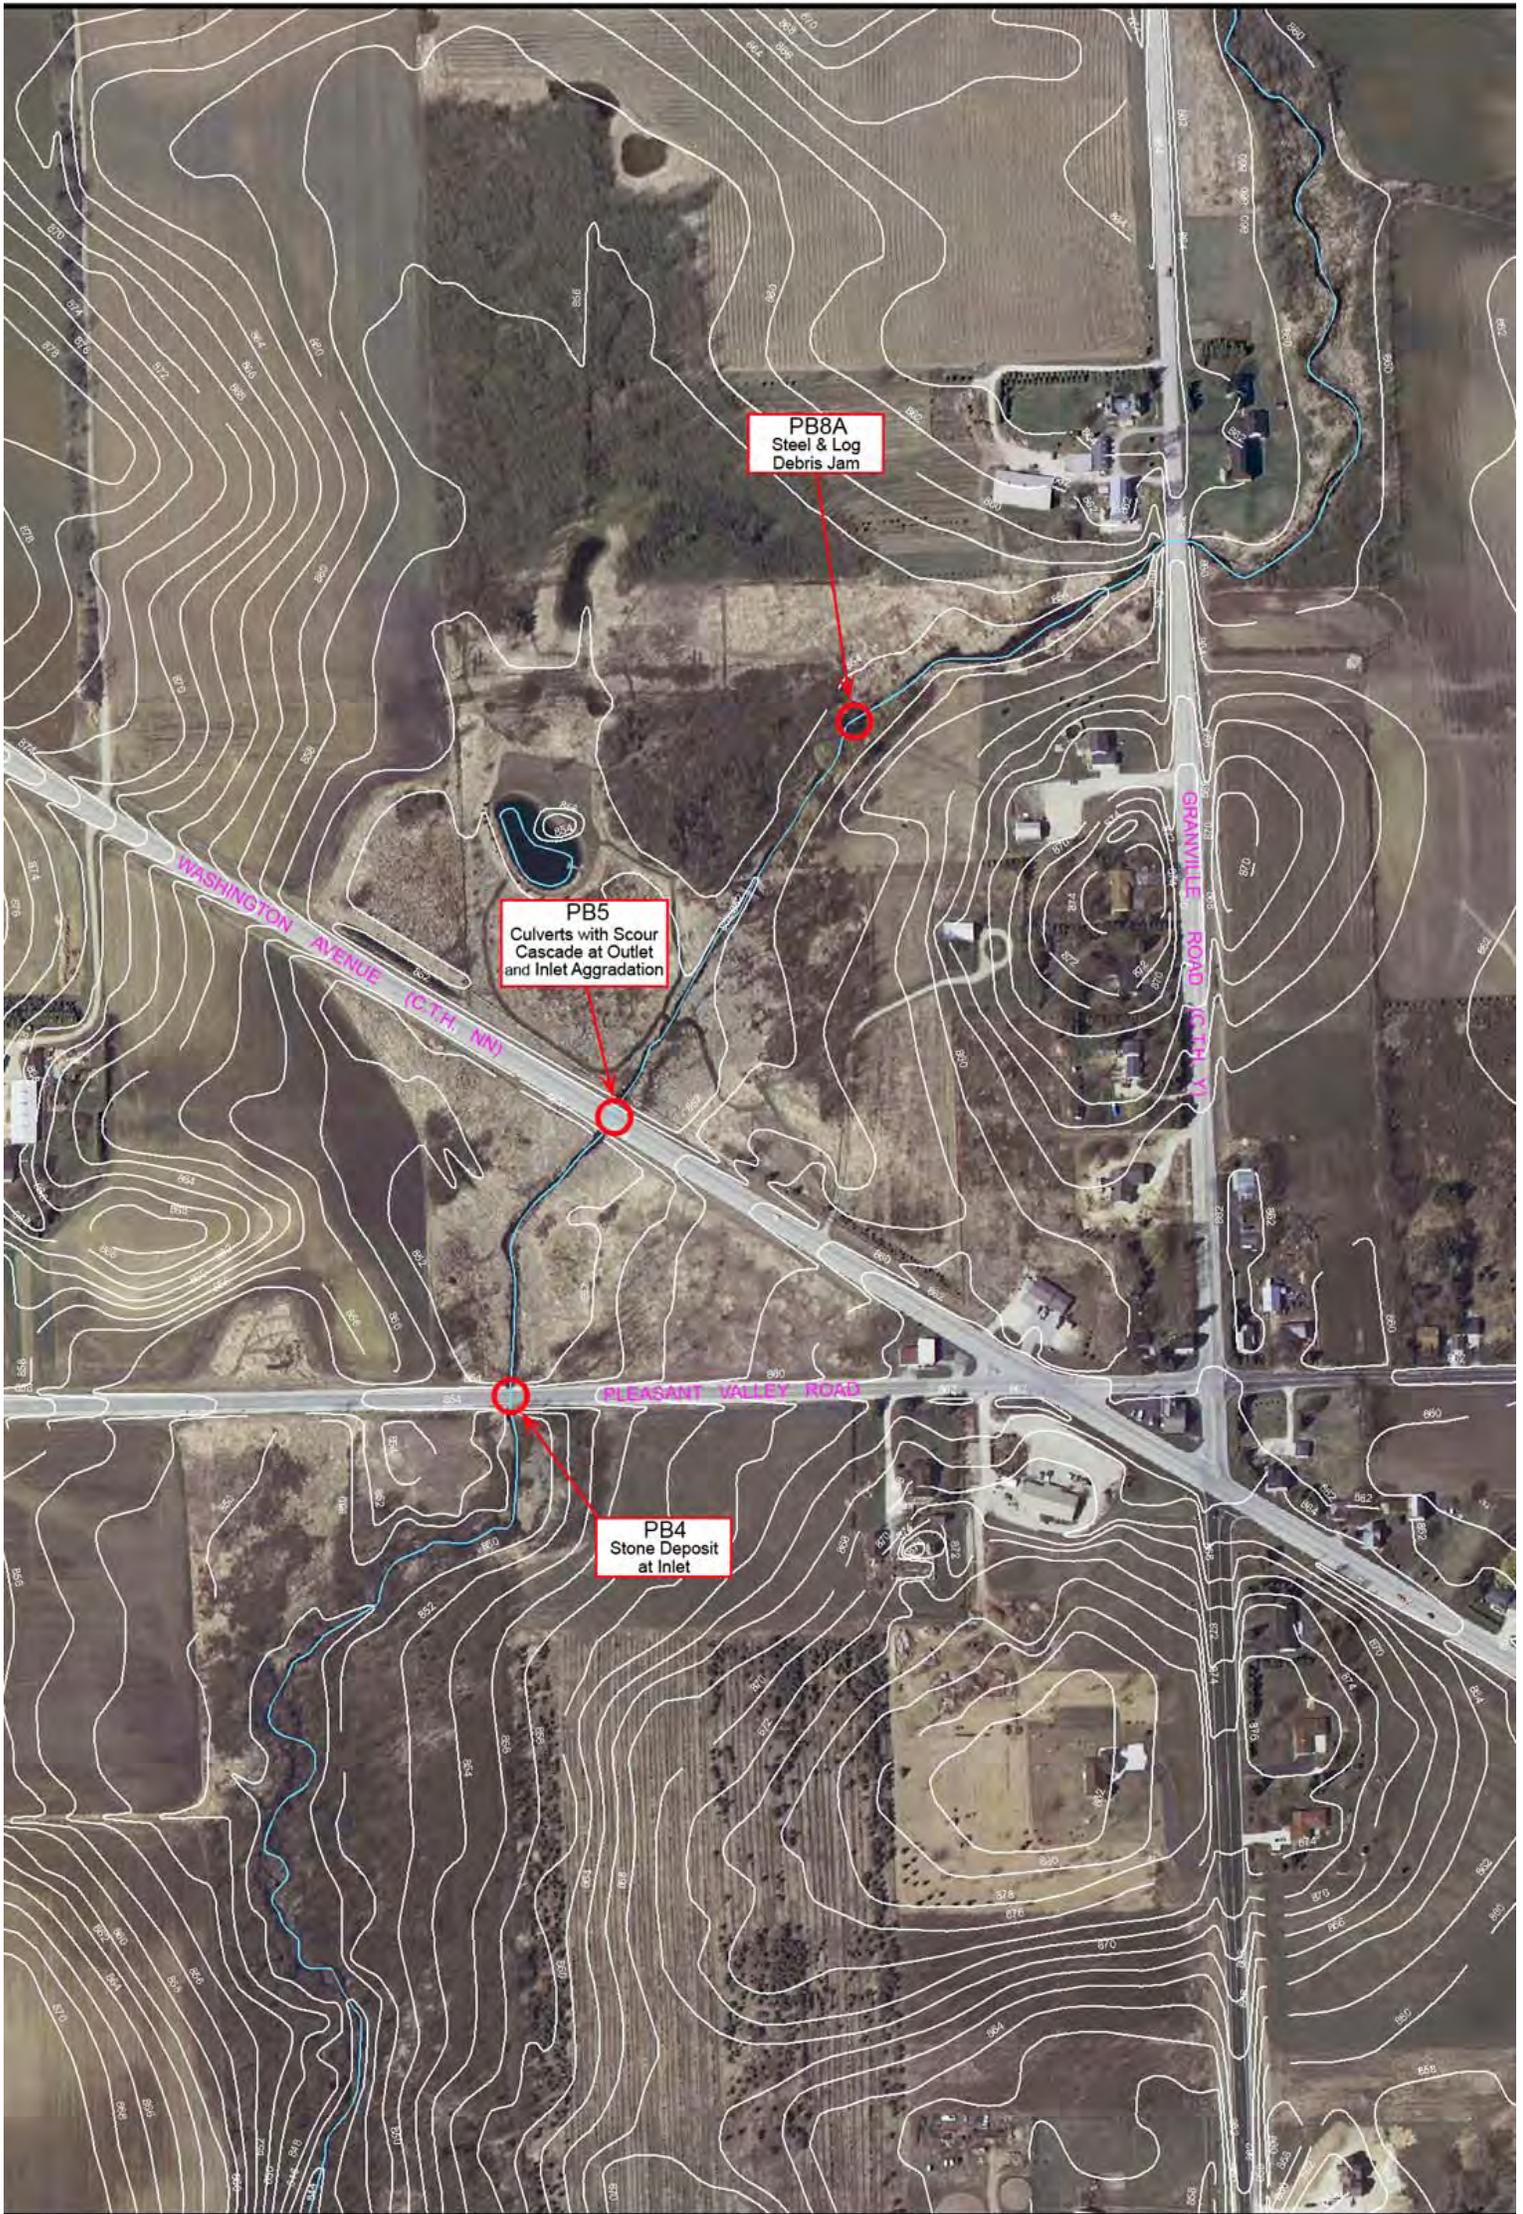
PB8A
Steel & Log
Debris Jam

PB5
Culverts with Scour
Cascade at Outlet
and Inlet Aggradation

PB4
Stone Deposit
at Inlet

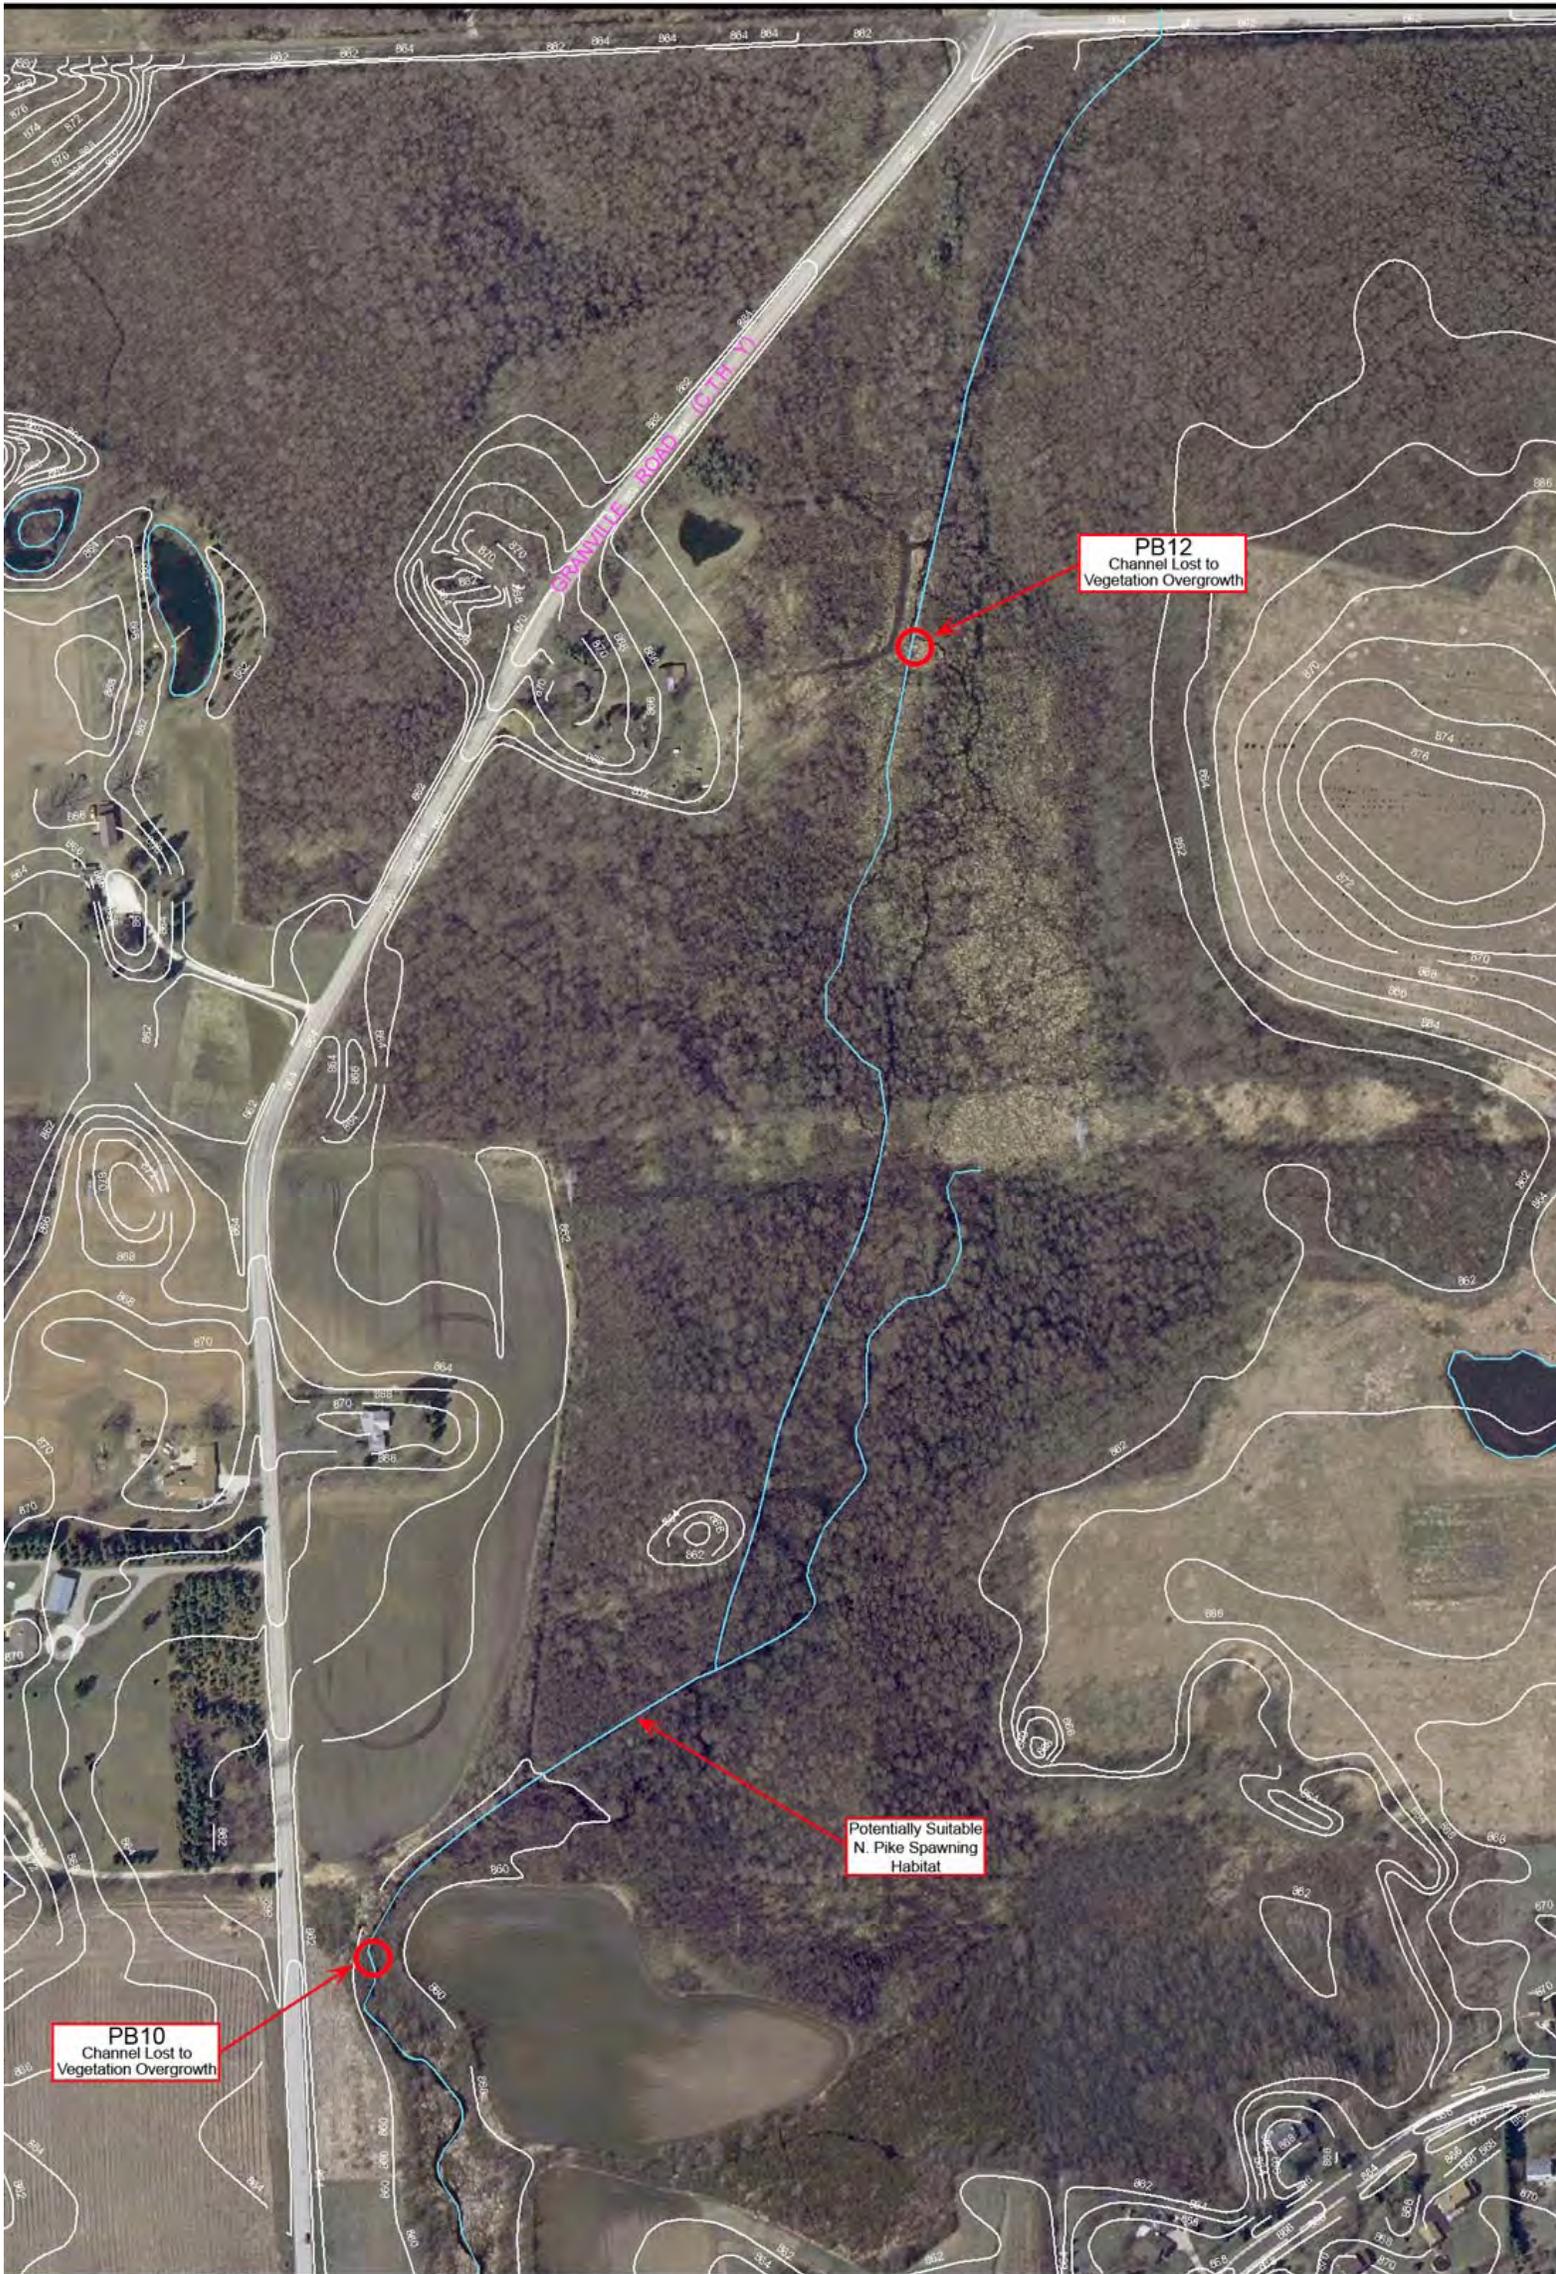
PB12
Channel Lost to
Vegetation Overgrowth

PB10
Channel Lost to
Vegetation Overgrowth

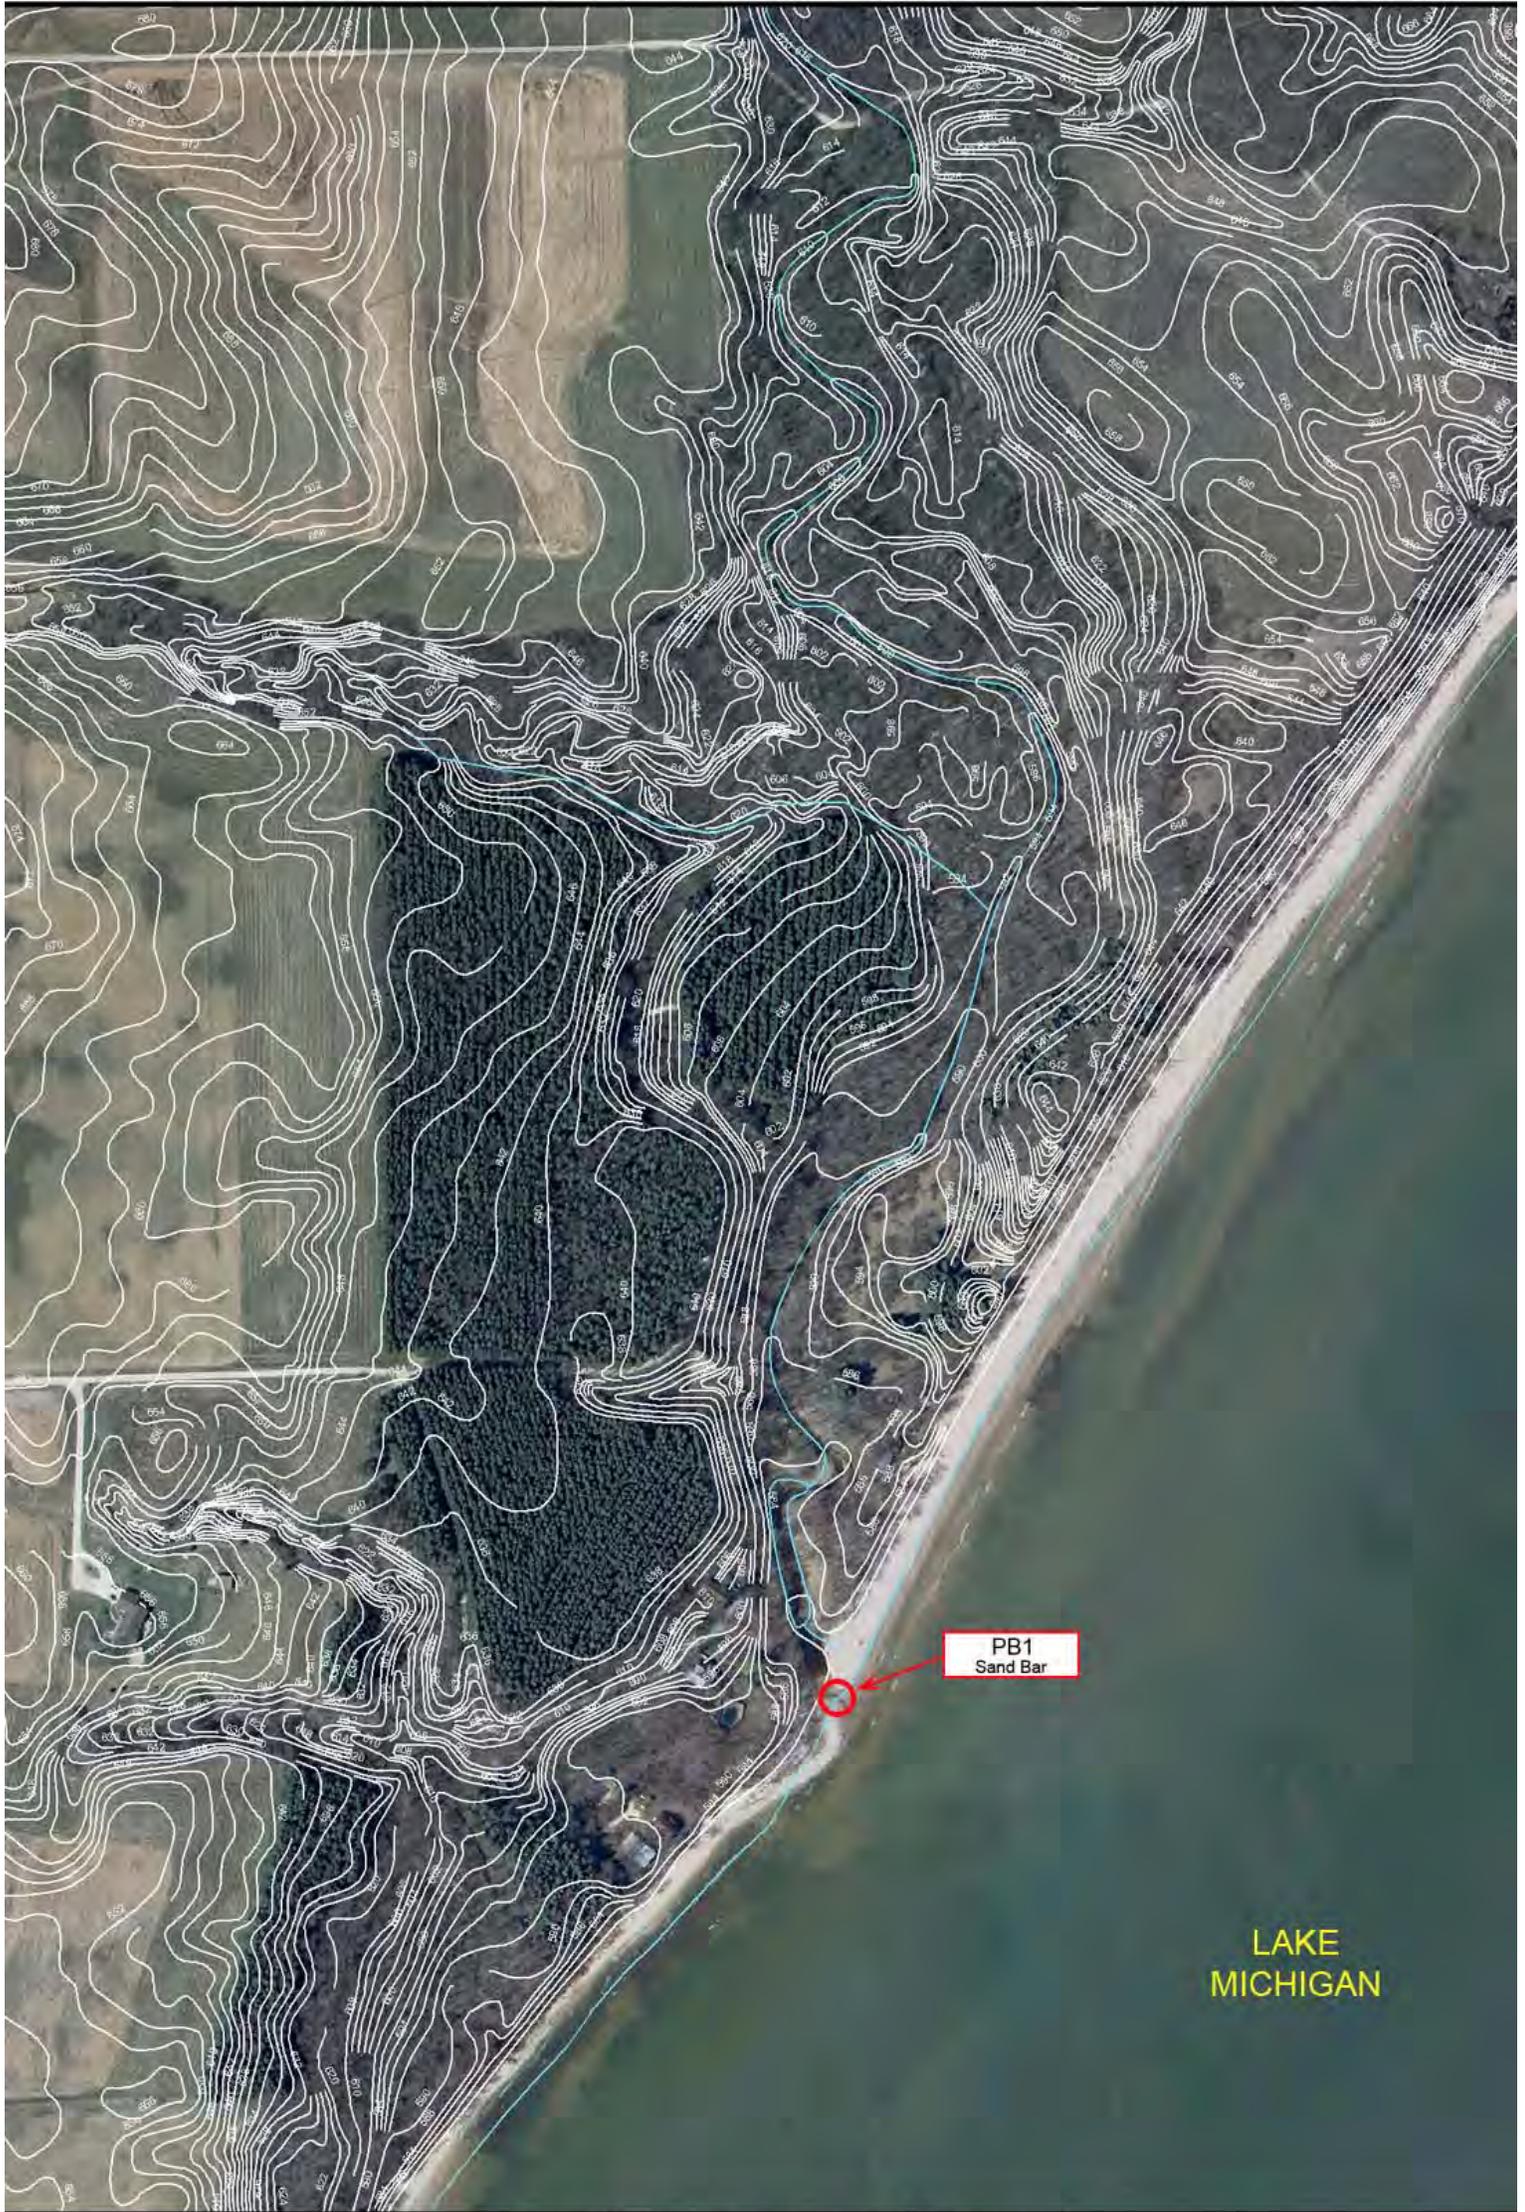
PB1
Sand Bar

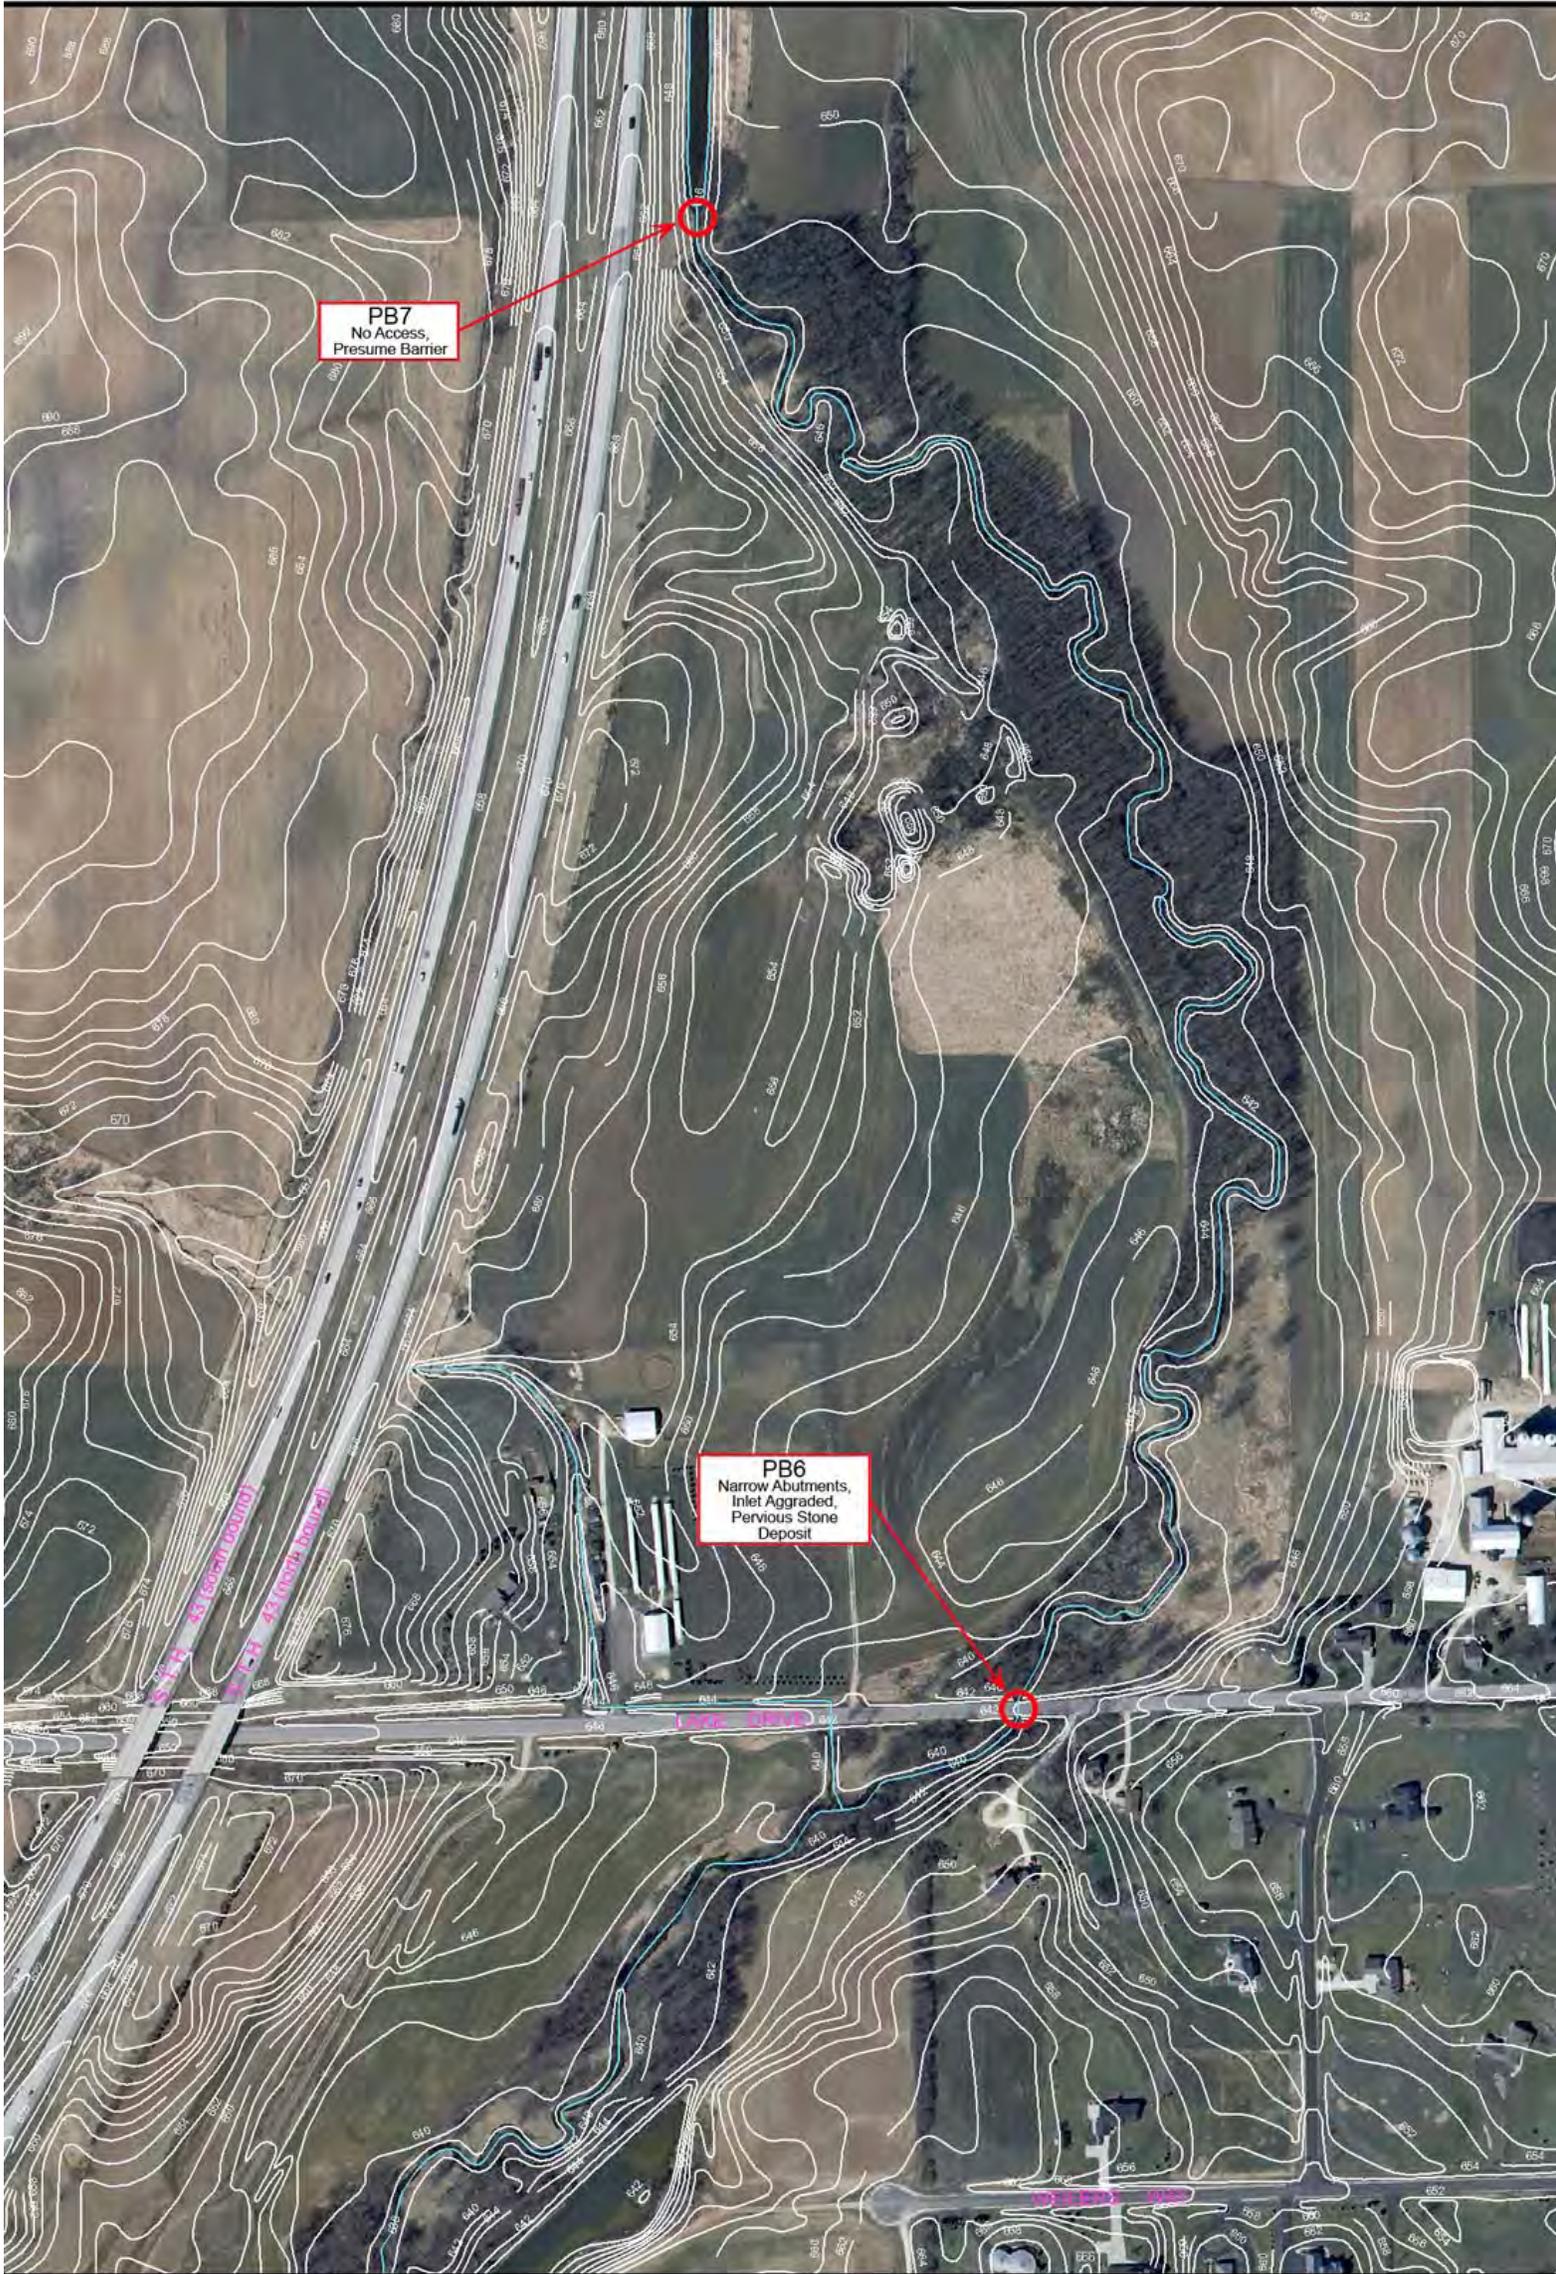
PB7
No Access,
Presume Barrier

PB6
Narrow Abutments,
Inlet Aggraded,
Pervious Stone
Deposit

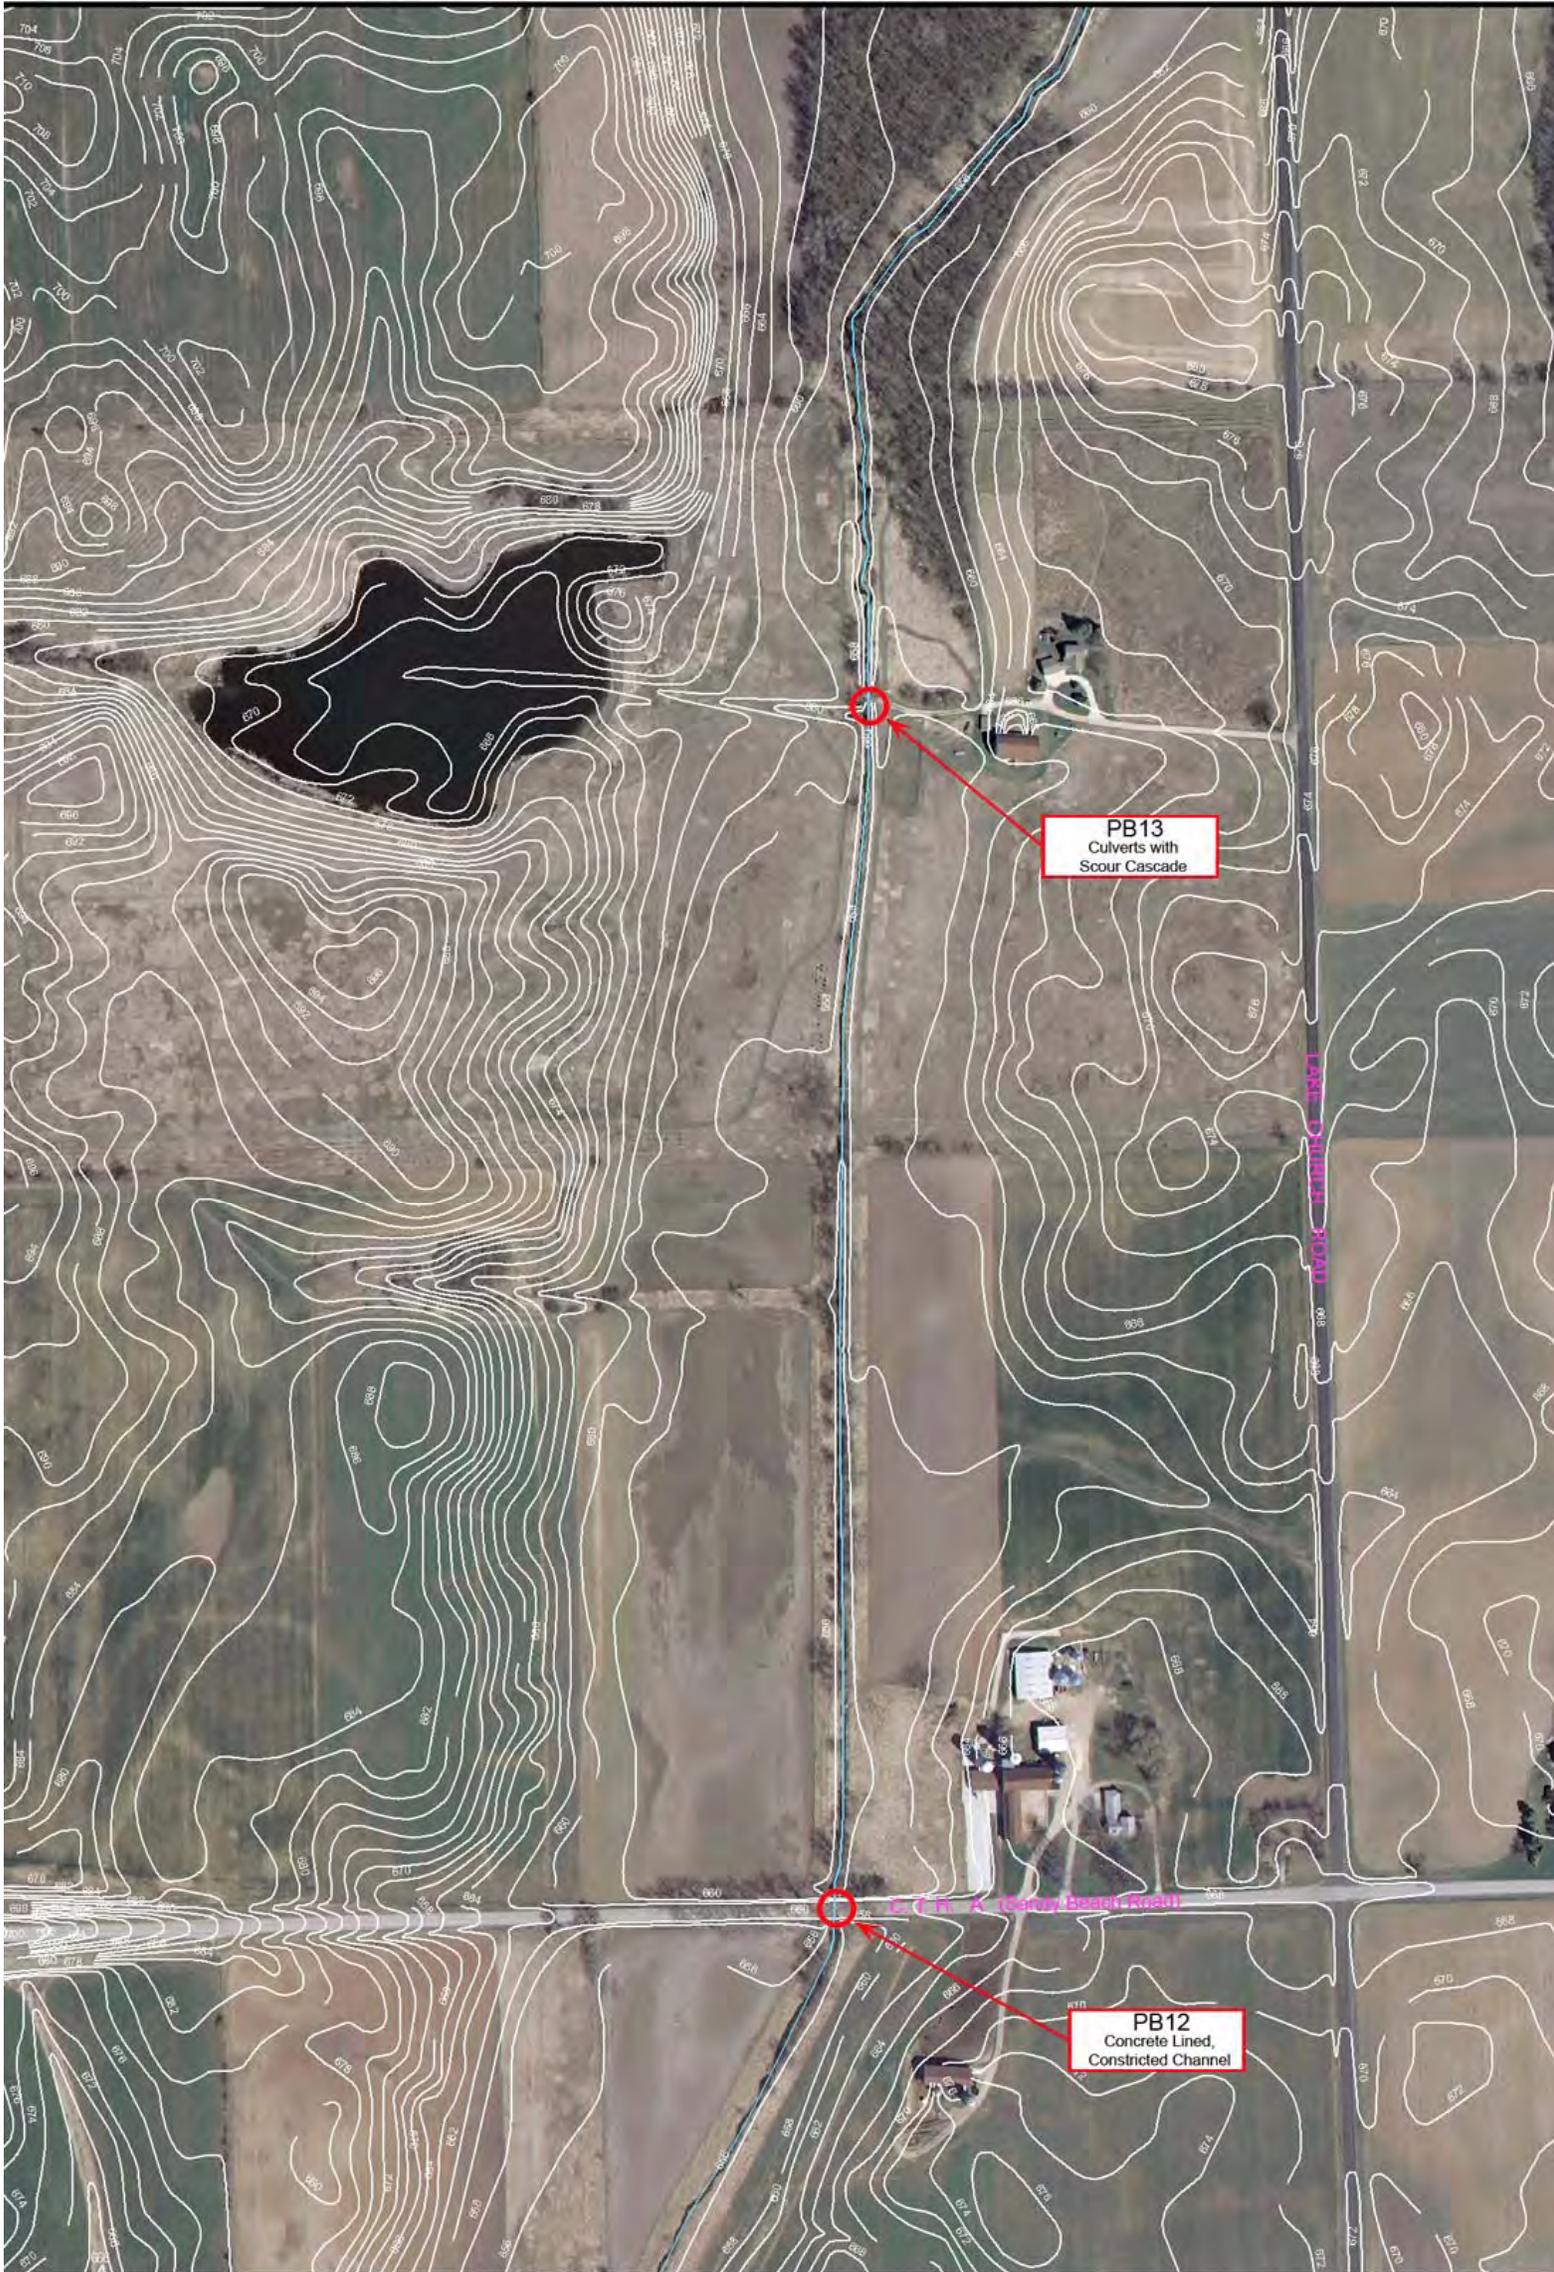
PB13
Culverts with
Scour Cascade

PB12
Concrete Lined,
Constricted Channel
