**STREAM PASSAGE IMPEDIMENTS
AND AQUATIC HABITAT
FRAGMENTATION INVENTORY**

**MILWAUKEE RIVER AND LAKE
MICHIGAN TRIBUTARY STREAMS
OZAUKEE COUNTY, WISCONSIN**

November 16, 2006

Project Number: OZC 01-5400-3000

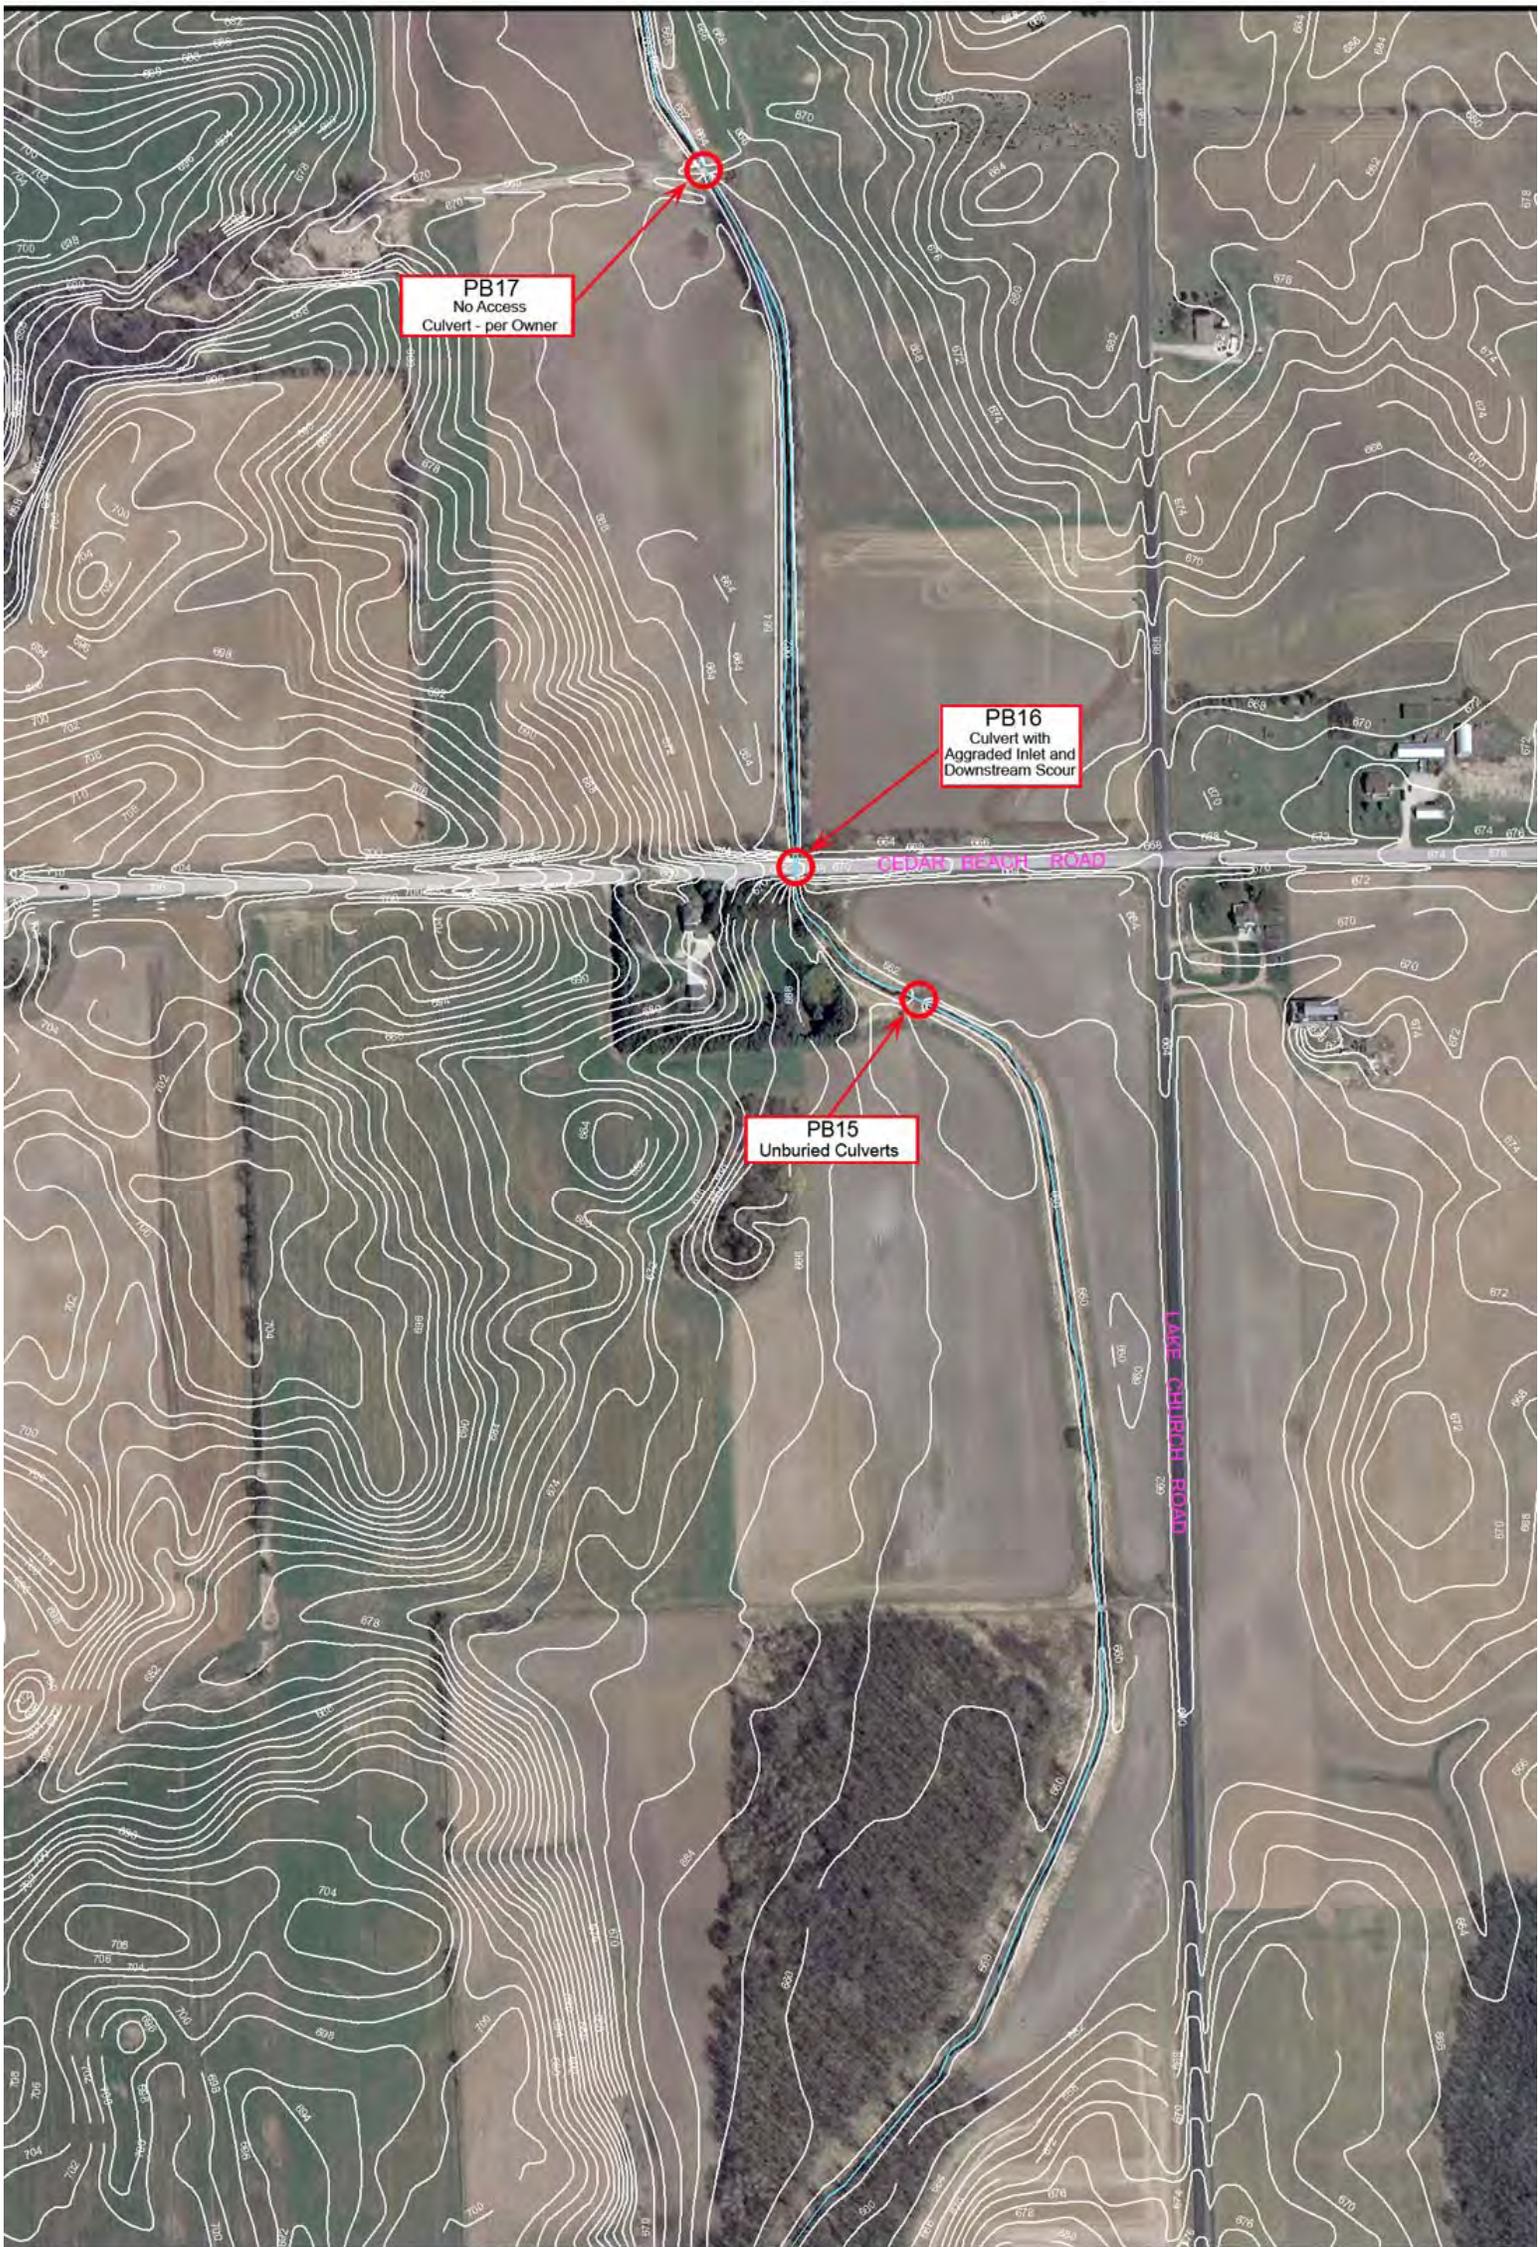
PB17
No Access
Culvert - per Owner

PB16
Culvert with
Aggraded Inlet and
Downstream Scour

PB15
Unburied Culverts

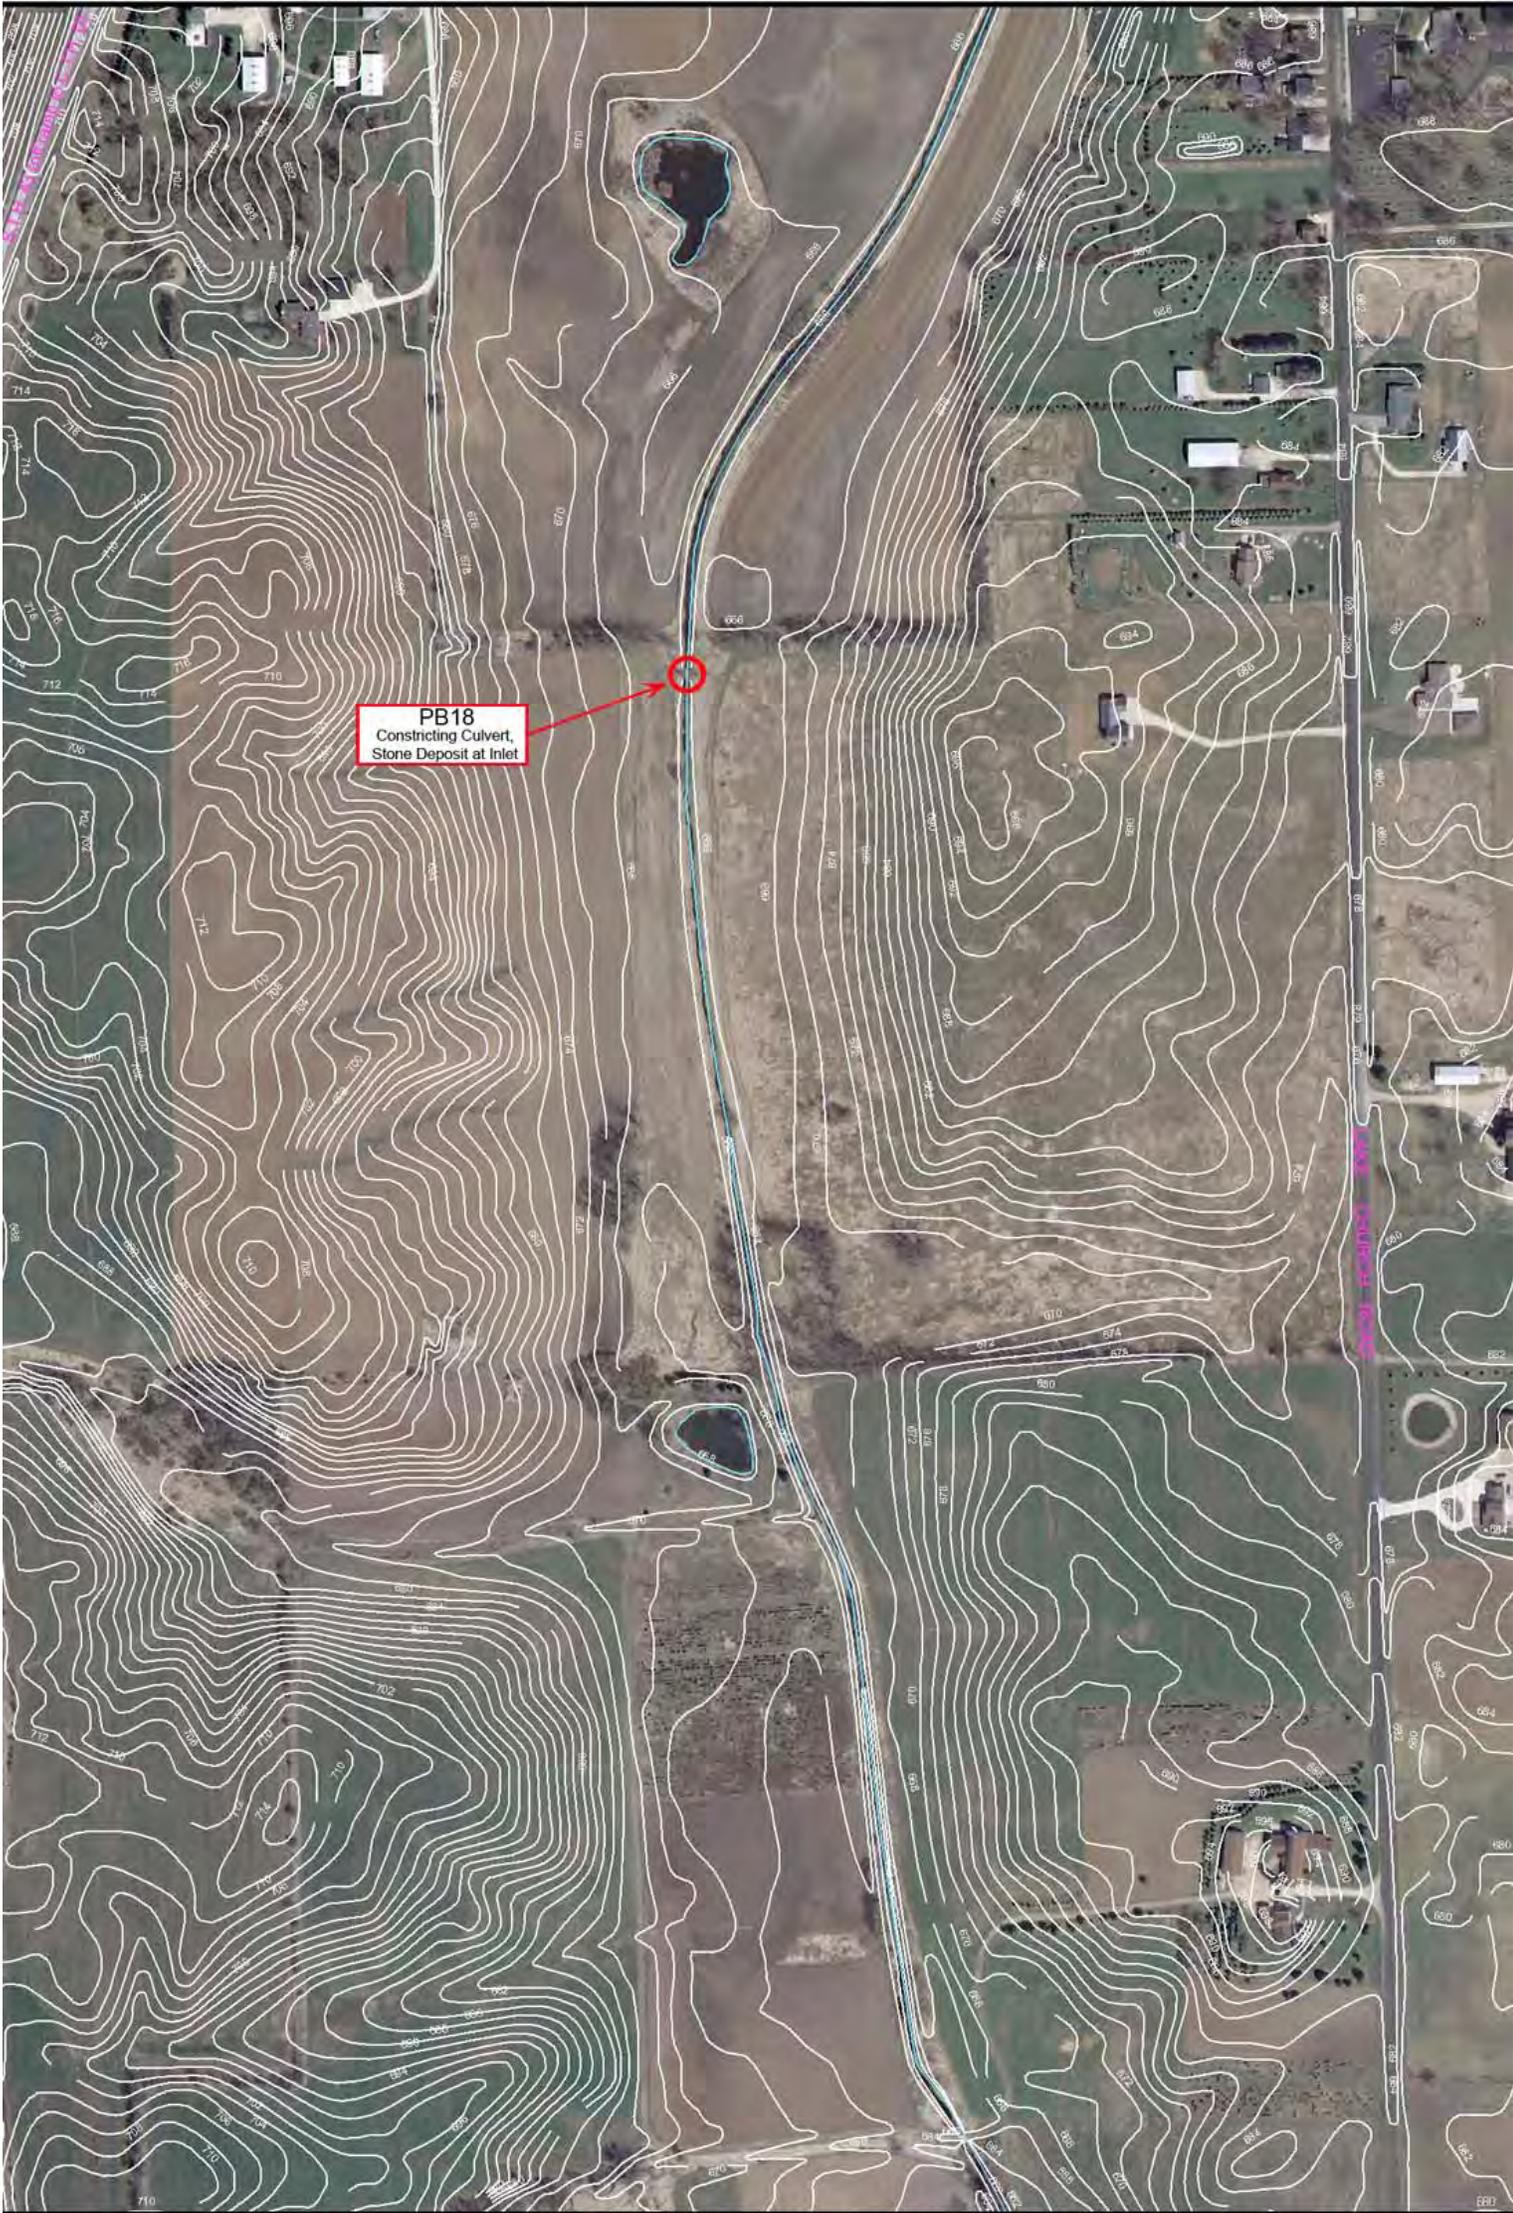
PB18
Constricting Culvert,
Stone Deposit at Inlet

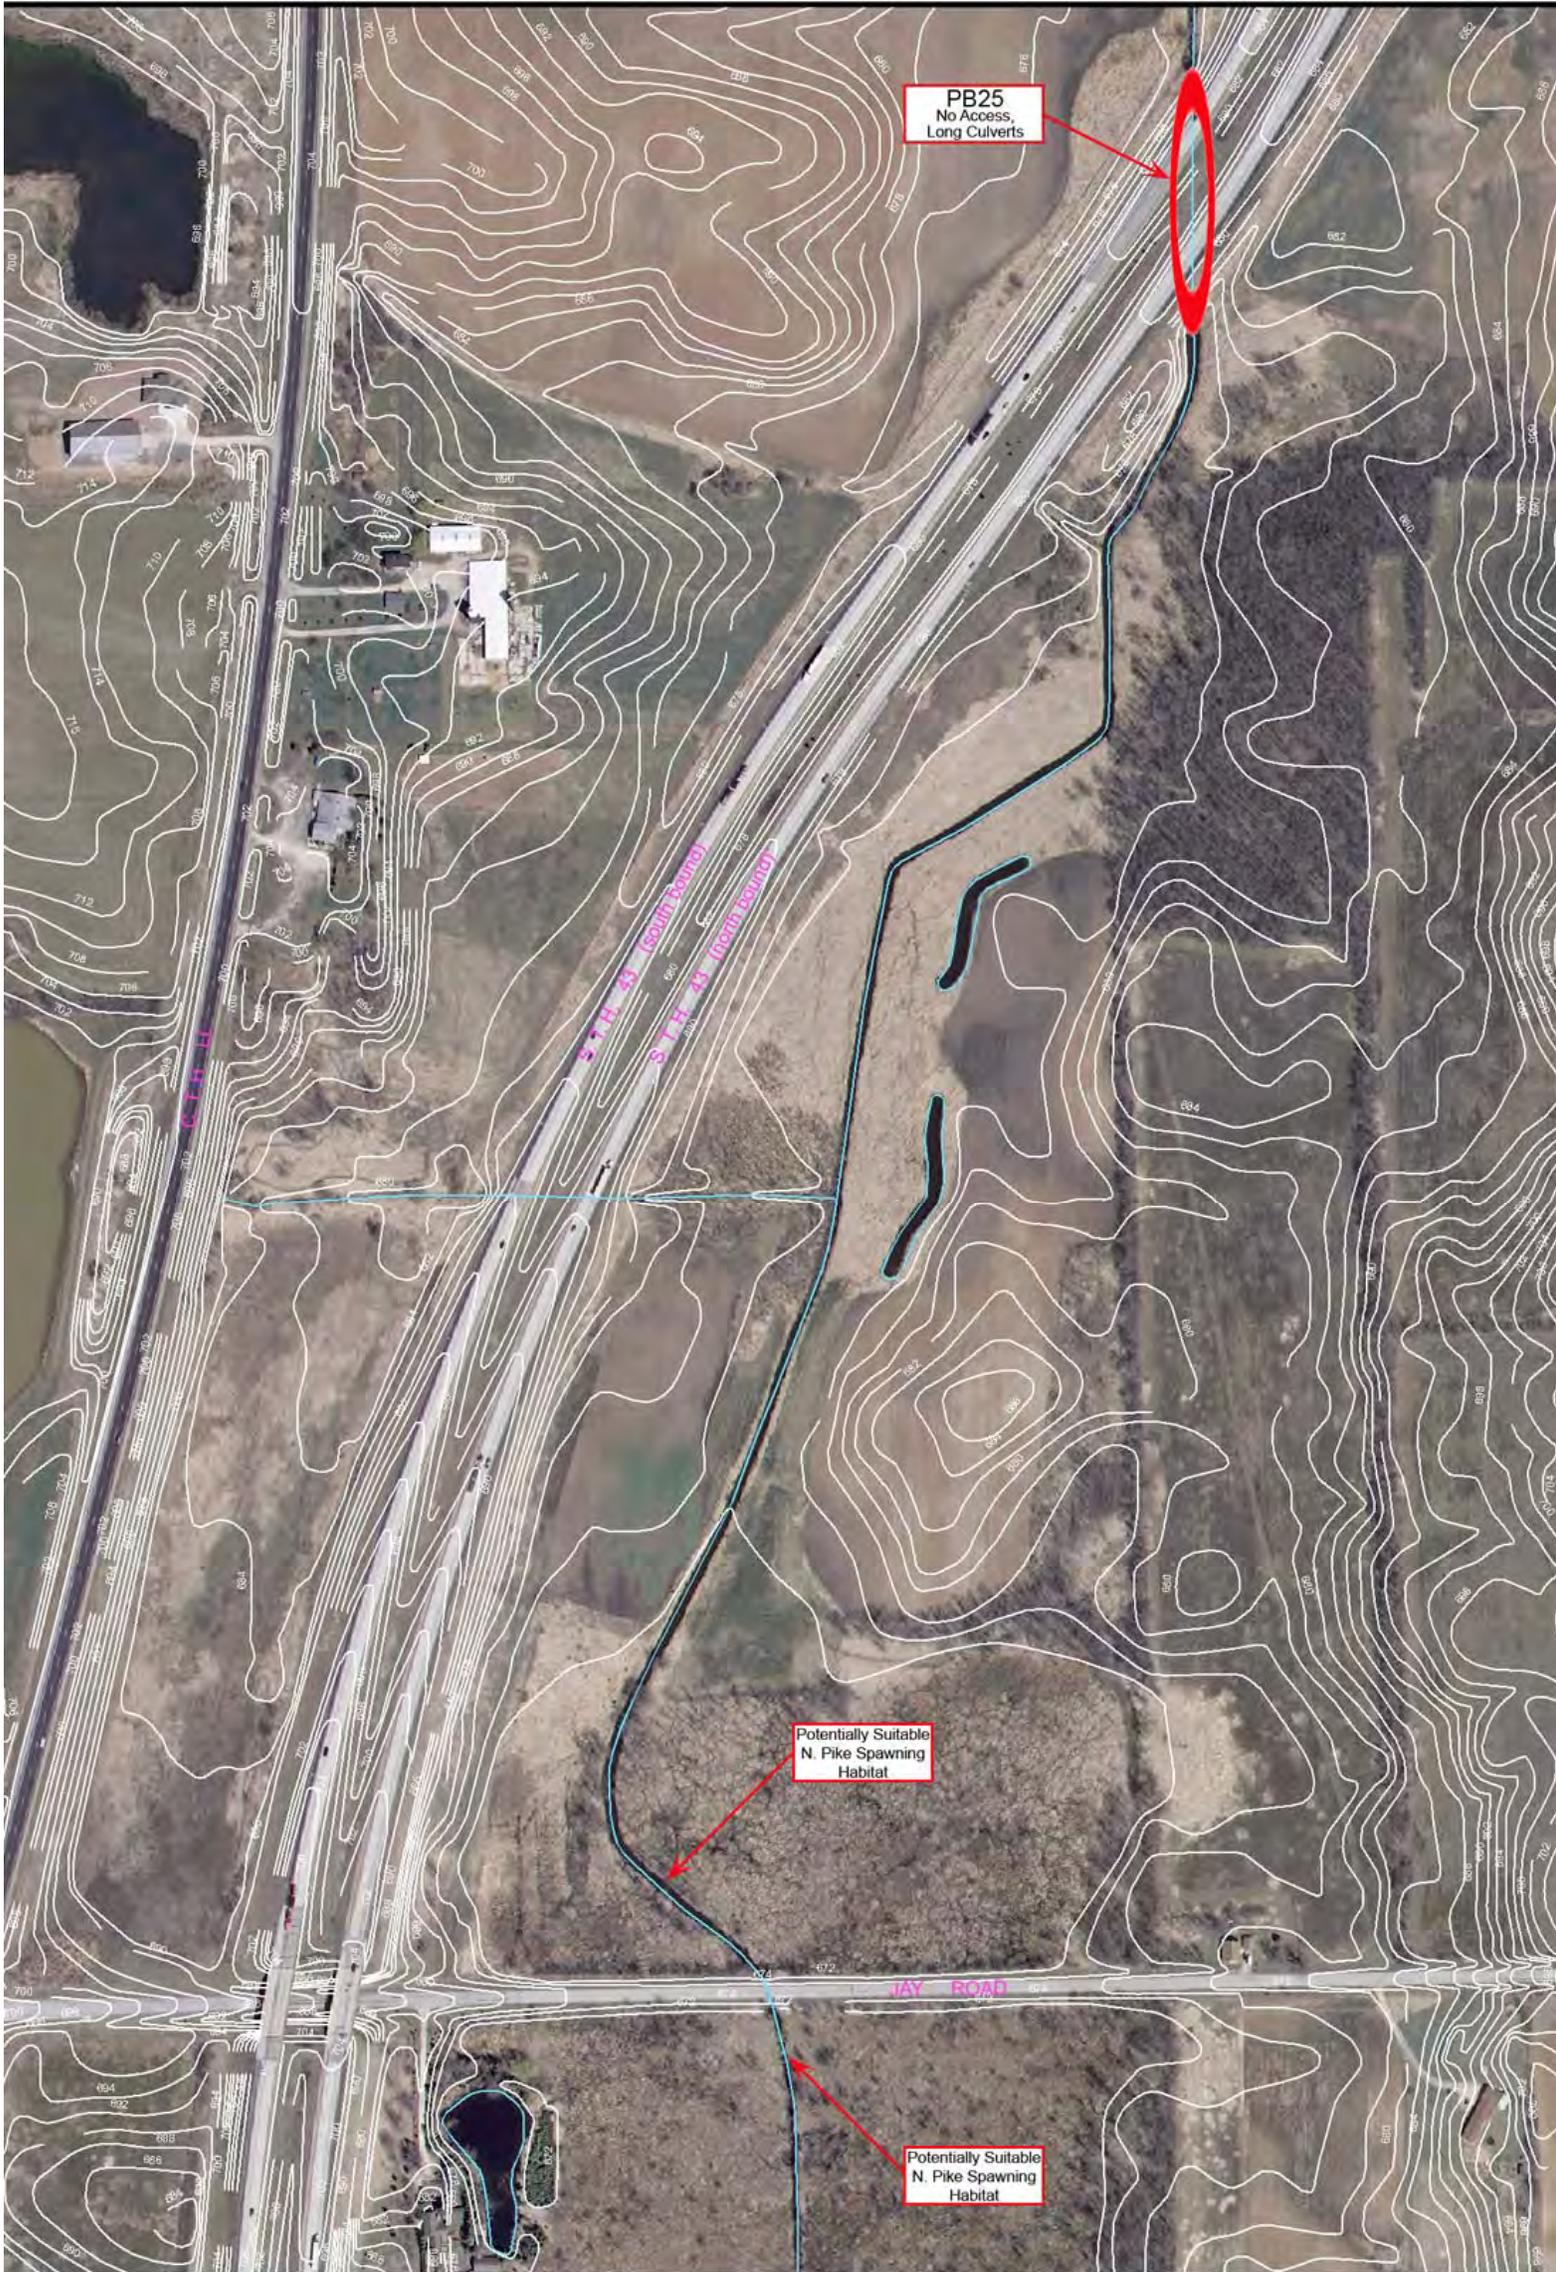
PB25
No Access,
Long Culverts

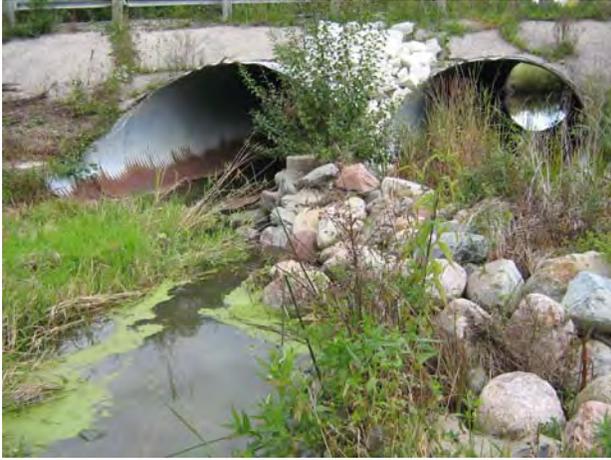
Photograph 1 – Riprap fill blocking inlet to culvert under North Cedarburg Road (TC PB2)

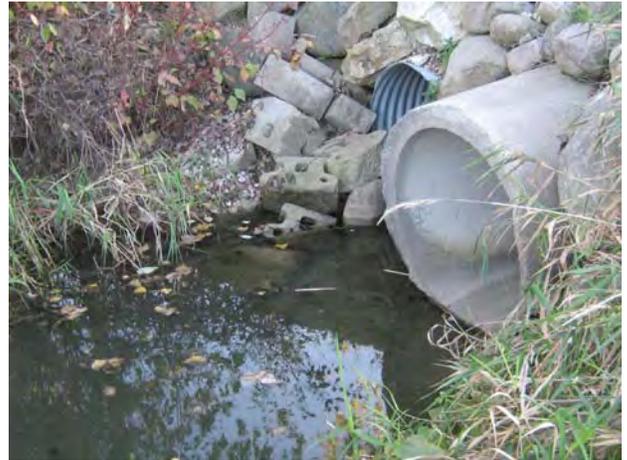
Photograph 4 – Culverts with low internal water depth during high flow conditions (SC PB21)

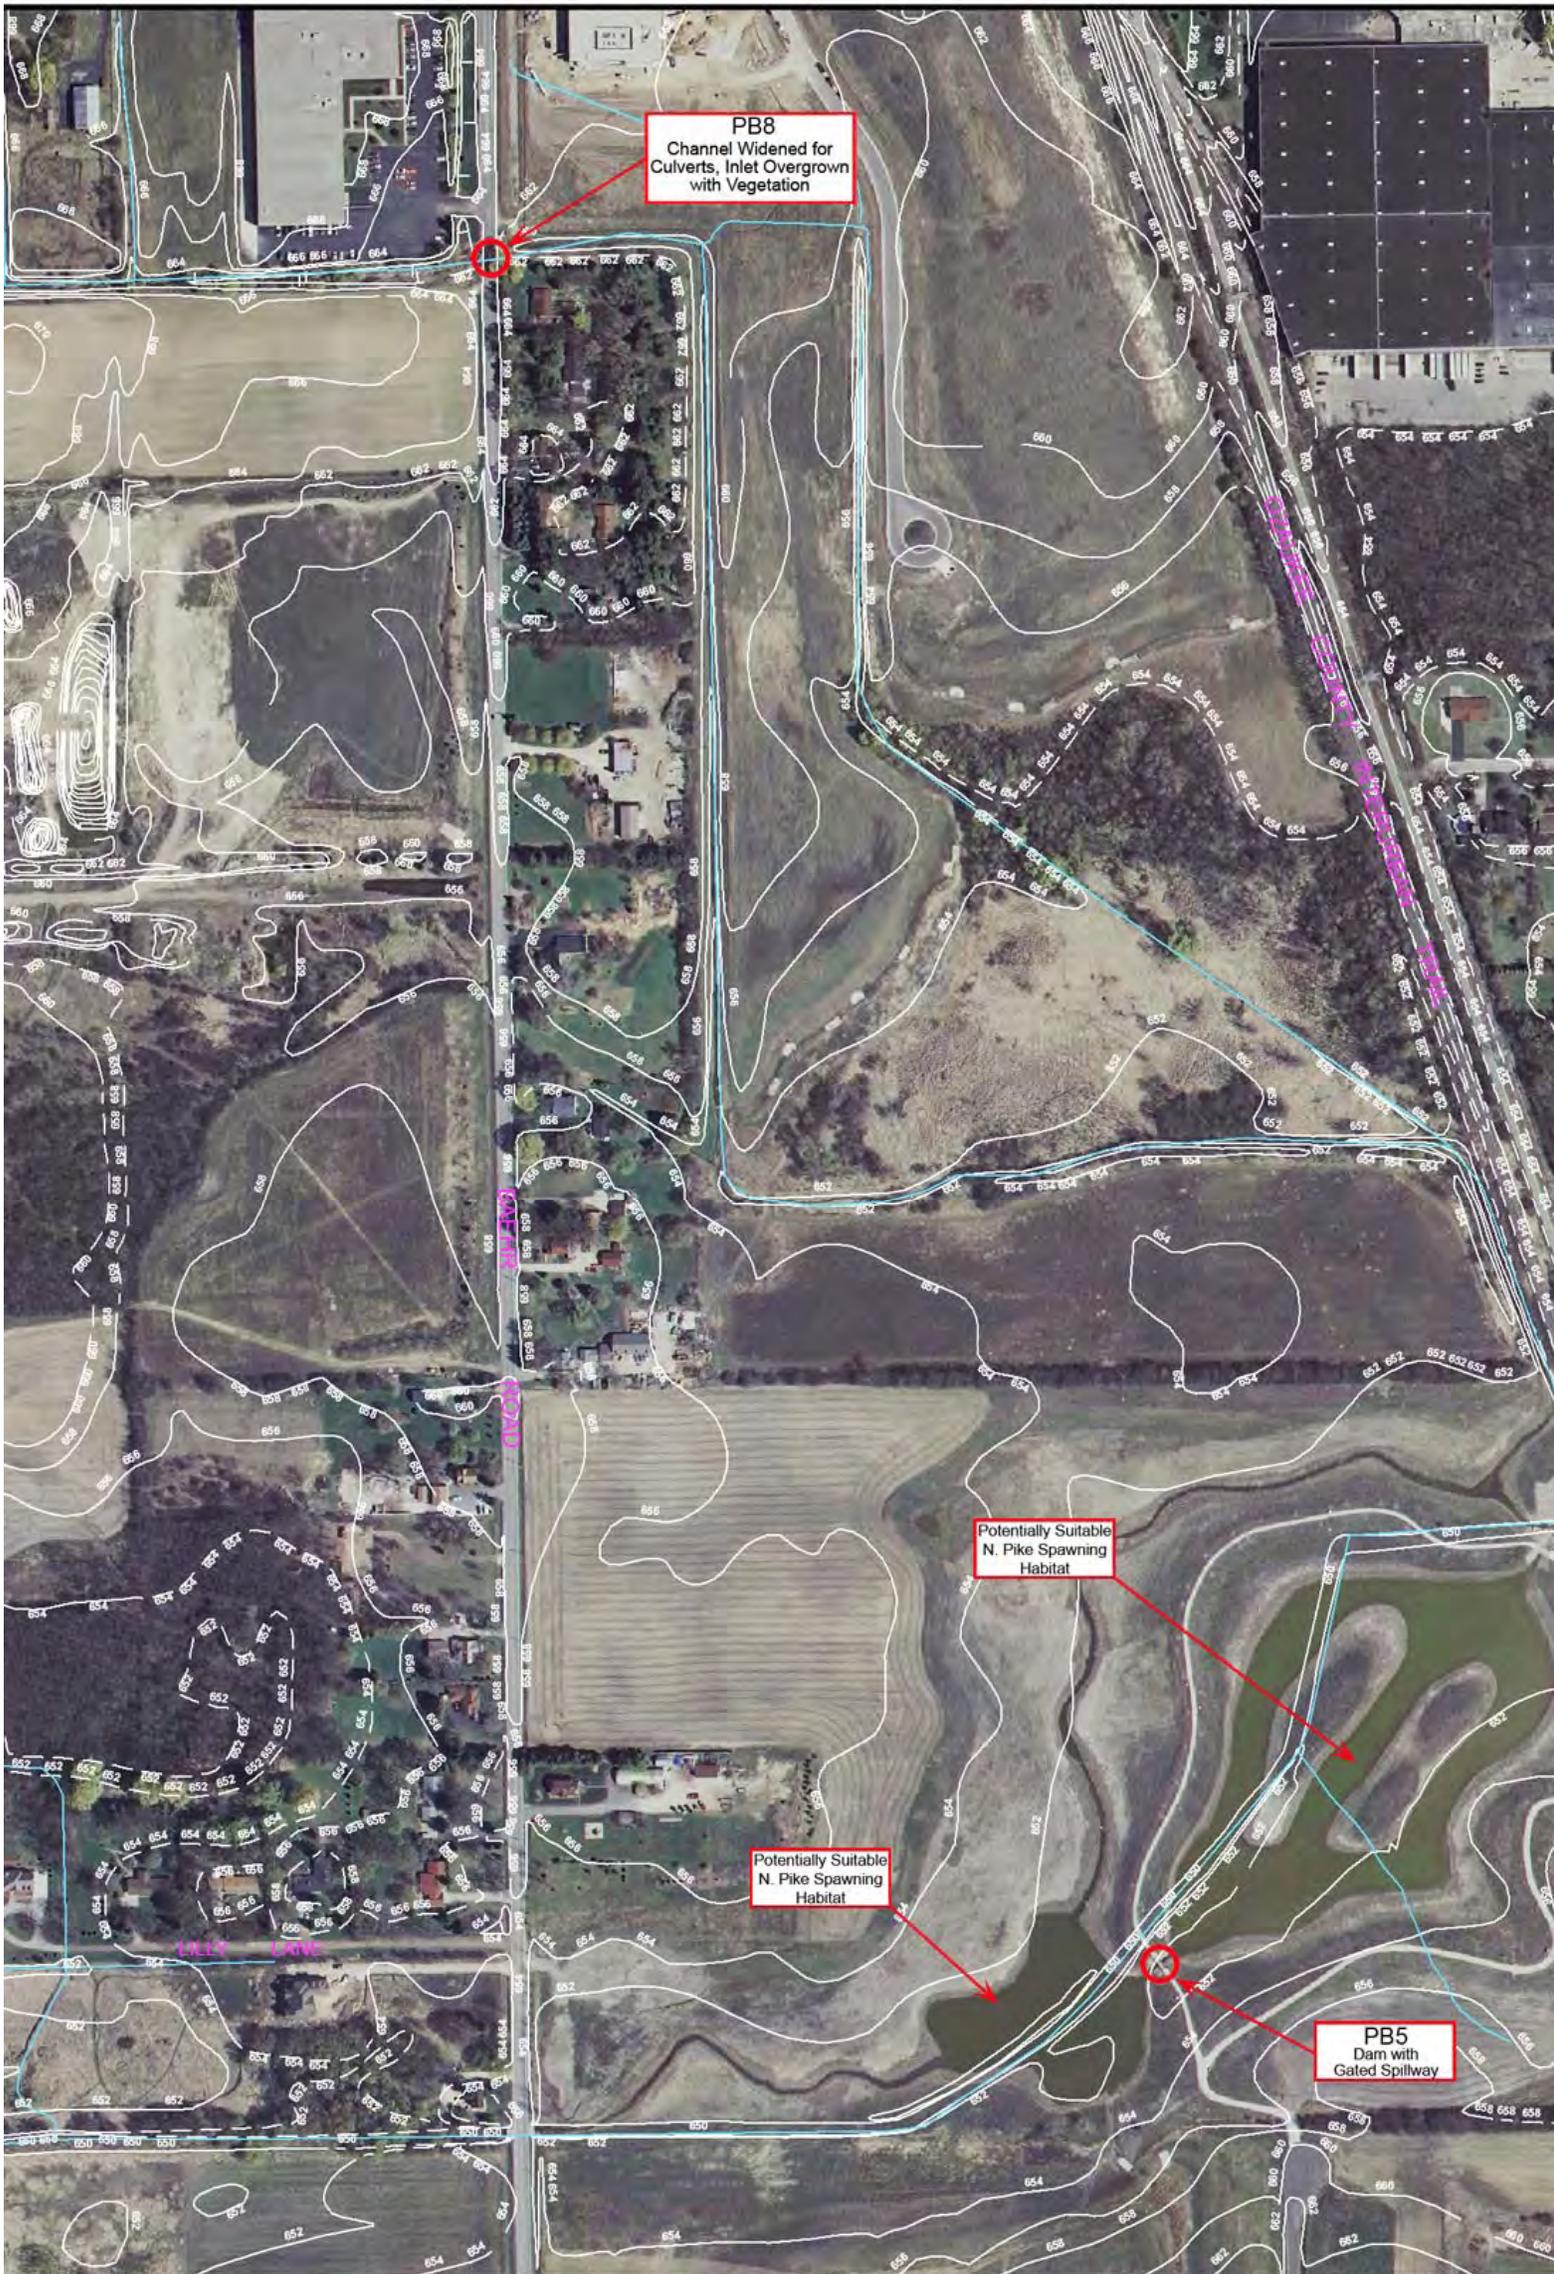
PB8
Channel Widened for
Culverts, Inlet Overgrown
with Vegetation

PB5
Dam with
Gated Spillway

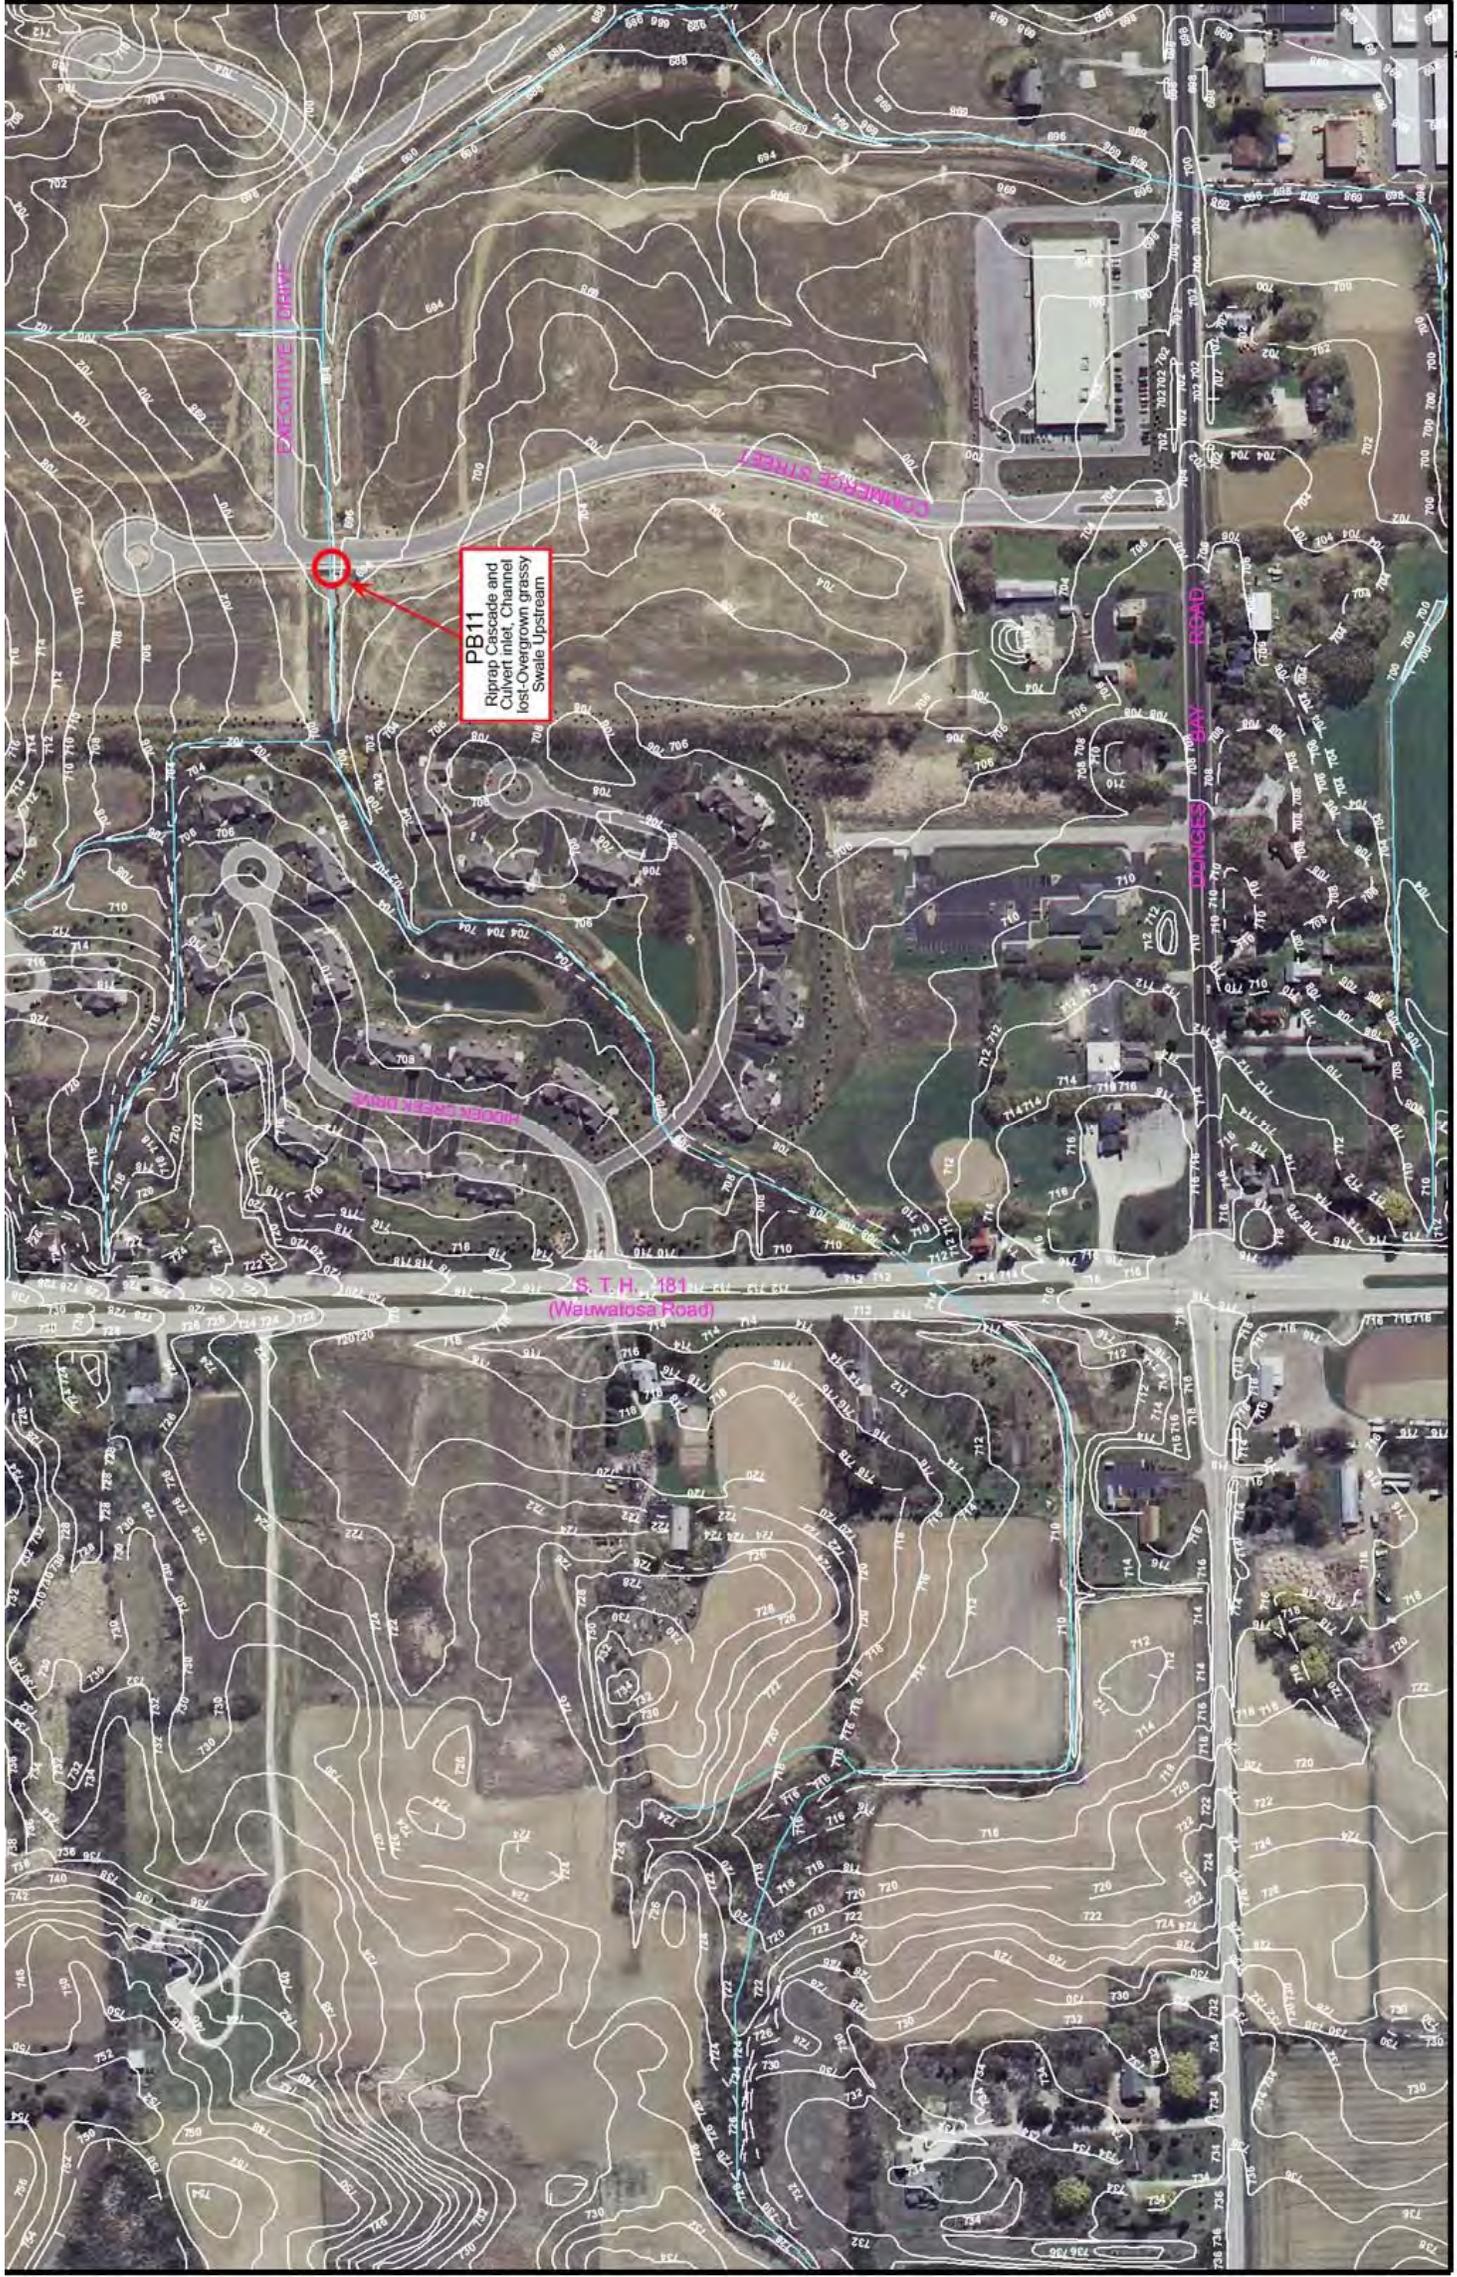
PB11
Riprap Cascade and
Culvert Inlet, Channel
loss, Overgrown grassy
Swale Upstream

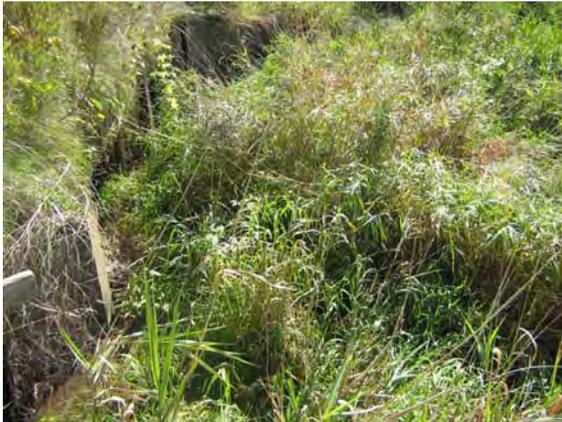
Photograph 1 – Vegetated sediment bar at outlet of box culverts under I-43 (UC PB10)

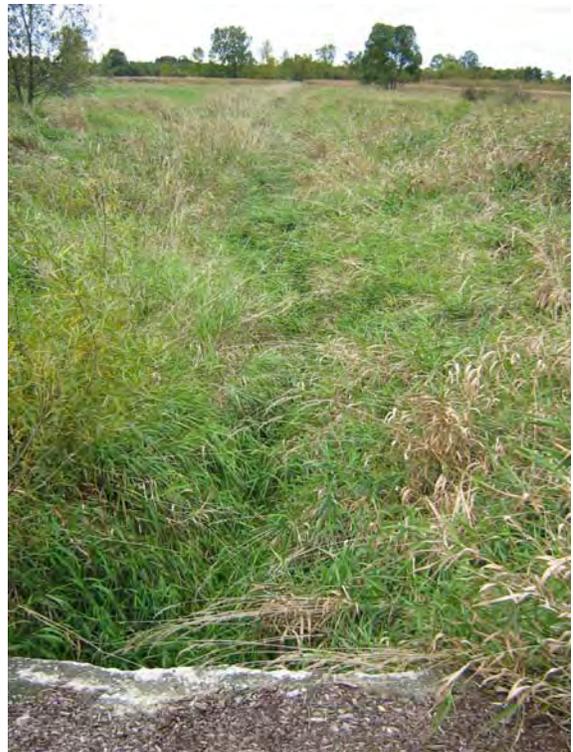
Photograph 4 – Channel lost to infiltration in a reed canary grass-dominated wetland (UC PB22)

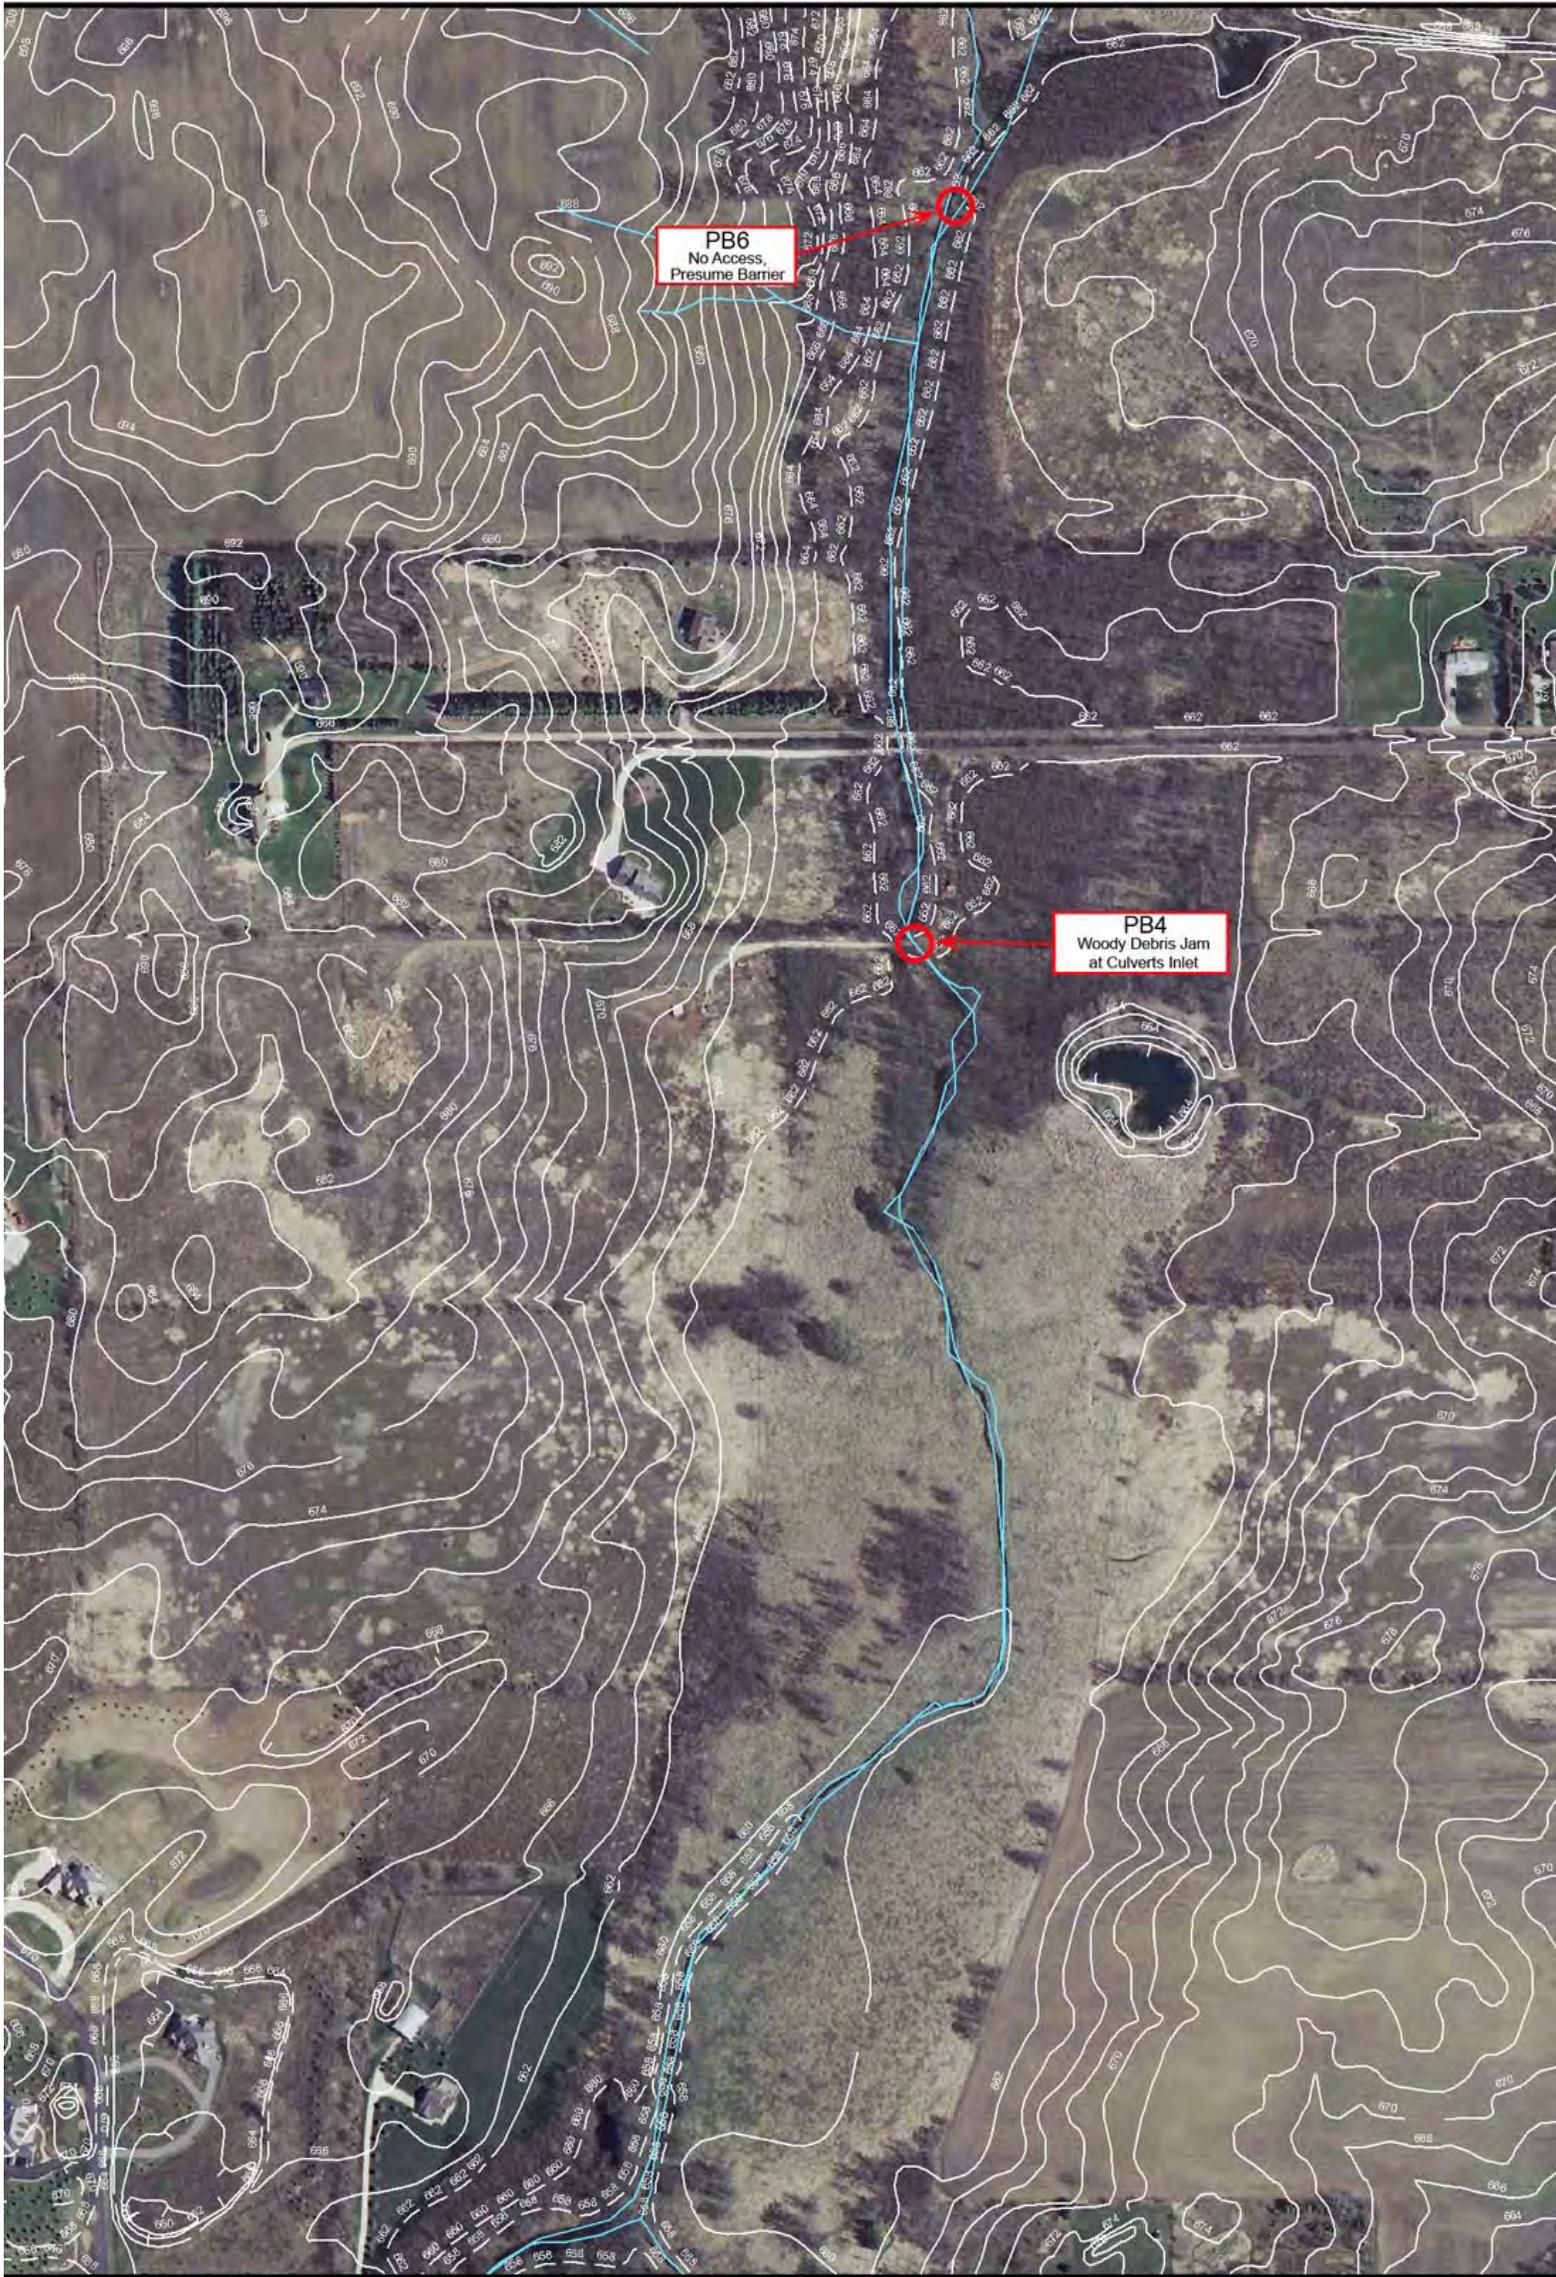
PB6
No Access,
Presume Barrier

PB4
Woody Debris Jam
at Culverts Inlet
