**STREAM PASSAGE IMPEDIMENTS
AND AQUATIC HABITAT
FRAGMENTATION INVENTORY**

**MILWAUKEE RIVER AND LAKE
MICHIGAN TRIBUTARY STREAMS
OZAUKEE COUNTY, WISCONSIN**

November 16, 2006

Project Number: OZC 01-5400-3000

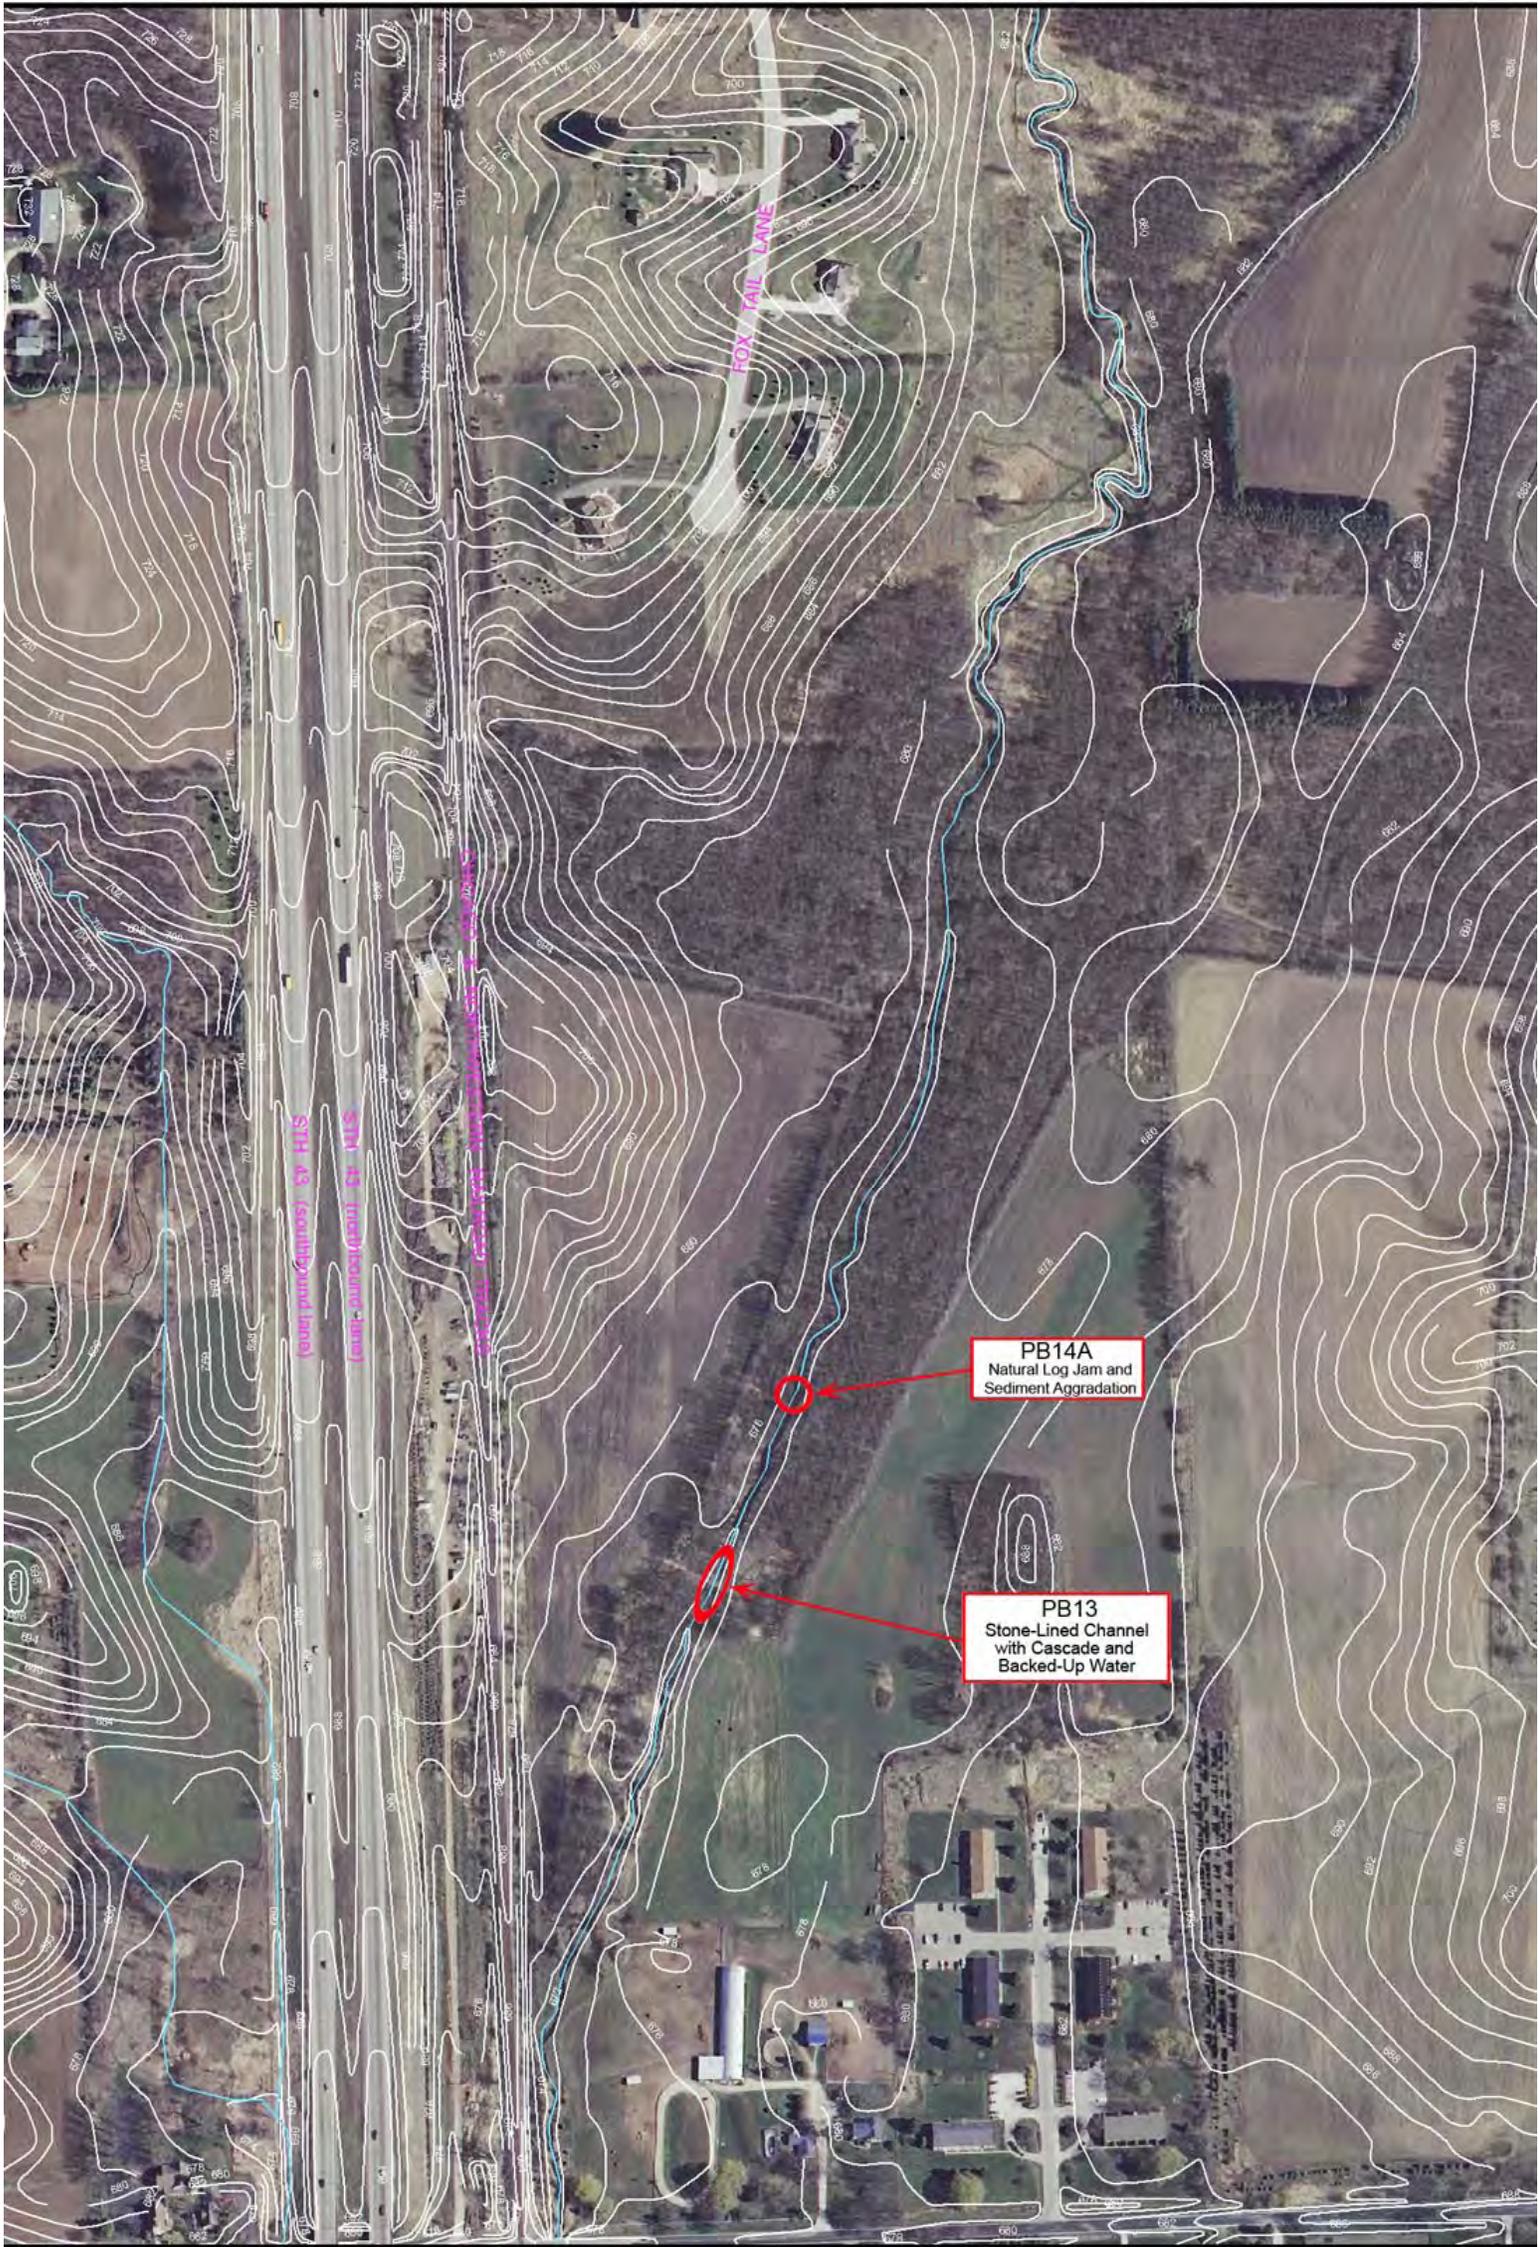
PB13
 Stone-Lined Channel
 with Cascade and
 Backed-Up Water

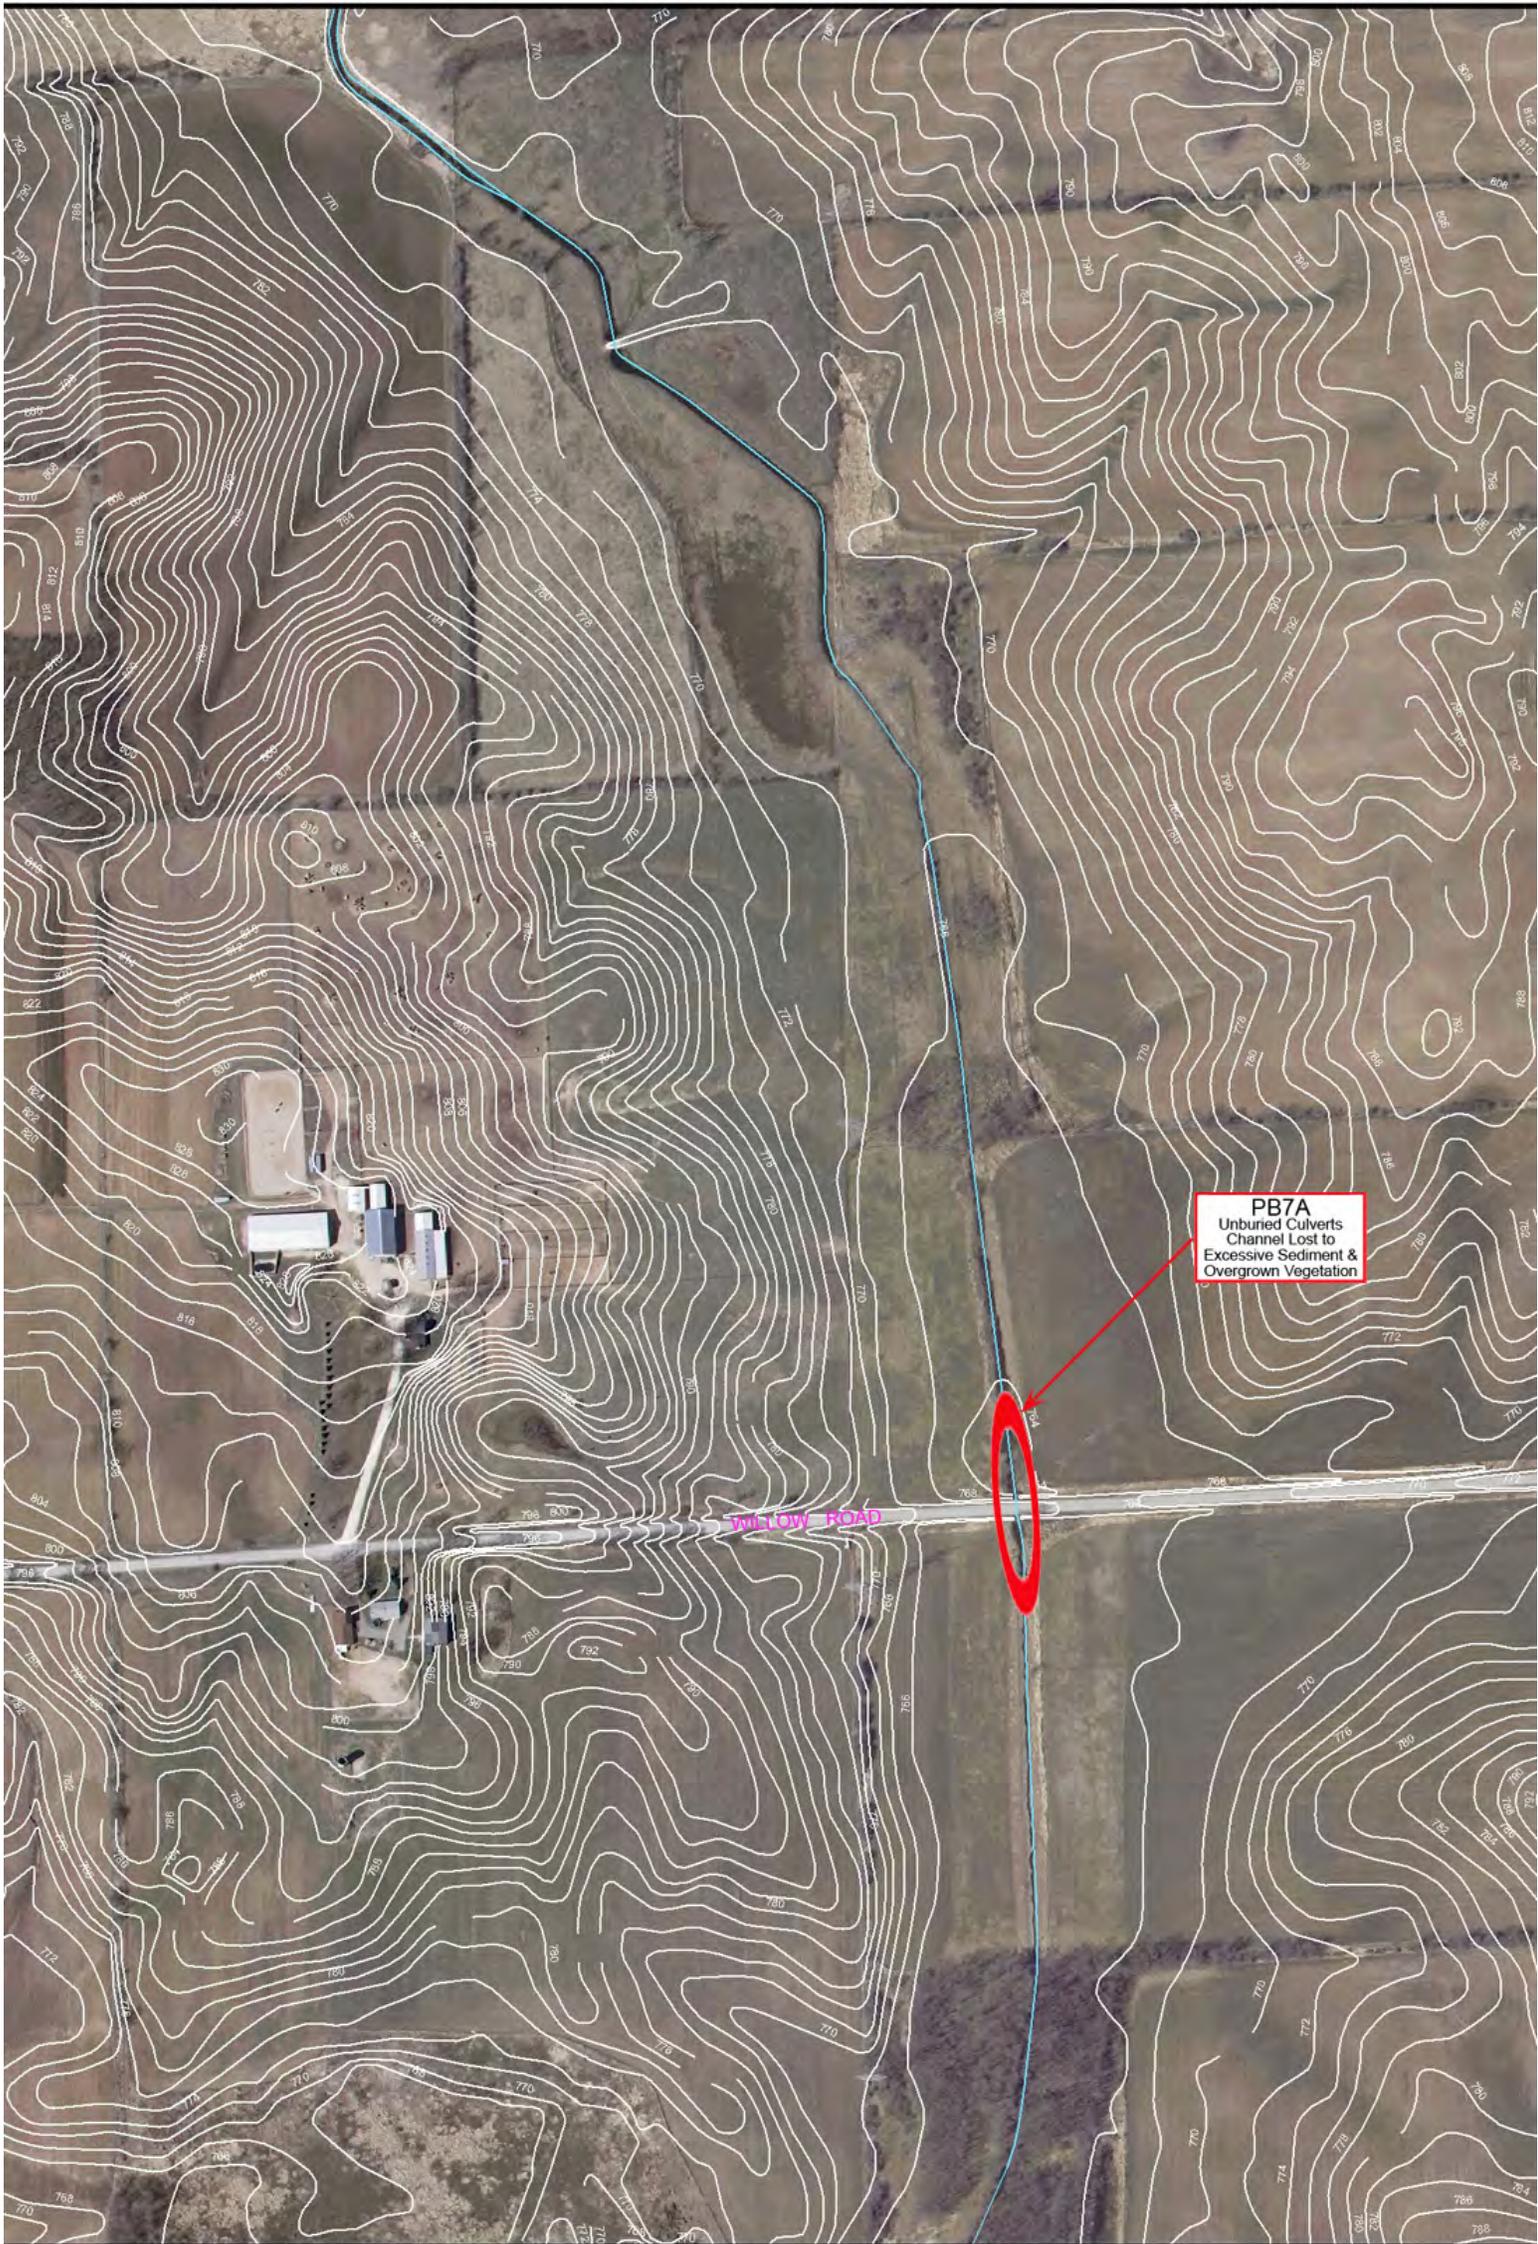
PB7A
Unburned Culverts
Channel Lost to
Excessive Sediment &
Overgrown Vegetation
