**STREAM PASSAGE IMPEDIMENTS
AND AQUATIC HABITAT
FRAGMENTATION INVENTORY**

**MILWAUKEE RIVER AND LAKE
MICHIGAN TRIBUTARY STREAMS
OZAUKEE COUNTY, WISCONSIN**

November 16, 2006

Project Number: OZC 01-5400-3000

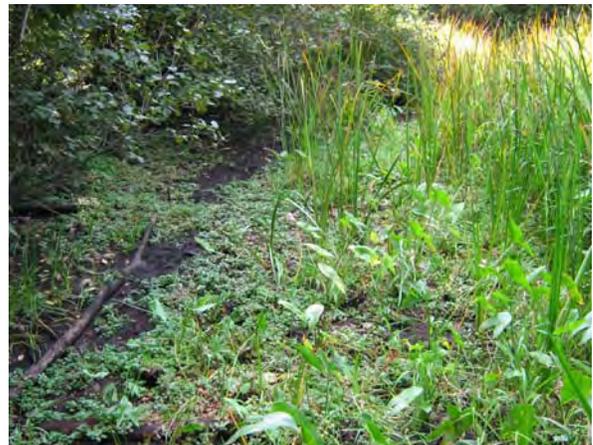
Photograph 1 – Mud Lake Outlet Creek
Creek bank hydrophytic vegetation

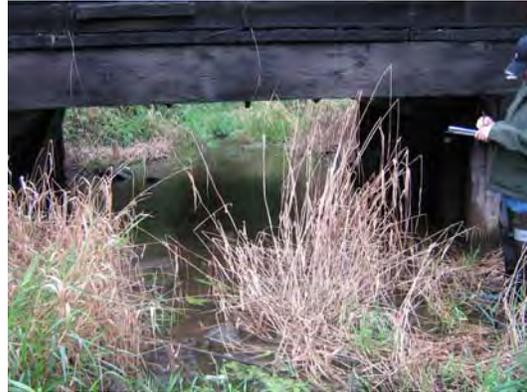
Photograph 2 – Railroad crossing ballast stone deposit (FC PB10)

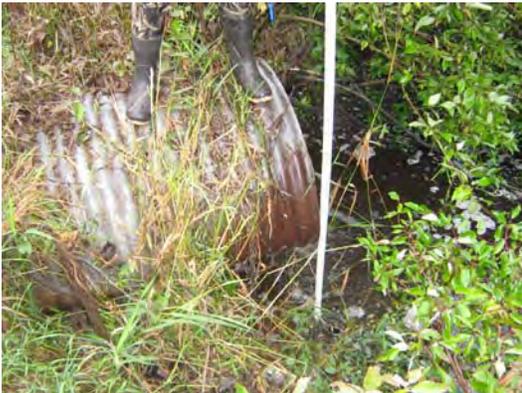
Photograph 3 – Perched culvert outlet (FC PB14)

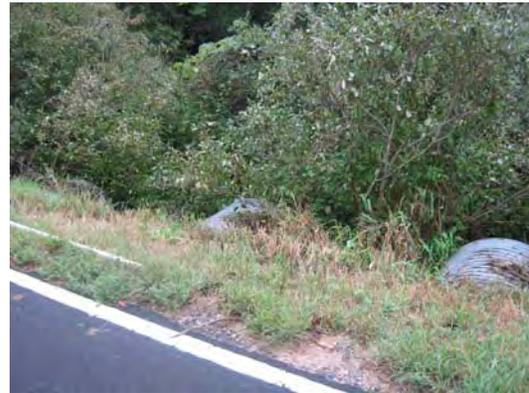
Photograph 4 – Perched culvert outlets (FC PB14)

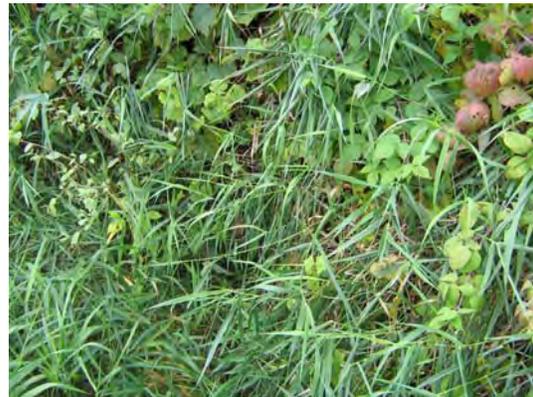
Photograph 2 – The ingrown inlet of a long,
unburied, corrugated metal culvert (GSC PB3)

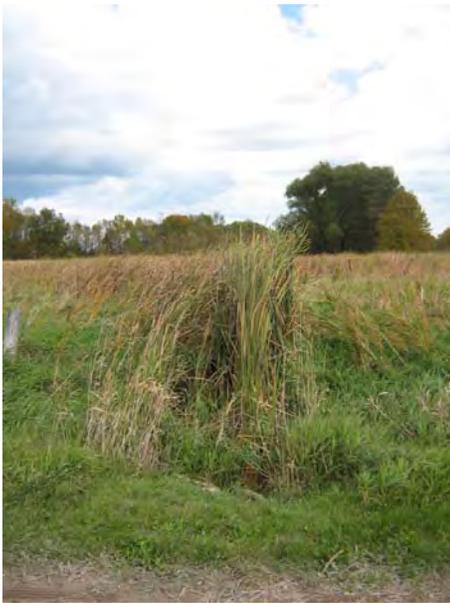
Photograph 3 – Channel lost to densely
ingrown cattails (GSC PB7)

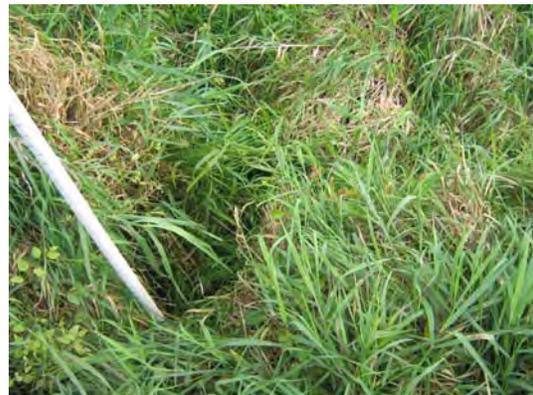
Photograph 4 – Channel lost to densely
ingrown vegetation (GSC PB11 & PB12)

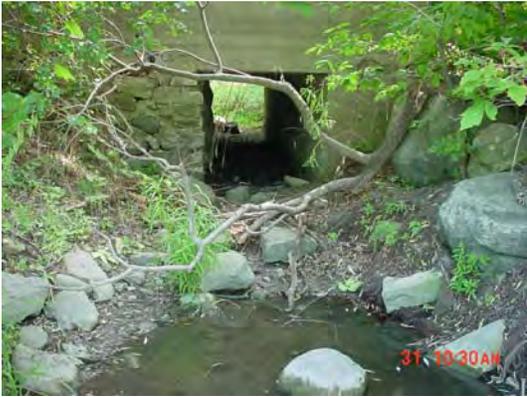
Between these abutments, the bankfull cross-sectional area of the channel is roughly one-tenth of that found in the stable reach upstream. The constriction likely results in swift flow velocities that are too fast for adult northern pike to traverse during spring-melt (the season when creeks are often swollen and northern pike migrate to spawn). If by chance adult northern pike did make it upstream to the small unnamed lake, another barrier could prevent their offspring from returning to the Milwaukee River. This barrier is a small deposit of concrete riprap that was placed across the channel, likely as a foot crossing (Photograph 3). During flooded conditions it is most likely irrelevant to stream and habitat connectivity. At less than bankfull flows, however, the pervious fill is likely a barrier to larval northern pike passage.

Photograph 1 – Narrow concrete bridge abutments (LDC PB1)

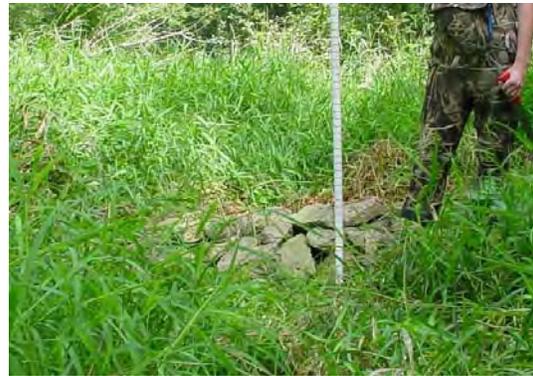
Photograph 2 – Pervious riprap fill placed in channel (LDC PB2)

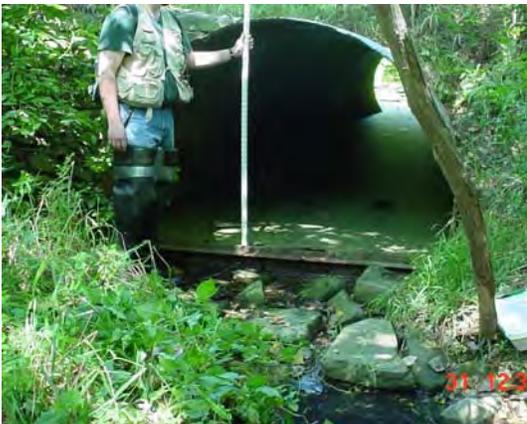
Photograph 3- Round corrugated metal culvert with water-level control and scour cascade (LDC PB3)

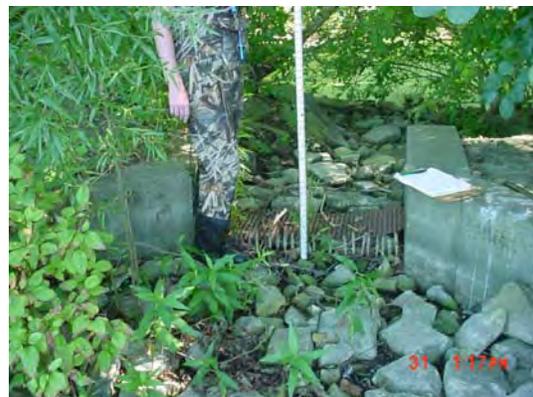
Photograph 4 – Non-functional low-head dam with riprap channel lining (LDC PB4)

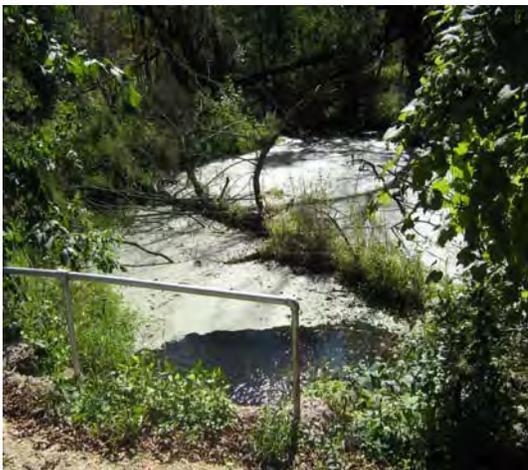
Photograph 3 – Single-log jam causing channel widening and pool (MC PB14)

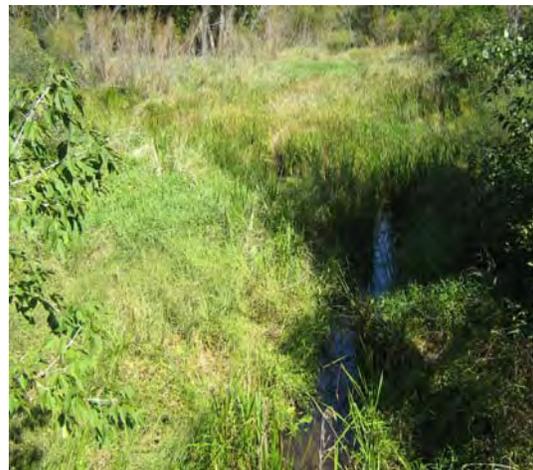
Photograph 4 – Habitat conditions suitable for northern pike spawning (located north of Cedar Sauk Road)

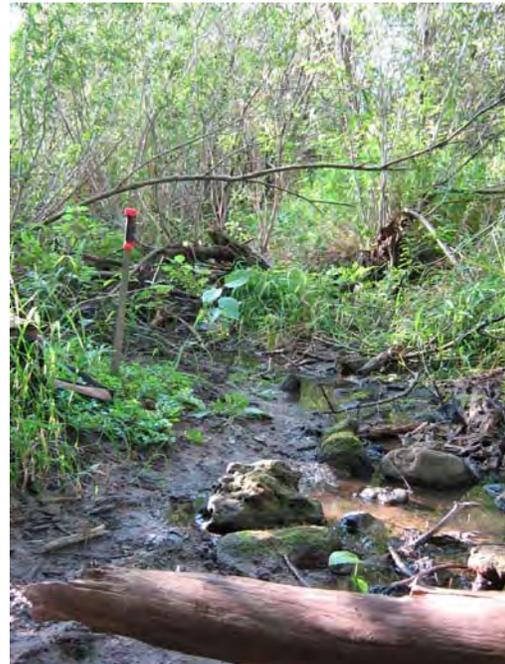
Photograph 2 – Channel lost to densely ingrown sandbar willow (ML PB3)

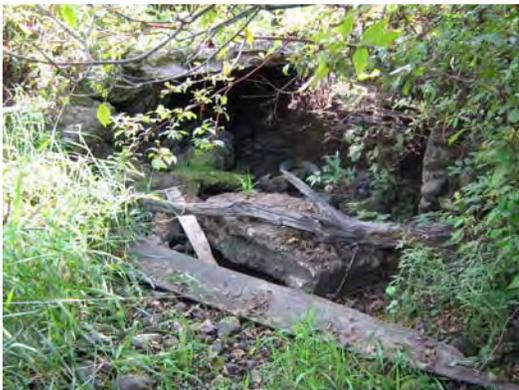
Photograph 3 – Old concrete bridge nearing collapse and with stone fill at inlet (ML PB15)

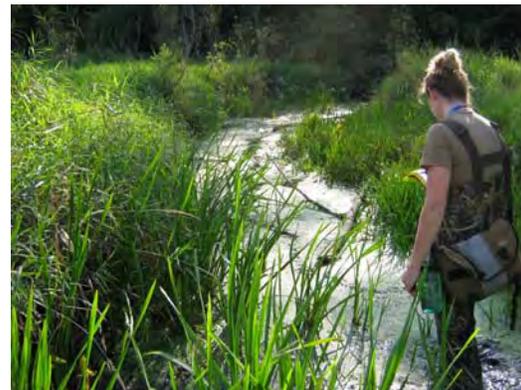
Photograph 4 – Habitat conditions suitable for northern pike spawning – located near Cedar Creek confluence

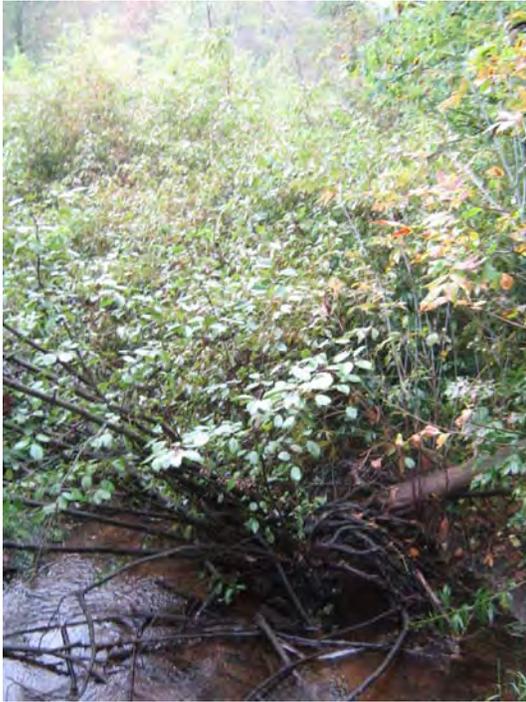
Photograph 1 – Channel lost to densely ingrown red osier dogwood near Milwaukee River confluence (RE PB1)

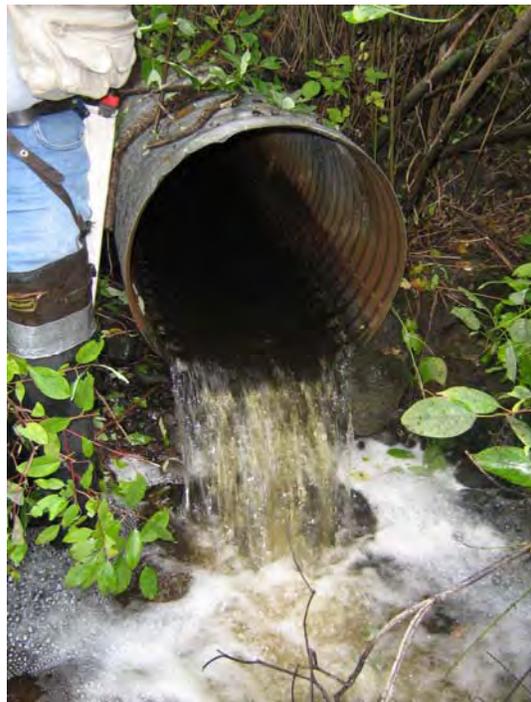
Photograph 2 – Perched culvert outlet under farm crossing (RE PB8)

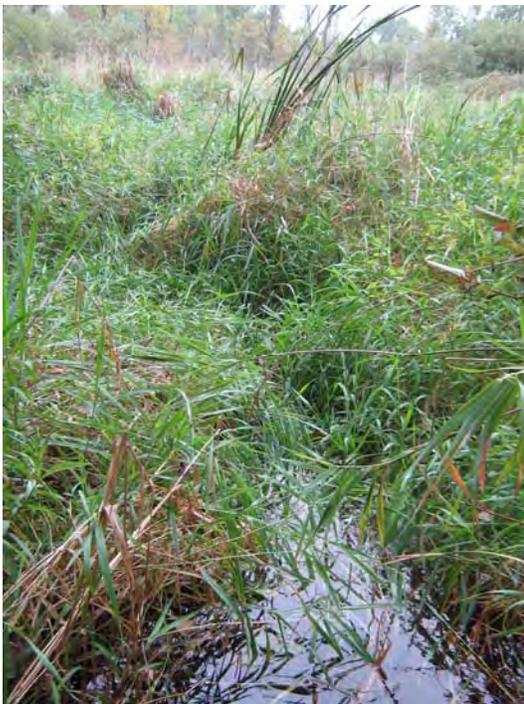
Photograph 3 – Channel lost to dispersion in wetland (RE PB9)

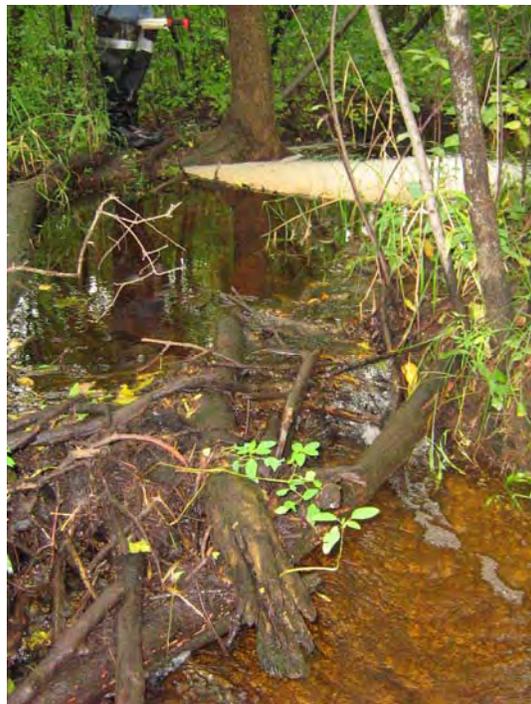
Photograph 4 – Natural wood debris jam and slow-water pool (RE PB8A)

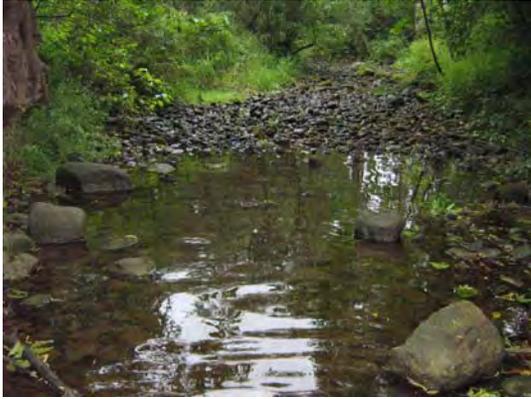
Photograph 1 – Moderately low gradient channel near High Point Beach Road

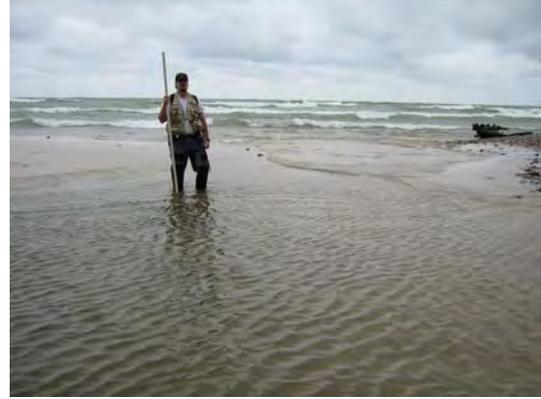
Photograph 2 – Sediment bar at Lake Michigan outlet (SC PB1)

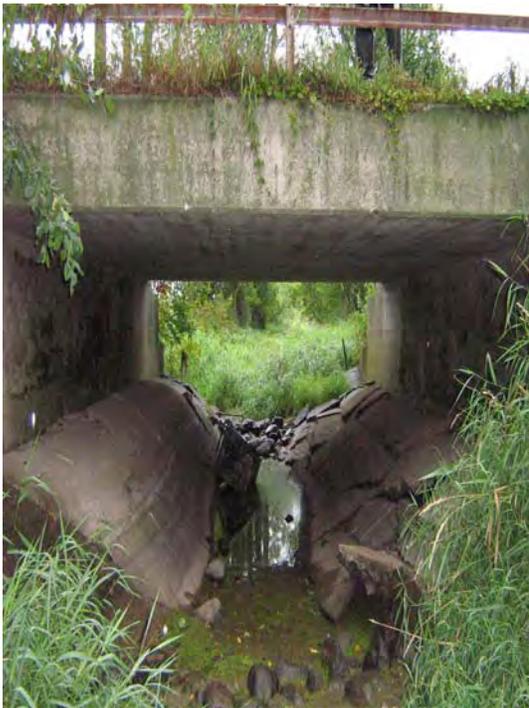
Photograph 3 – Constricted and concrete-lined channel (SC PB12)

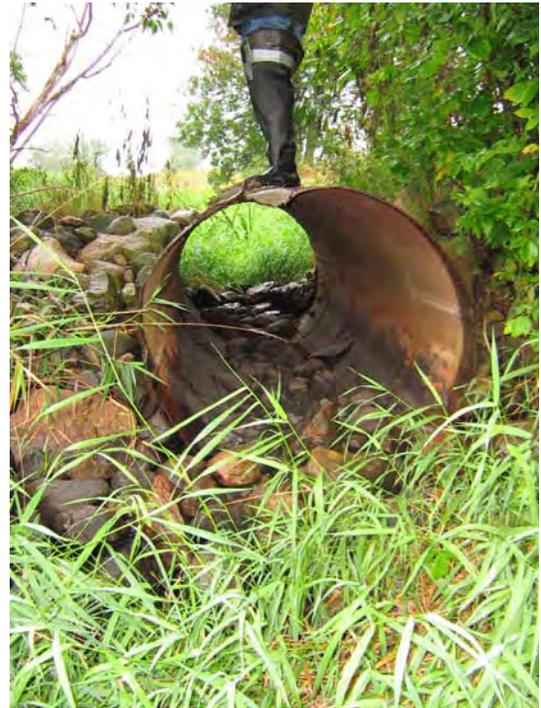
Photograph 4 – Channel constricted by culvert and pervious stone fill (SC PB18)

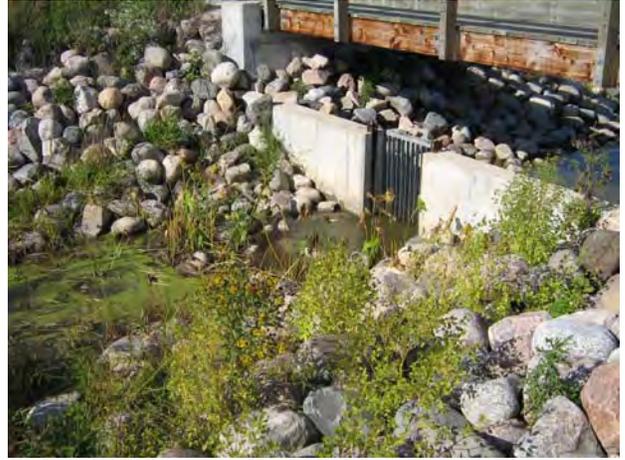
Photograph 2 – Trinity Creek wetland habitat area concrete dam with steel gate (SC PB5)

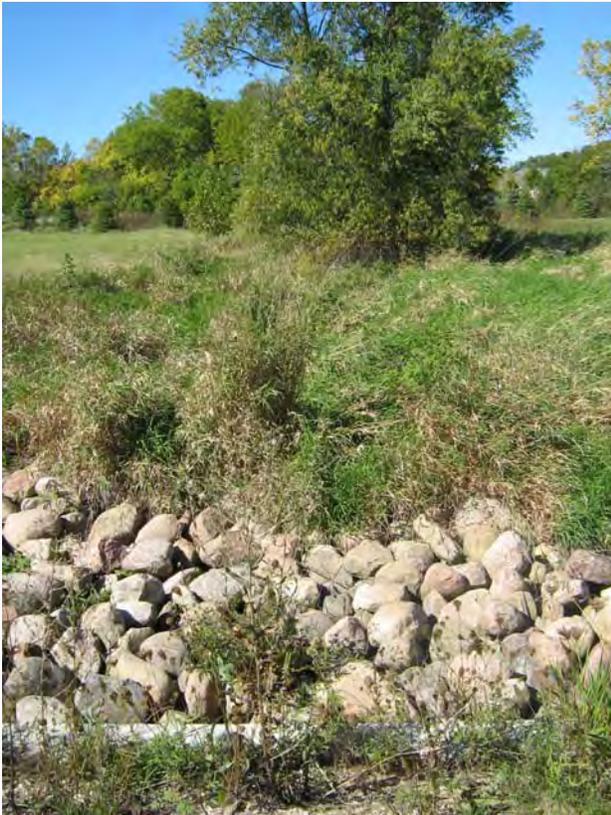
Photograph 3 – Artificial cascade formed by stone riprap at box culvert inlet (SC PB11)

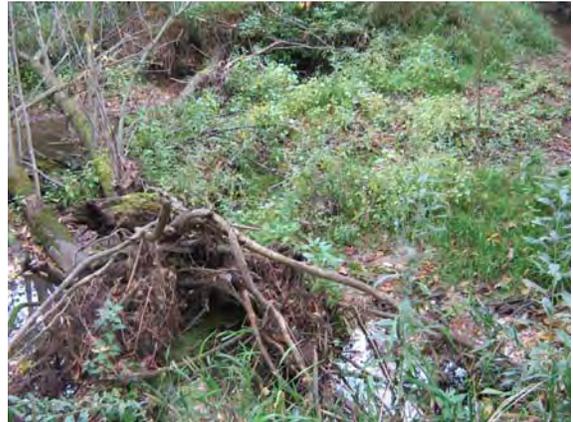
Photograph 2 – Large natural log jam with sediment aggradation (UC PB14A)

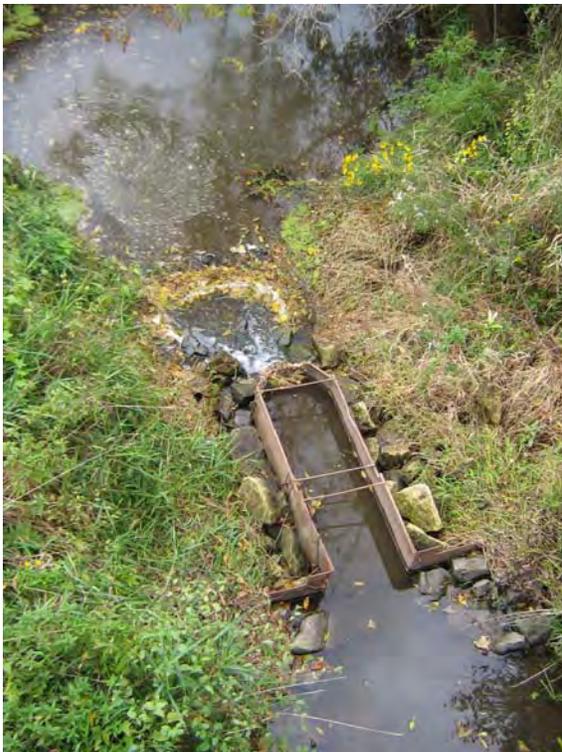
Photograph 3 – Channel constricted by steel flume stabilized with stone and soil fill (UC PB19)

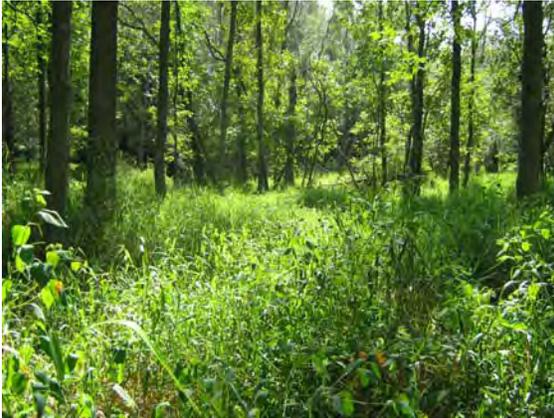
Four areas of desirable northern pike-spawning habitat were observed during field inspection. The first is a large floodplain wetland extending from the Cedar Creek confluence upstream approximately 1000 feet. The Creek channel disperses upon reaching the upstream boundary of this wetland and the wetland likely isolates the Creek during all but very high flow events. It is forested but relatively open with a dense herbaceous layer dominated by reed-canary grass. Watermarks on mature trees indicate that water depths slightly less than 6 inches are common.

Photograph 1 – Channel lost to dispersion in forested floodplain wetland (UC1 PB4)

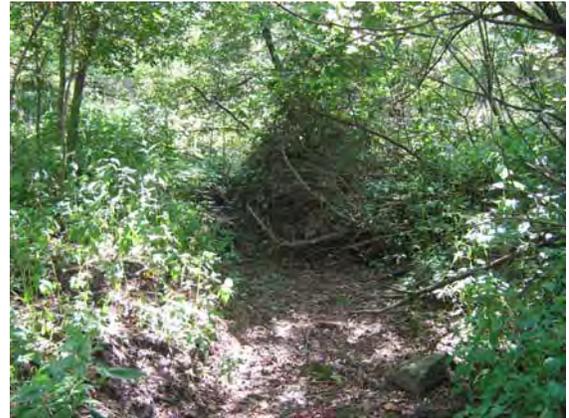
Photograph 2 – Channel lost to braiding and ingrown vegetation (UC1 PB3)

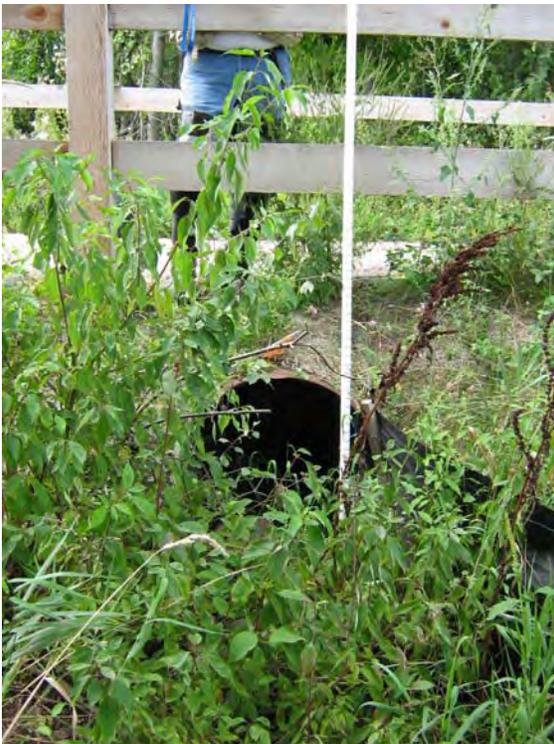
Photograph 3 – Channel constricted and scoured by a narrow culvert that has a pervious debris jam at its inlet (UC1 PB2)

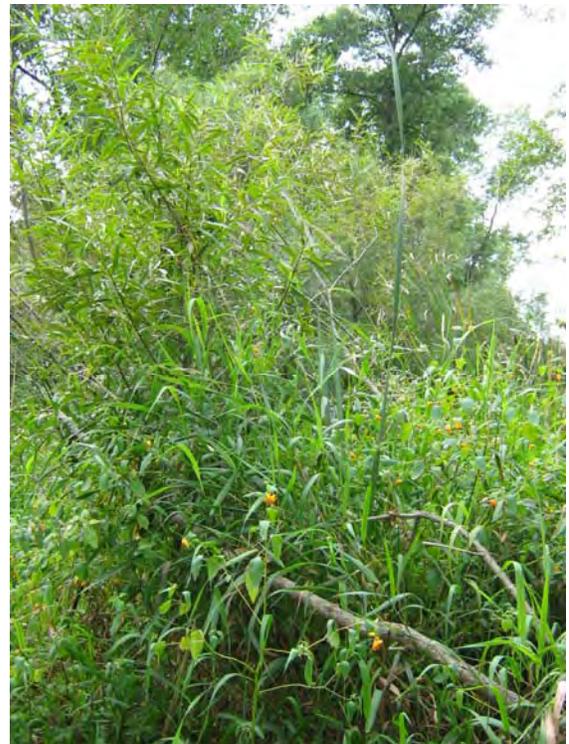
Finally, the littoral zone of the Pond is densely vegetated by cattails and appears to have many desirable pike-spawning habitat characteristics. The Pond outlet is also inhabited by a variety of other hydrophytic species (Photograph 4).

Photograph 4 – Dense vegetation along channel banks of the Pond outlet

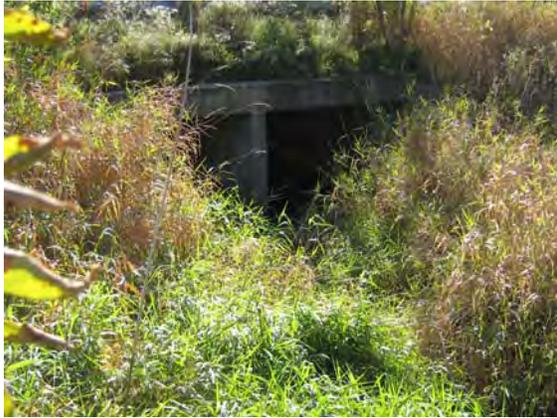
Photograph 1 – Box culverts with sediment aggradations and densely ingrown vegetation (UC2 PB2)

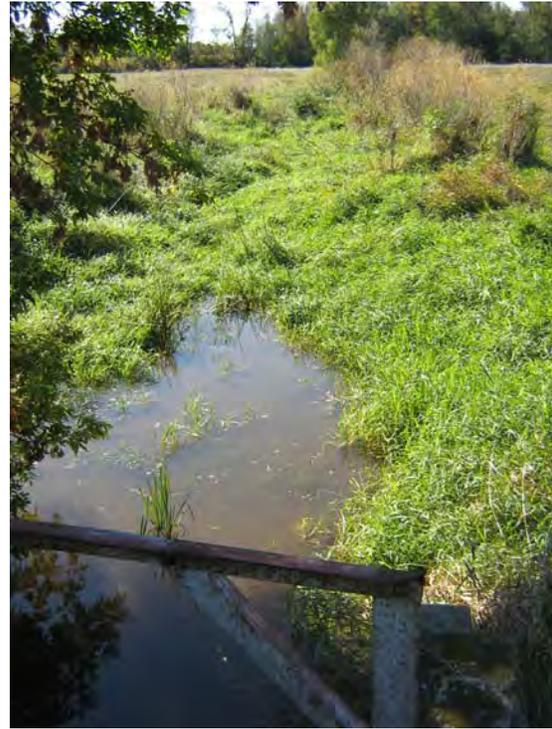
Photograph 2 – Channel lost to densely ingrown vegetation (UC2 PB4B)

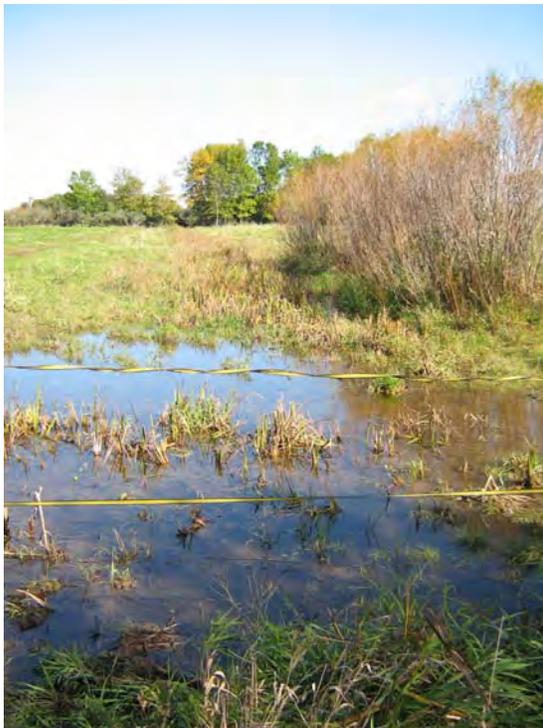
Photograph 3 – Channel lost to excessive sedimentation (UC1 PB4B)

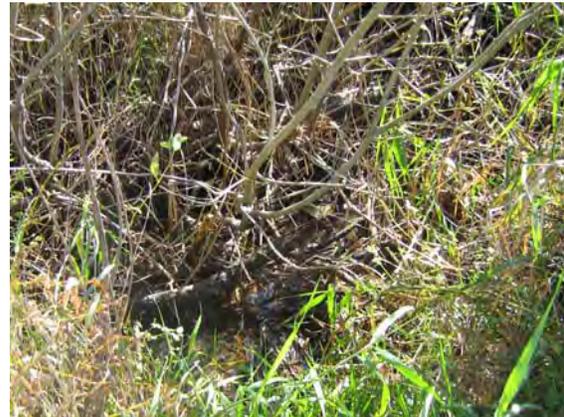
Photograph 4 – Densely ingrown sandbar willow (UC2 PB7)
